Precautions for using zirconia implant abutments

authors_Moustafa N Aboushelib*, Egypt, and Rien van Paridon**, Netherlands *DDS, MSc, PhD, Dental Biomaterials department, Faculty of Dentistry, Alexandria University, Egypt **DDS, PhD, Materials Science Department, ACTA, University of Amsterdam and the Free University, The Netherlands

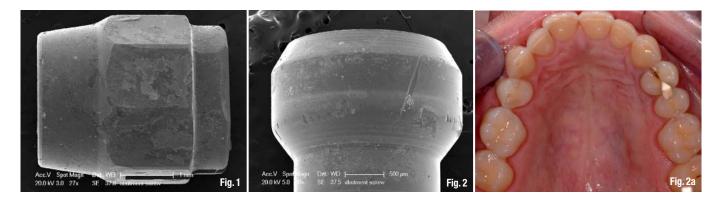
Fig. 1_SEM image, 27x. Internal metallic nut which depends on friction fit inside the zirconia implant abutment.

Fig. 2_SEM image, 10x. The metallic fixation screw used to press on the metallic nut for providing adequate retention with the implant body.
Fig. 2a_A broken maxillary premolar was extracted and implant was immediately inserted.

Fig. 2b_ Procera zirconia abutment. Fig. 2c_ Procera zirconia veneered crown inserted over the zirconia abutment.

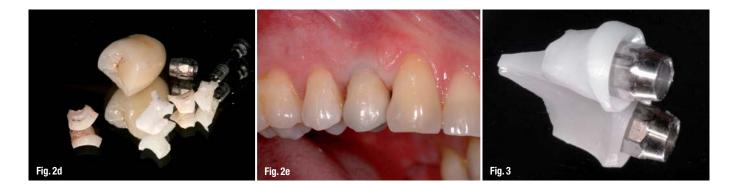
records indicated that the patient complained of loosening of the implant supported zirconia veneered crown (tooth 21). The treating dentist also complained that the internal metallic nut lost friction contact with the zirconia abutment and that he had to re-assemble the components before screw fixation. The abutment was fractured after two incidence of screw loosening. The same problem led to fracture of the second abutment after which the dentist decided to insert a titanium abutment. Scanning electron microscopic examination indicated that the abutment was fractured due to pressure from the metallic screw nut.

Fig. 2d_ The first and the second Procera zirconia abutments were fractured after short period of service intra-orally.

Fig. 2e_ A new zirconia veneered crown was inserted over a titanium abutment. Observe the grayish color at the cervical margin. Fig. 3_ Digital image demonstrating a fractured zirconia abutment due to over reduction of the buccal wall.

Fig. 4a_ Digital image of a broken veneer porcelain from a four unit implant supported fixed partial denture. Fig. 4b_ Digital image demonstrating the contact surface with the implant body. Antirotation is not required for this fixed partial denture as the whole framework and the implant abutment are joined into a single superstructure.

Once the metallic nut has lost friction fit with the zirconia abutment it can not be correctly reinserted inside the abutment and areas of friction contact between the improperly assembled components could lead to generation of high internal stresses causing fracture of the zirconia implant abutment as was reported for the two examined abutments. A new abutment should be used in such case.

Zirconia is a brittle ceramic material that must be used in adequate thickness to gain full potential of its high strength. A minimal wall thickness (0.5-0.7mm) is required in the entire structure of the zirconia implant abutment. This thickness must be increased in areas of high stresses to avoid unexpected fracture. Tilt correction—resulted in over reduction of the buccal wall (0.3 mm thickness) which resulted in fracture of the weakened segment. To reduce possibility of fracture, it is recommend to use a metallic abutment for correction of angle of insertion.
