# Quality of implant surfaces and deficient osseointegration

## Part I: Deficient implant surfaces and production processes

Author\_Dr Nikolaos Papagiannoulis

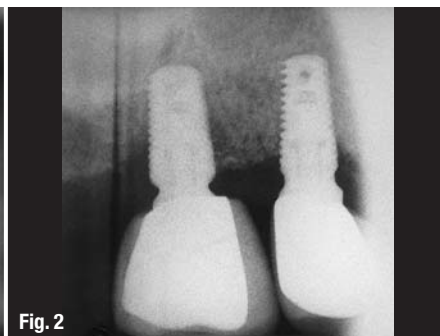
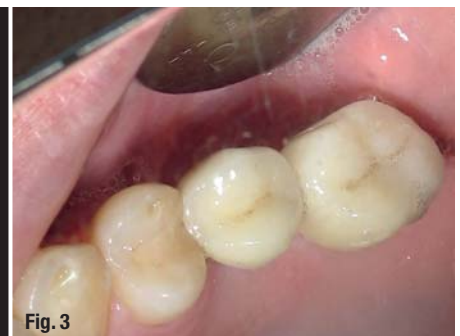
**Figs. 1-3** The clinical examination found a mesial rotation of implant #16 of approximately 10 degrees and implant mobility. The radiograph showed bone resorption around implant #16 (4.7 mm × 8 mm) of 2 mm distally and around implant #15 (4.1 mm × 8 mm) of 1 mm mesially.

Two weeks after loading, the patient complained about occlusal malfunction in region #16. The clinical examination found a mesial rotation of #16 of approximately 10 degrees. A closer look revealed implant mobility. On the radiograph, we could detect bone resorption around implant #16 (4.7 mm × 8 mm) of 2 mm distally and around implant #15 (4.1 mm × 8 mm) of 1 mm mesially. Nonetheless, these observations were insufficient to explain the clinical findings (Figs. 1–3).

The mobility of #16 was identified as rotation. Separating the crowns from each other and the adjacent tooth, #14, led to explantation at zero torque. The macroscopic examination of the implants found a clean implant surface on the coronal half and some indications of tissue on-growth on the apical half. The

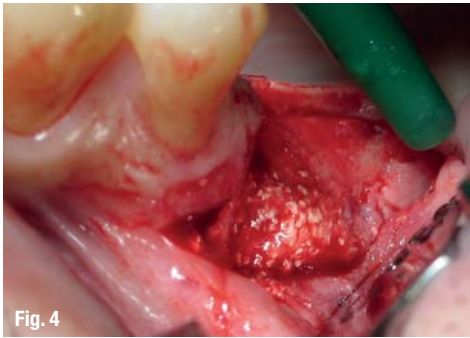
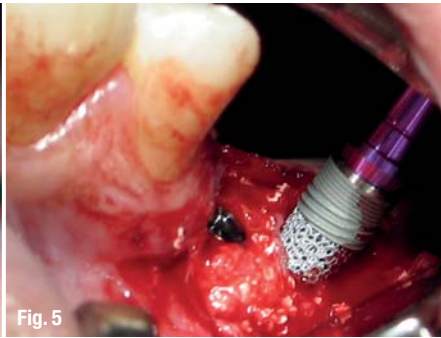
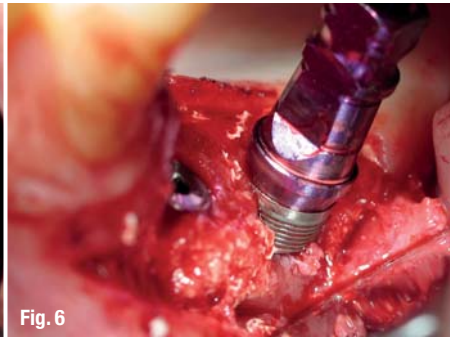
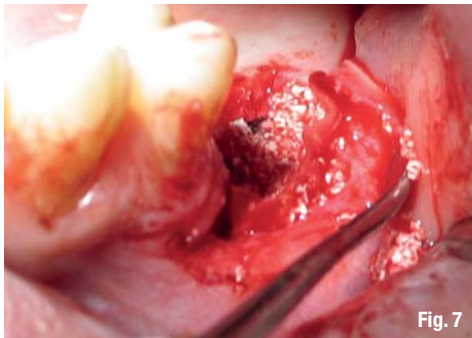
**Figs. 4–7** Insertion of two implants with a modern design and a porous tantalum cylinder, as well as promising osseo-incorporation.

Three months after the implant failure, the surgical was repeated. Since we had not received a statement from the manufacturer yet, we decided on a different implant type. We inserted two implants with a modern design and a porous tantalum cylinder, as well as promising osseo-incorporation (Figs. 4–7). In order to reduce risk and prevent any further complications, we allowed a healing phase of four months, taking into consideration that the rest of the implant body had shown standard surface characteristics.

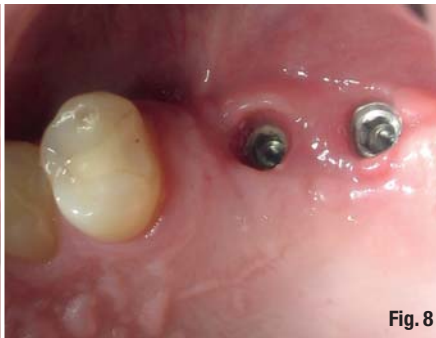
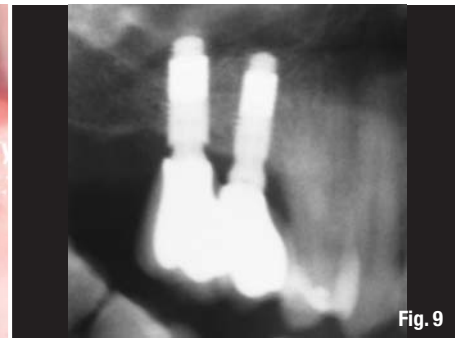
**Figs. 8 & 9** Sandwich technique with autologous bone, allograft and xenograft.

During surgery, we determined after raising the flap that no bone loss resulting from the explantation had occurred. Also all of the bone augmented buccally during the first surgery (region #15) remained. These findings solidified our strong suspicion that the first implant probably had surface defects that had influenced osseointegration. Guided bone regeneration at region #16 to ensure 2 mm of bone buccally (sandwich technique with autologous bone, allograft and xenograft; Figs. 8&9) was performed. The implants inserted had a diameter of 4.1 mm and 4.7 mm, respectively.
