Quality of implant surfaces and deficient osseointegration

Part I: Deficient implant surfaces and production processes

Author_Dr Nikolaos Papagiannoulis

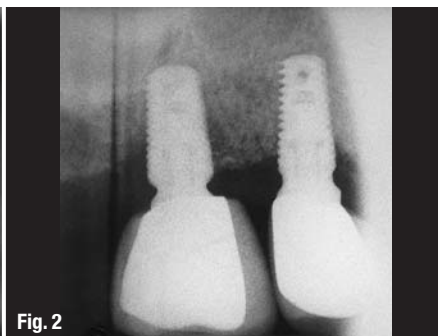
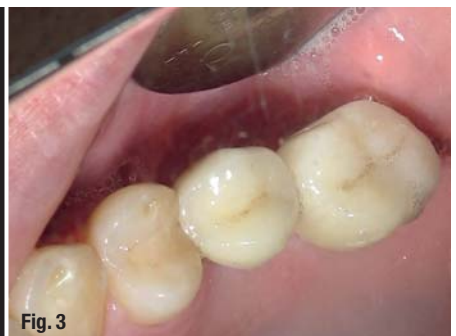
Figs. 1-3 The clinical examination found a mesial rotation of implant #16 of approximately 10 degrees and implant mobility. The radiograph showed bone resorption around implant #16 (4.7 mm × 8 mm) of 2 mm distally and around implant #15 (4.1 mm × 8 mm) of 1 mm mesially.

Two weeks after loading, the patient complained about occlusal malfunction in region #16. The clinical examination found a mesial rotation of #16 of approximately 10 degrees. A closer look revealed implant mobility. On the radiograph, we could detect bone resorption around implant #16 (4.7 mm × 8 mm) of 2 mm distally and around implant #15 (4.1 mm × 8 mm) of 1 mm mesially. Nonetheless, these observations were insufficient to explain the clinical findings (Figs. 1–3).

The mobility of #16 was identified as rotation. Separating the crowns from each other and the adjacent tooth, #14, led to explantation at zero torque. The macroscopic examination of the implants found a clean implant surface on the coronal half and some indications of tissue on-growth on the apical half. The
