Quality of implant surfaces and deficient osseointegration

Part I: Deficient implant surfaces and production processes

Author_Dr Nikolaos Papagiannoulis

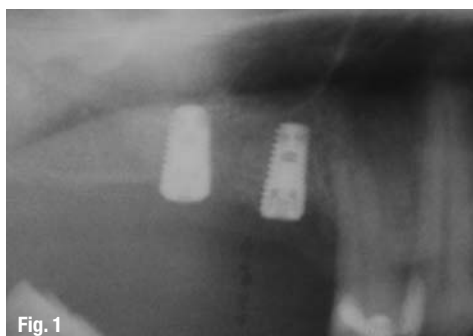
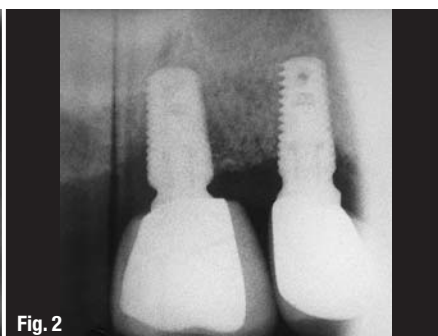
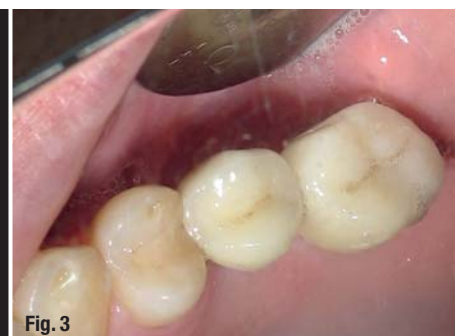
Figs. 1-3_ The clinical examination found a mesial rotation of implant #16 of approximately 10 degrees and implant mobility. The radiograph showed bone resorption around implant #16 (4.7 mm × 8 mm) of 2 mm distally and around implant #15 (4.1 mm × 8 mm) of 1 mm mesially.

Two weeks after loading, the patient complained about occlusal malfunction in region #16. The clinical examination found a mesial rotation of #16 of approximately 10 degrees. A closer look revealed implant mobility. On the radiograph, we could detect bone resorption around implant #16 (4.7 mm × 8 mm) of 2 mm distally and around implant #15 (4.1 mm × 8 mm) of 1 mm mesially. Nonetheless, these observations were insufficient to explain the clinical findings (Figs. 1–3).

The mobility of #16 was identified as rotation. Separating the crowns from each other and the adjacent tooth, #14, led to explantation at zero torque. The macroscopic examination of the implants found a clean implant surface on the coronal half and some indications of tissue on-growth on the apical half. The

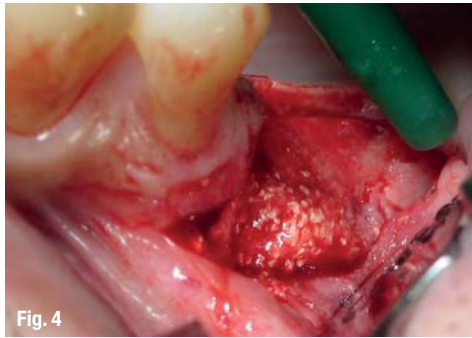
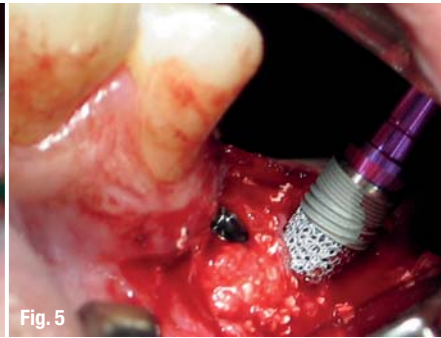
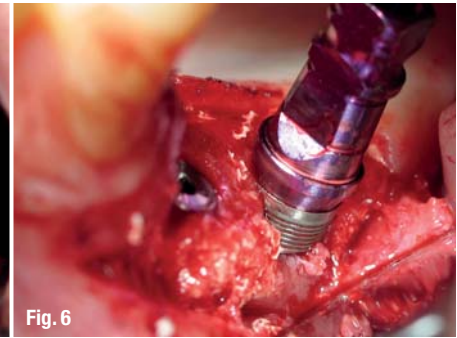
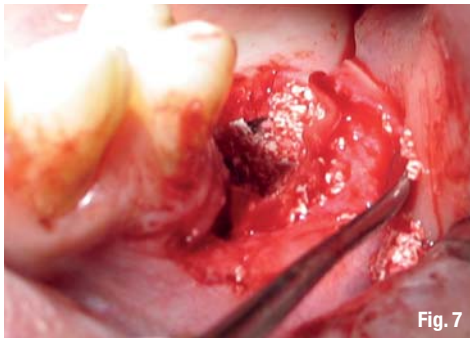
Figs. 4–7 Insertion of two implants with a modern design and a porous tantalum cylinder, as well as promising osseo-incorporation.

Three months after the implant failure, the surgical was repeated. Since we had not received a statement from the manufacturer yet, we decided on a different implant type. We inserted two implants with a modern design and a porous tantalum cylinder, as well as promising osseo-incorporation (Figs. 4–7). In order to reduce risk and prevent any further complications, we allowed a healing phase of four months, taking into consideration that the rest of the implant body had shown standard surface characteristics.

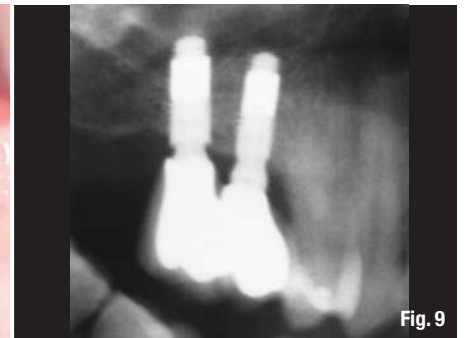
Figs. 8 & 9 Sandwich technique with autologous bone, allograft and xenograft.

During surgery, we determined after raising the flap that no bone loss resulting from the explantation had occurred. Also all of the bone augmented buccally during the first surgery (region #15) remained. These findings solidified our strong suspicion that the first implant probably had surface defects that had influenced osseointegration. Guided bone regeneration at region #16 to ensure 2 mm of bone buccally (sandwich technique with autologous bone, allograft and xenograft; Figs. 8&9) was performed. The implants inserted had a diameter of 4.1 mm and 4.7 mm, respectively.
