Quality of implant surfaces and deficient osseointegration

Part I: Deficient implant surfaces and production processes

Author_Dr Nikolaos Papagiannoulis

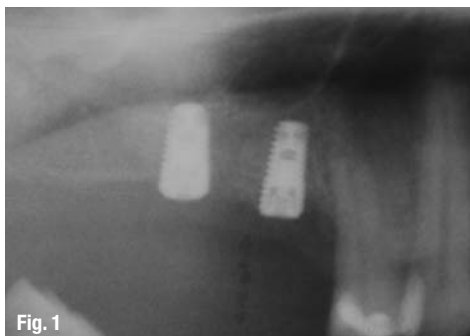
Figs. 1-3 The clinical examination found a mesial rotation of implant #16 of approximately 10 degrees and implant mobility. The radiograph showed bone resorption around implant #16 (4.7 mm × 8 mm) of 2 mm distally and around implant #15 (4.1 mm × 8 mm) of 1 mm mesially.

Two weeks after loading, the patient complained about occlusal malfunction in region #16. The clinical examination found a mesial rotation of #16 of approximately 10 degrees. A closer look revealed implant mobility. On the radiograph, we could detect bone resorption around implant #16 (4.7 mm × 8 mm) of 2 mm distally and around implant #15 (4.1 mm × 8 mm) of 1 mm mesially. Nonetheless, these observations were insufficient to explain the clinical findings (Figs. 1–3).

The mobility of #16 was identified as rotation. Separating the crowns from each other and the adjacent tooth, #14, led to explantation at zero torque. The macroscopic examination of the implants found a clean implant surface on the coronal half and some indications of tissue on-growth on the apical half. The

osteotomy in the bone showed no signs of soft-tissue ingrowth, as is often seen in cases of implant mobility caused by peri-implantitis. Further signs of inflammation were not evident.
