Quality of implant surfaces and deficient osseointegration

Part I: Deficient implant surfaces and production processes

Author_Dr Nikolaos Papagiannoulis

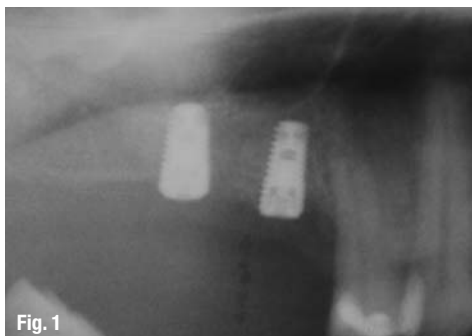
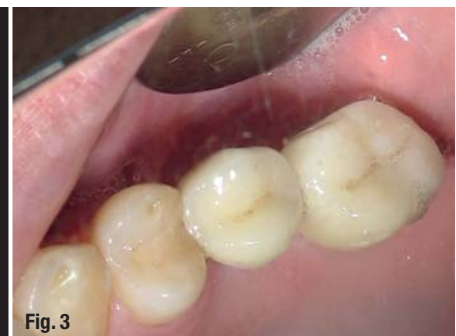
Figs. 1-3_The clinical examination found a mesial rotation of implant #16 of approximately 10 degrees and implant mobility. The radiograph showed bone resorption around implant #16 (4.7 mm × 8 mm) of 2 mm distally and around implant #15 (4.1 mm × 8 mm) of 1 mm mesially.

Two weeks after loading, the patient complained about occlusal malfunction in region #16. The clinical examination found a mesial rotation of #16 of approximately 10 degrees. A closer look revealed implant mobility. On the radiograph, we could detect bone resorption around implant #16 (4.7 mm × 8 mm) of 2 mm distally and around implant #15 (4.1 mm × 8 mm) of 1 mm mesially. Nonetheless, these observations were insufficient to explain the clinical findings (Figs. 1–3).

The mobility of #16 was identified as rotation. Separating the crowns from each other and the adjacent tooth, #14, led to explantation at zero torque. The macroscopic examination of the implants found a clean implant surface on the coronal half and some indications of tissue on-growth on the apical half. The

osteotomy in the bone showed no signs of soft-tissue ingrowth, as is often seen in cases of implant mobility caused by peri-implantitis. Further signs of inflammation were not evident.

Since we could not explain the reason for this implant failure, we decided against immediate implantation and to allow healing of the sockets. After a collagen fleece had been applied to the sockets, the wound was fixed with single sutures.

Implant #15 was sent back to the manufacturer for reclamation and analysis. Implant #16 was sent to a university for further examination, microscopy and reflection electron microscope morphometry. Our focus was on the analysis of defects and determination of the implant surface roughness in order to compare this analysis with the manufacturer's data.

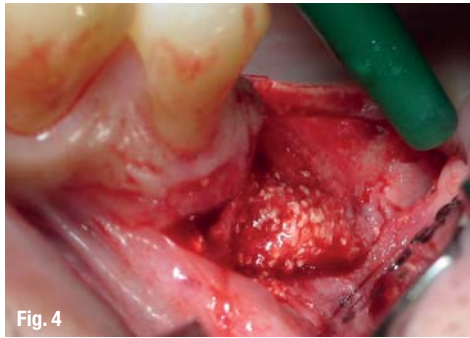
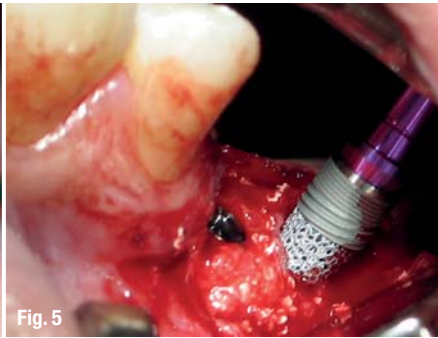
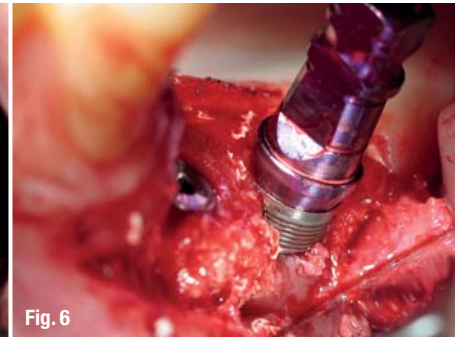
Fig. 7

Figs. 4–7 Insertion of two implants with a modern design and a porous tantalum cylinder, as well as promising osseo-incorporation.

Three months after the implant failure, the surgical was repeated. Since we had not received a statement from the manufacturer yet, we decided on a different implant type. We inserted two implants with a modern design and a porous tantalum cylinder, as well as promising osseo-incorporation (Figs. 4–7). In order to reduce risk and prevent any further complications, we allowed a healing phase of four months, taking into consideration that the rest of the implant body had shown standard surface characteristics.
