# Quality of implant surfaces and poor osseointegration

## Part II: Irregular surface roughness suspected of causing deficient osseointegration

**Authors** Drs Nikolaos Papagiannoulis, Andreas Sakkas & Adrian Kasaj, Germany

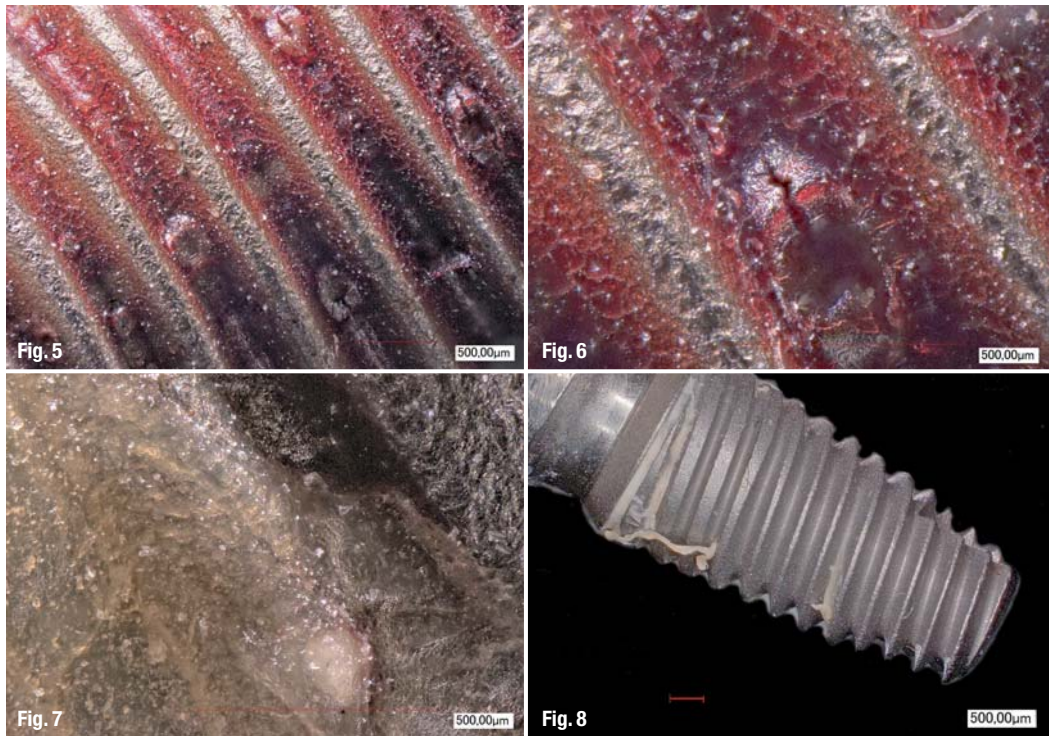
**Fig. 5**\_Implant #002 (SBA M-line) at 100× magnification.

**Figs. 6 & 7**\_Implant #002 (SBA M-line) at 300× magnification.

**Fig. 8**\_Implant #007 (ZBM) at 30× magnification.

tectible. At 100×, parts on the crestal implant body with sanding marks and no surface treatment were observed. At 300×, structural defects due to blasting media and massive residue could be seen. Besides production faults, there was a reduced and irregular roughness. We also made findings that could not be specified, but that included artificial and faulty defects (Figs. 1–10).

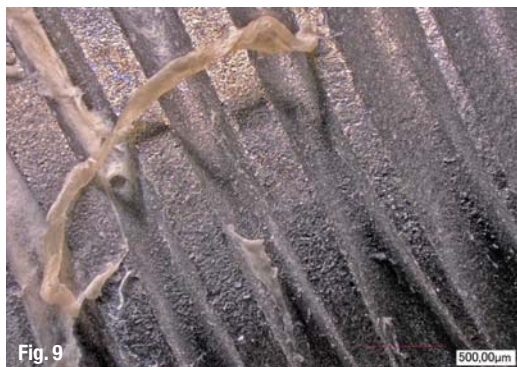
**Fig. 9**\_Implant #007 (ZBM) at 100× magnification.

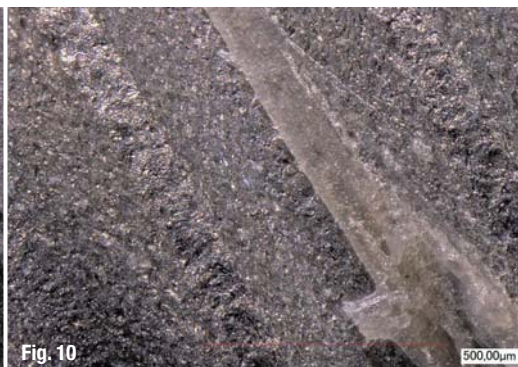
**Fig. 10**\_Implant #007 (ZBM) at 400× magnification.

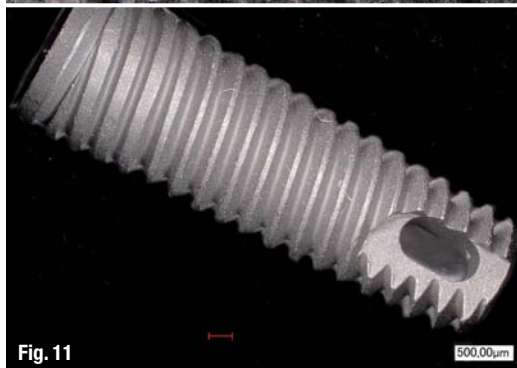
**Fig. 11**\_Implant #0011 (ZBM Kontr.) at 30× magnification: bone-level implant, blasted and not etched.

Implant #0011 was only blasted and not etched. It was a bone-level implant. Apart from blasting media residue covering the whole implant body, we detected metal cuttings. The presence of such cuttings could be explained as being due to deficient cleaning procedures and poor quality control, since such contamination was apparently not detected. Generally, the surface appeared rather metallic. Reflection electron microscopy would help determine micro-roughness (Figs. 11–13).

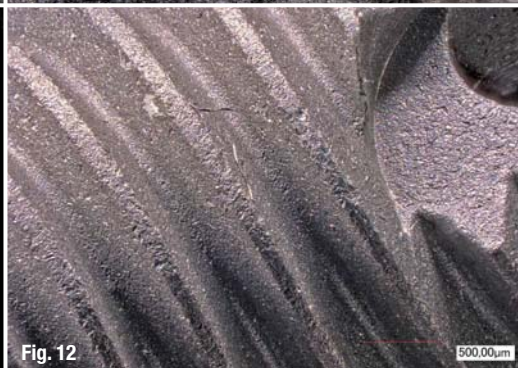
**Fig. 12**\_Implant #0011 (ZBM Kontr.) at 100× magnification: the surface appears rather metallic.

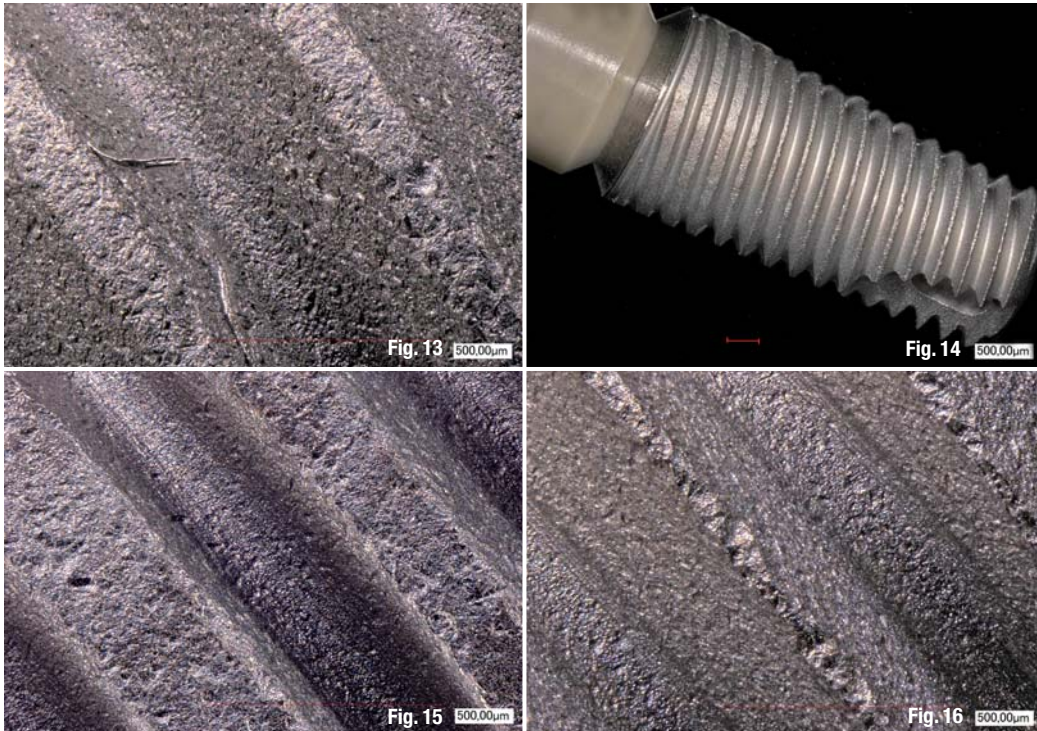
These implants exhibited a more precise thread design and surface treatment. The metallic lustre of the surface and the major blasting media defects on the crest of the threads were prominent. The thread flanks showed no macrostructure, so we found also in these implants an irregular surface roughness. The most serious issue in this group was the labelling of the implants as bone level although the implants had a machined collar inside (Figs. 14–16).

**Fig. 13** Implant #0011 (ZBM Kontr.) at 300× magnification.

**Fig. 14** Implant #0012 (SBA B-line) at 30× magnification.

**Fig. 15** Implant #0012 (SBA B-line) at 100× magnification.

**Fig. 16** Implant #0012 (SBA B-line) at 300× magnification.
