Quality of implant surfaces and poor osseointegration

Part II: Irregular surface roughness suspected of causing deficient osseointegration

Authors Drs Nikolaos Papagiannoulis, Andreas Sakkas & Adrian Kasaj, Germany

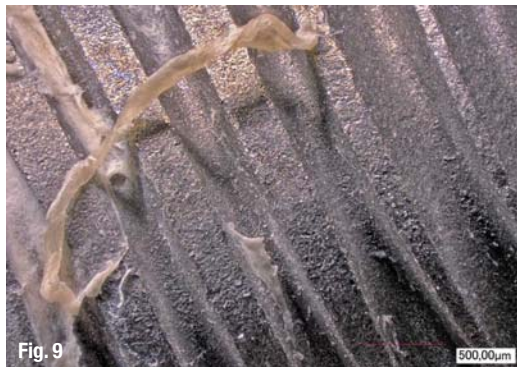
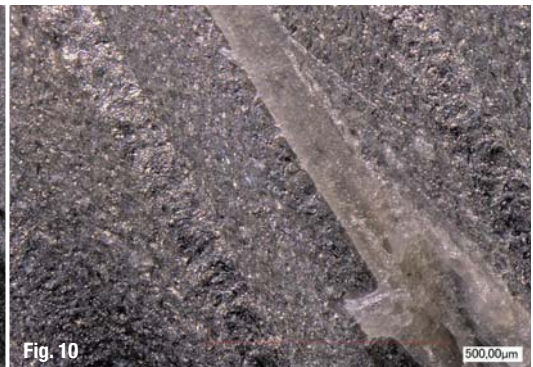
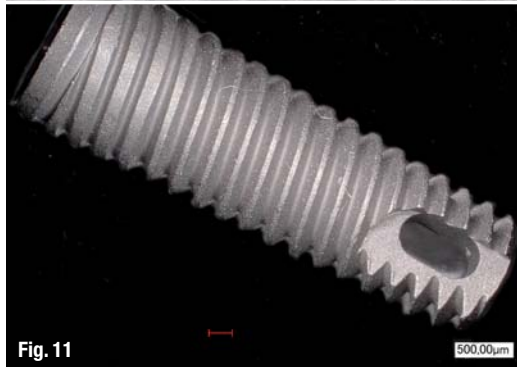
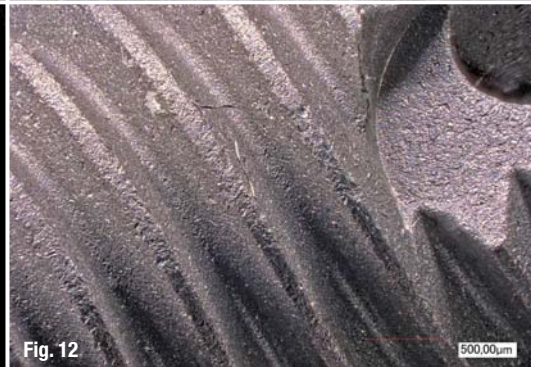
Fig. 9_Implant #007 (ZBM) at 100× magnification.

Fig. 10_Implant #007 (ZBM) at 400× magnification.

Fig. 11_Implant #0011 (ZBM Kontr.) at 30× magnification: bone-level implant, blasted and not etched.

Fig. 12_Implant #0011 (ZBM Kontr.) at 100× magnification: the surface appears rather metallic.

Implant #0011 was only blasted and not etched. It was a bone-level implant. Apart from blasting media residue covering the whole implant body, we detected metal cuttings. The presence of such cuttings could be explained as being due to deficient cleaning procedures and poor quality control, since such contamination was apparently not detected. Generally, the surface appeared rather metallic. Reflection electron microscopy would help determine micro-roughness (Figs. 11–13).

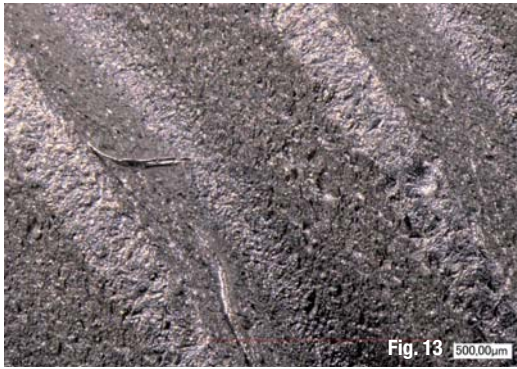
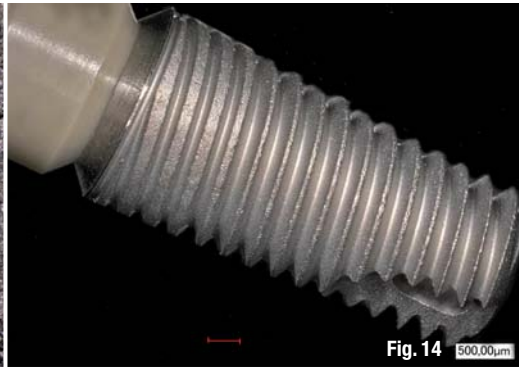
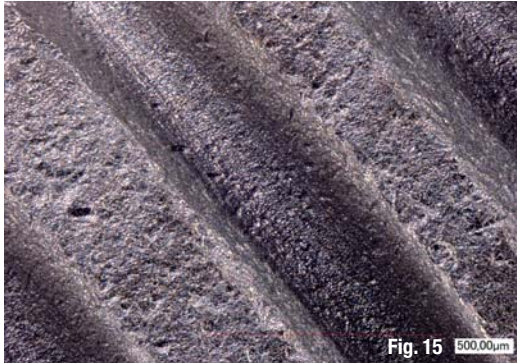
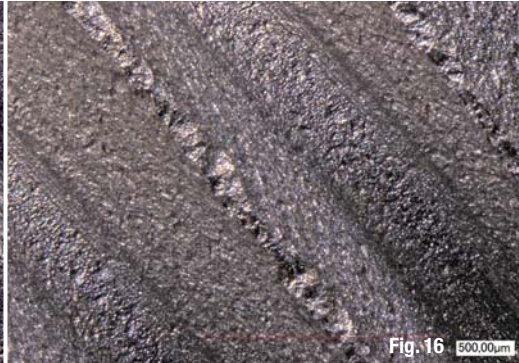
These implants exhibited a more precise thread design and surface treatment. The metallic lustre of the surface and the major blasting media defects on the crest of the threads were prominent. The thread flanks showed no macrostructure, so we found also in these implants an irregular surface roughness. The most serious issue in this group was the labelling of the implants as bone level although the implants had a machined collar inside (Figs. 14–16).

Fig. 13 Implant #0011 (ZBM Kontr.) at 300× magnification.

Fig. 14 Implant #0012 (SBA B-line) at 30× magnification.

Fig. 15 Implant #0012 (SBA B-line) at 100× magnification.

Fig. 16 Implant #0012 (SBA B-line) at 300× magnification.
