# Quality of implant surfaces and poor osseointegration

## Part II: Irregular surface roughness suspected of causing deficient osseointegration

**Authors** Drs Nikolaos Papagiannoulis, Andreas Sakkas & Adrian Kasaj, Germany

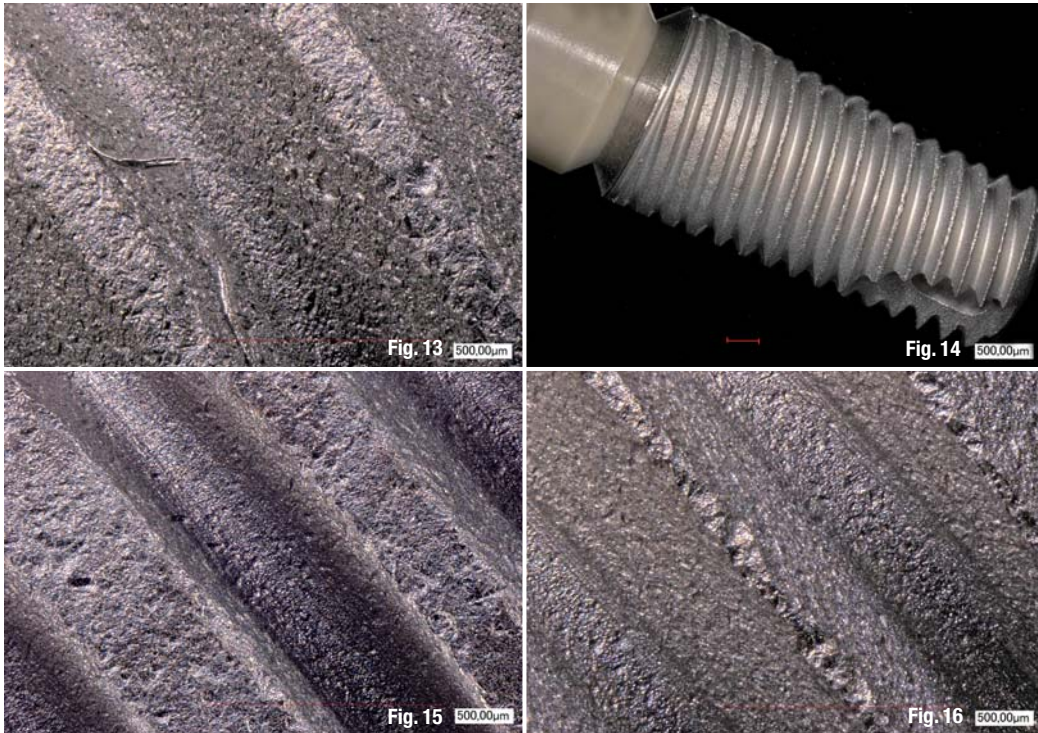
Implant #0011 was only blasted and not etched. It was a bone-level implant. Apart from blasting media residue covering the whole implant body, we detected metal cuttings. The presence of such cuttings could be explained as being due to deficient cleaning procedures and poor quality control, since such contamination was apparently not detected. Generally, the surface appeared rather metallic. Reflection electron microscopy would help determine micro-roughness (Figs. 11–13).

**Fig. 13** Implant #0011 (ZBM Kontr.) at 300× magnification.
