Quality of implant surfaces and poor osseointegration

Part II: Irregular surface roughness suspected of causing deficient osseointegration

Authors Drs Nikolaos Papagiannoulis, Andreas Sakkas & Adrian Kasaj, Germany

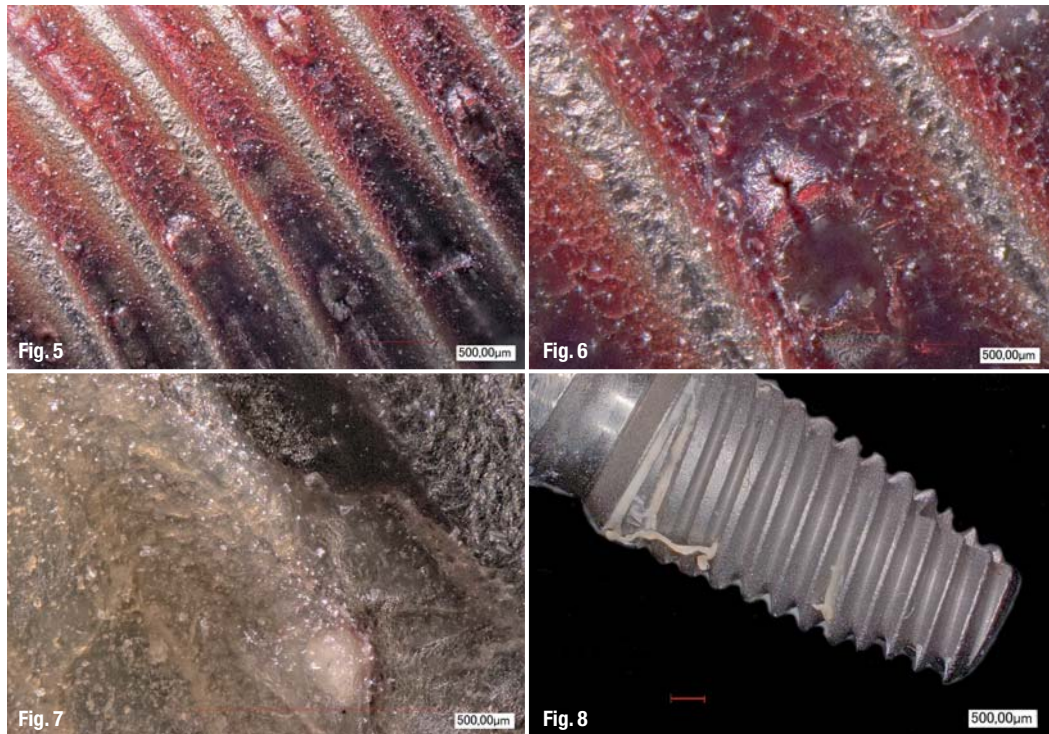
Fig. 5_Implant #002 (SBA M-line) at 100× magnification.

Figs. 6 & 7_Implant #002 (SBA M-line) at 300× magnification.

Fig. 8_Implant #007 (ZBM) at 30× magnification.

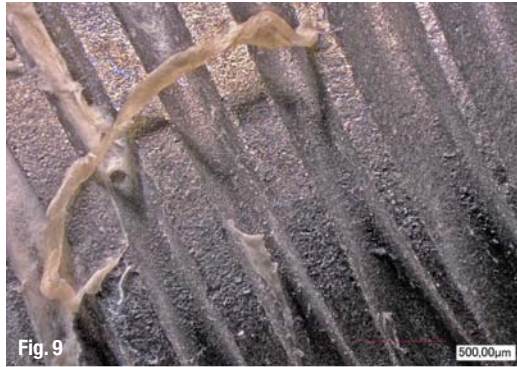
Fig. 9_Implant #007 (ZBM) at 100× magnification.

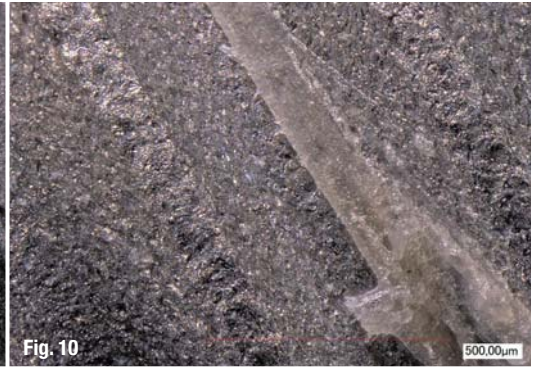
Fig. 10_Implant #007 (ZBM) at 400× magnification.

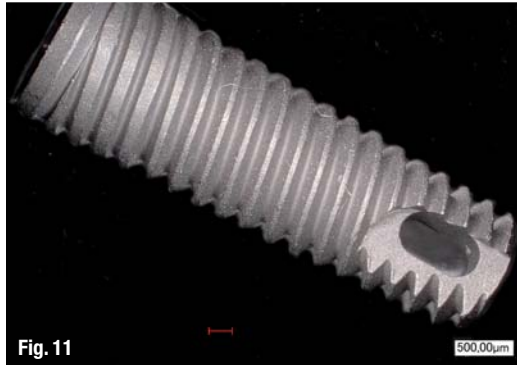
Fig. 11_Implant #0011 (ZBM Kontr.) at 30× magnification: bone-level implant, blasted and not etched.

Implant #0011 was only blasted and not etched. It was a bone-level implant. Apart from blasting media residue covering the whole implant body, we detected metal cuttings. The presence of such cuttings could be explained as being due to deficient cleaning procedures and poor quality control, since such contamination was apparently not detected. Generally, the surface appeared rather metallic. Reflection electron microscopy would help determine micro-roughness (Figs. 11–13).

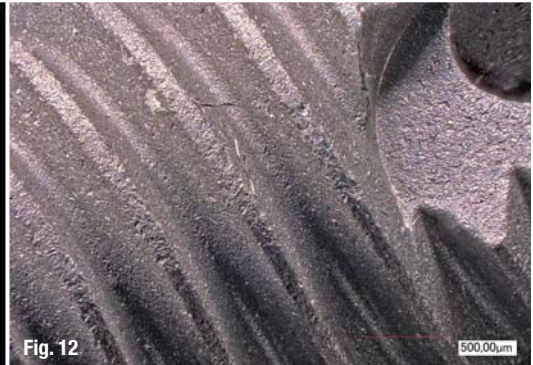
Fig. 12_Implant #0011 (ZBM Kontr.) at 100× magnification: the surface appears rather metallic.

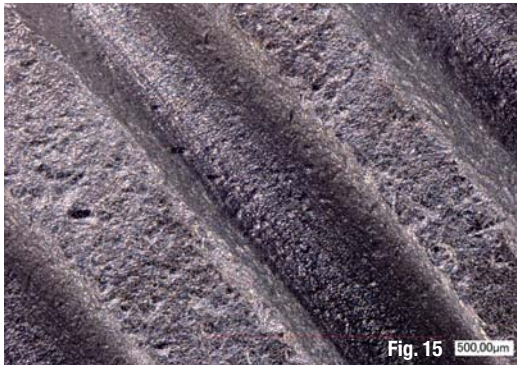
These implants exhibited a more precise thread design and surface treatment. The metallic lustre of the surface and the major blasting media defects on the crest of the threads were prominent. The thread flanks showed no macrostructure, so we found also in these implants an irregular surface roughness. The most serious issue in this group was the labelling of the implants as bone level although the implants had a machined collar inside (Figs. 14–16).

Fig. 15 Implant #0012 (SBA B-line) at 100× magnification.

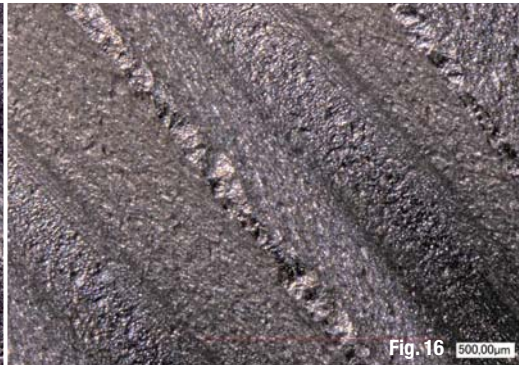
Fig. 16 Implant #0012 (SBA B-line) at 300× magnification.
