# Quality of implant surfaces and deficient osseointegration

## Part I: Deficient implant surfaces and production processes

**Author**\_Dr Nikolaos Papagiannoulis

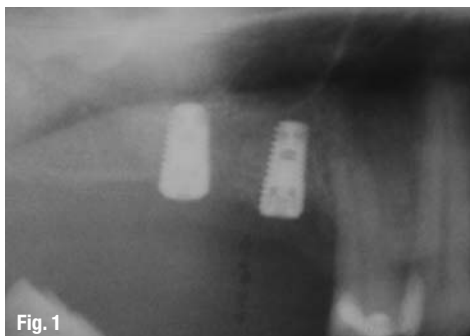
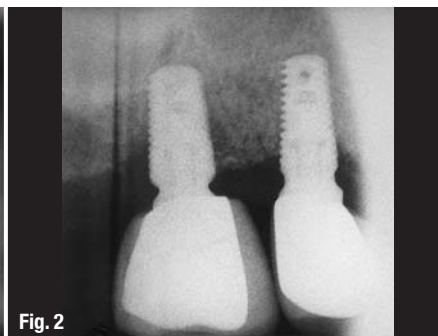
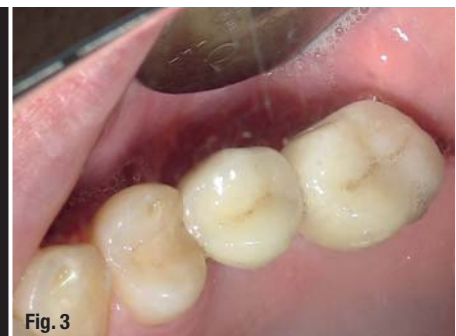
**Figs. 1-3**\_The clinical examination found a mesial rotation of implant #16 of approximately 10 degrees and implant mobility. The radiograph showed bone resorption around implant #16 (4.7 mm × 8 mm) of 2 mm distally and around implant #15 (4.1 mm × 8 mm) of 1 mm mesially.

Two weeks after loading, the patient complained about occlusal malfunction in region #16. The clinical examination found a mesial rotation of #16 of approximately 10 degrees. A closer look revealed implant mobility. On the radiograph, we could detect bone resorption around implant #16 (4.7 mm × 8 mm) of 2 mm distally and around implant #15 (4.1 mm × 8 mm) of 1 mm mesially. Nonetheless, these observations were insufficient to explain the clinical findings (Figs. 1–3).

The mobility of #16 was identified as rotation. Separating the crowns from each other and the adjacent tooth, #14, led to explantation at zero torque. The macroscopic examination of the implants found a clean implant surface on the coronal half and some indications of tissue on-growth on the apical half. The

Since we could not explain the reason for this implant failure, we decided against immediate implantation and to allow healing of the sockets. After a collagen fleece had been applied to the sockets, the wound was fixed with single sutures.

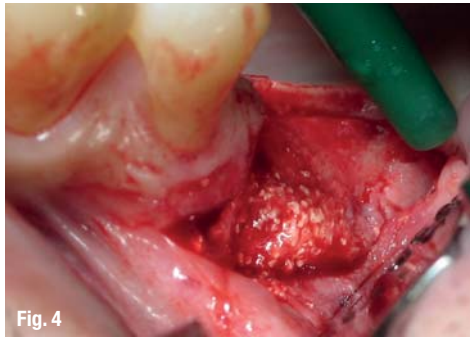
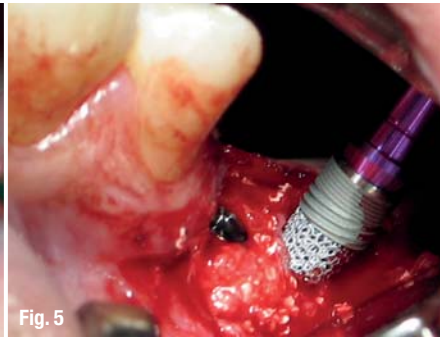
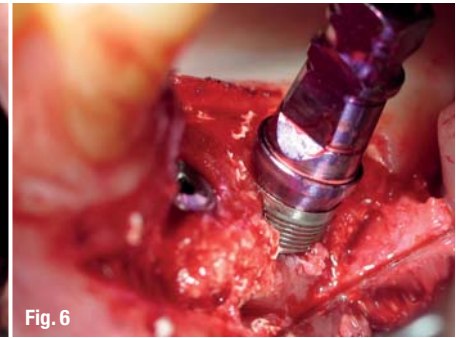
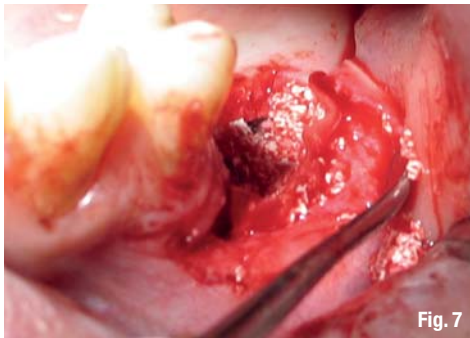
Fig. 7

**Figs. 4–7** Insertion of two implants with a modern design and a porous tantalum cylinder, as well as promising osseo-incorporation.

Three months after the implant failure, the surgical was repeated. Since we had not received a statement from the manufacturer yet, we decided on a different implant type. We inserted two implants with a modern design and a porous tantalum cylinder, as well as promising osseo-incorporation (Figs. 4–7). In order to reduce risk and prevent any further complications, we allowed a healing phase of four months, taking into consideration that the rest of the implant body had shown standard surface characteristics.

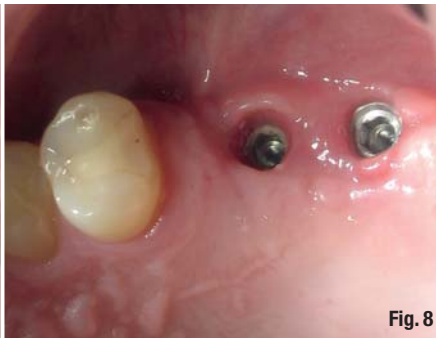
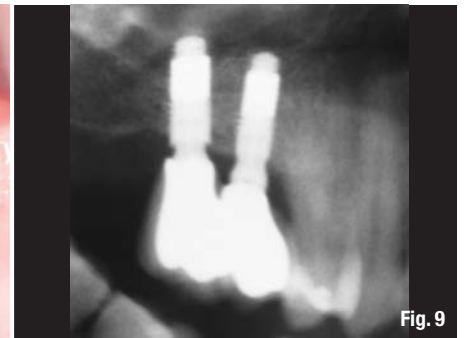
**Figs. 8 & 9** Sandwich technique with autologous bone, allograft and xenograft.

During surgery, we determined after raising the flap that no bone loss resulting from the explantation had occurred. Also all of the bone augmented buccally during the first surgery (region #15) remained. These findings solidified our strong suspicion that the first implant probably had surface defects that had influenced osseointegration. Guided bone regeneration at region #16 to ensure 2 mm of bone buccally (sandwich technique with autologous bone, allograft and xenograft; Figs. 8 & 9) was performed. The implants inserted had a diameter of 4.1 mm and 4.7 mm, respectively.
