Quality of implant surfaces and poor osseointegration

Part II: Irregular surface roughness suspected of causing deficient osseointegration

Authors Drs Nikolaos Papagiannoulis, Andreas Sakkas & Adrian Kasaj, Germany

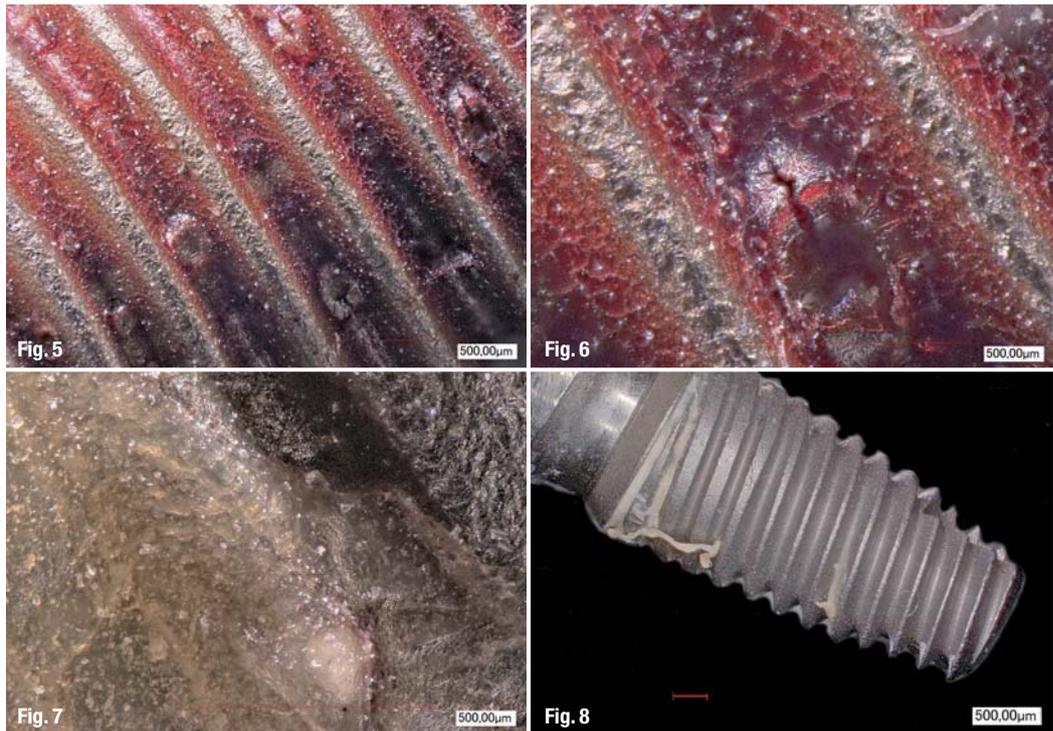
Fig. 5_Implant #002 (SBA M-line) at 100× magnification.
Figs. 6 & 7_Implant #002 (SBA M-line) at 300× magnification.
Fig. 8_Implant #007 (ZBM) at 30× magnification.

tectible. At 100×, parts on the crestal implant body with sanding marks and no surface treatment were observed. At 300×, structural defects due to blasting media and massive residue could be seen. Besides production faults, there was a reduced and irregular roughness. We also made findings that could not be specified, but that included artificial and faulty defects (Figs. 1–10).

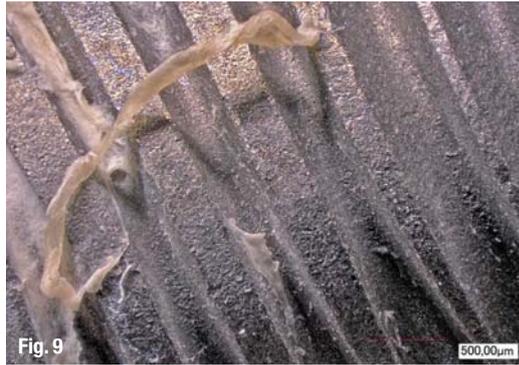
Fig. 9_Implant #007 (ZBM) at 100× magnification.

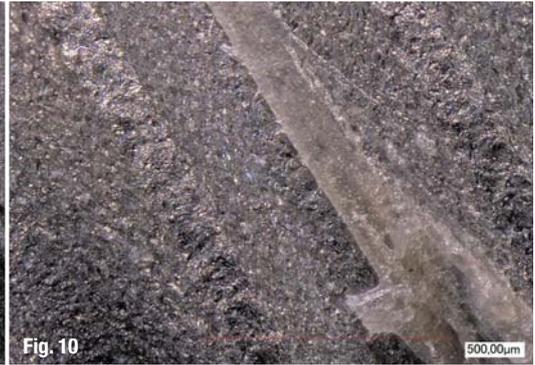
Fig. 10_Implant #007 (ZBM) at 400× magnification.

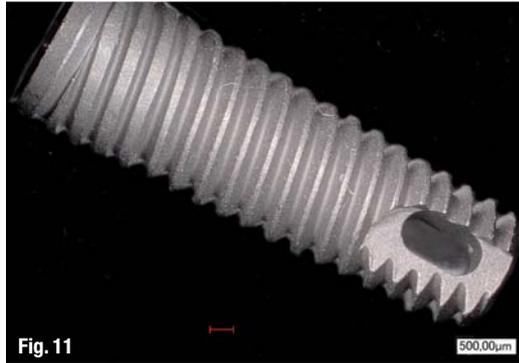
Fig. 11_Implant #0011 (ZBM Kontr.) at 30× magnification: bone-level implant, blasted and not etched.

Implant #0011 was only blasted and not etched. It was a bone-level implant. Apart from blasting media residue covering the whole implant body, we detected metal cuttings. The presence of such cuttings could be explained as being due to deficient cleaning procedures and poor quality control, since such contamination was apparently not detected. Generally, the surface appeared rather metallic. Reflection electron microscopy would help determine micro-roughness (Figs. 11–13).

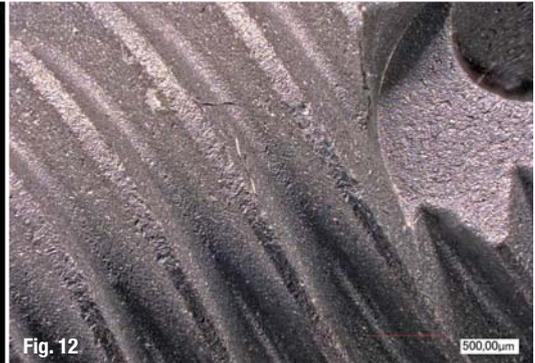
Fig. 12_Implant #0011 (ZBM Kontr.) at 100× magnification: the surface appears rather metallic.

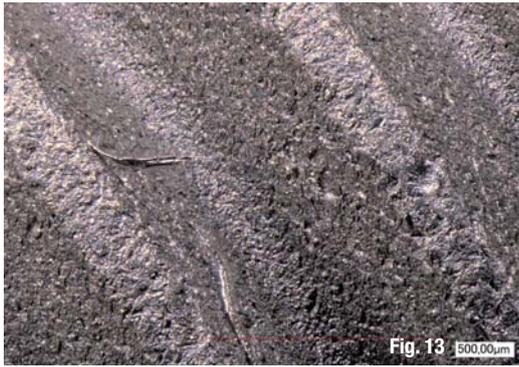
Fig. 13 Implant #0011 (ZBM Kontr.) at 300× magnification.

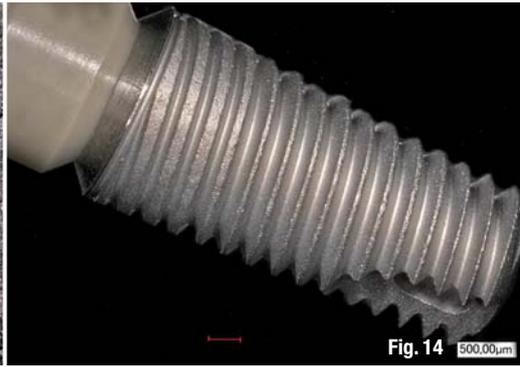
These implants exhibited a more precise thread design and surface treatment. The metallic lustre of the surface and the major blasting media defects on the crest of the threads were prominent. The thread flanks showed no macrostructure, so we found also in these implants an irregular surface roughness. The most serious issue in this group was the labelling of the implants as bone level although the implants had a machined collar inside (Figs. 14–16).

Fig. 14 Implant #0012 (SBA B-line) at 30× magnification.

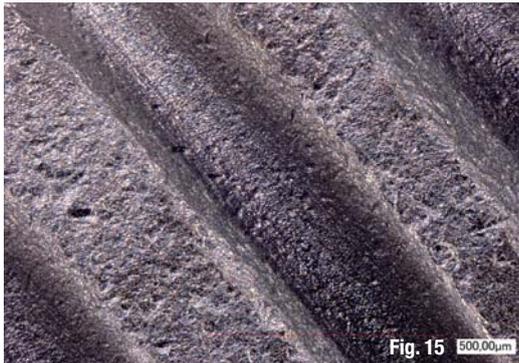
Fig. 15 Implant #0012 (SBA B-line) at 100× magnification.

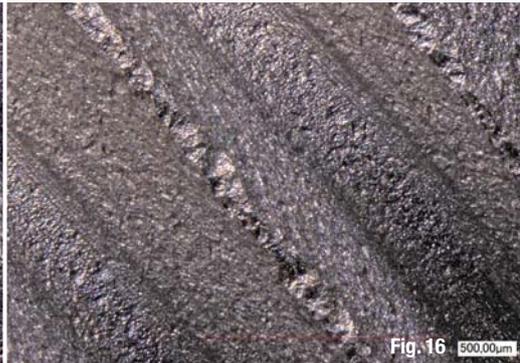
Fig. 16 Implant #0012 (SBA B-line) at 300× magnification.
