Precautions for using zirconia implant abutments

authors Moustafa N Aboushelib*, Egypt, and Rien van Paridon**, Netherlands

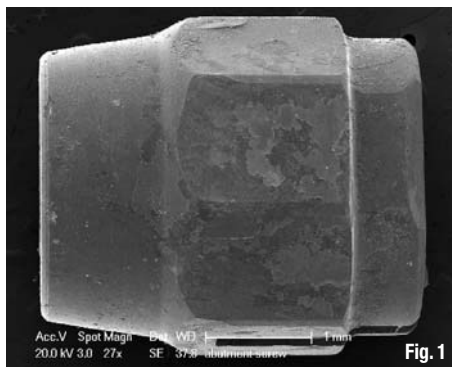
Fig. 1 SEM image, 27x. Internal metallic nut which depends on friction fit inside the zirconia implant abutment.

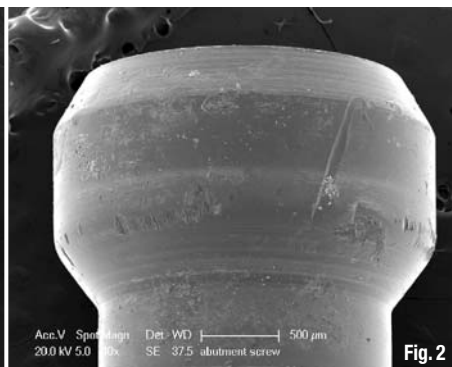
Fig. 2 SEM image, 10x. The metallic fixation screw used to press on the metallic nut for providing adequate retention with the implant body.

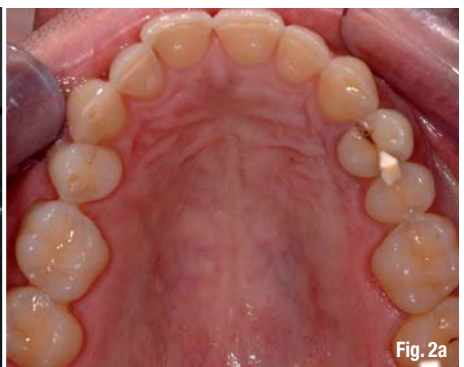
Fig. 2a A broken maxillary premolar was extracted and implant was immediately inserted.

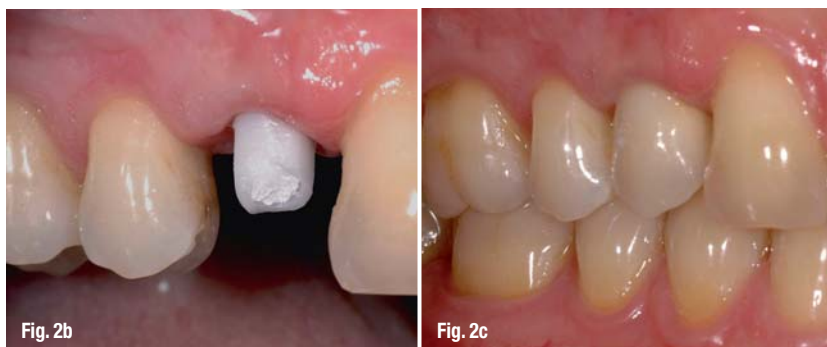
Fig. 2b_ Procera zirconia abutment. **Fig. 2c_** Procera zirconia veneered crown inserted over the zirconia abutment.

records indicated that the patient complained of loosening of the implant supported zirconia veneered crown (tooth 21). The treating dentist also complained that the internal metallic nut lost friction contact with the zirconia abutment and that he had to re-assemble the components before screw fixation. The abutment was fractured after two incidence of screw loosening. The same problem led to fracture of the second abutment after which the dentist decided to insert a titanium abutment. Scanning electron microscopic examination indicated that the abutment was fractured due to pressure from the metallic screw nut.

Once the metallic nut has lost friction fit with the zirconia abutment it can not be correctly reinserted inside the abutment and areas of friction contact between the improperly assembled components could lead to generation of high internal stresses causing fracture of the zirconia implant abutment as was reported for the two examined abutments. A new abutment should be used in such case.

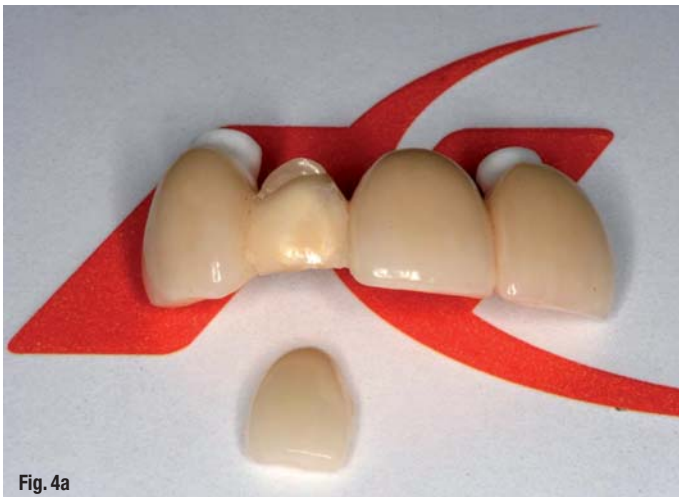
Fig. 4a

A broken veneer porcelain from a Procera zirconia superstructure. This new design combines both the implant abutment and the framework of the restoration in one single structure thus reducing the number of components the dentist uses during the prosthetic phase.

Fig. 4a_ Digital image of a broken veneer porcelain from a four unit implant supported fixed partial denture.

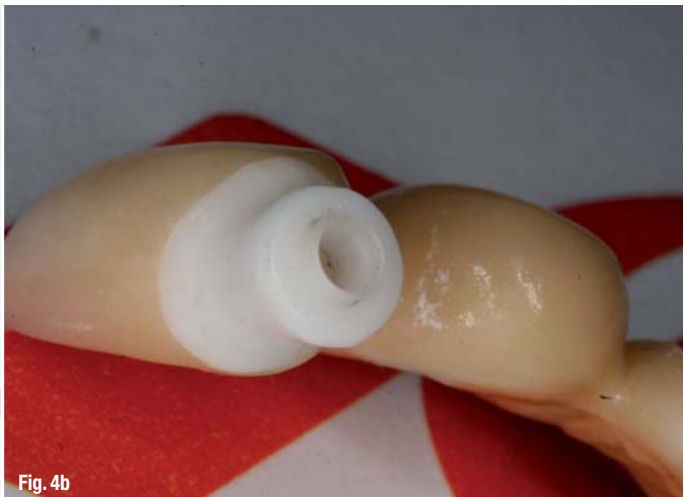
Fig. 4b

This single component zirconia structure does not utilize an internal metallic nut for achieving contact with the implant body. On the contrary, this single component super structure utilizes directly the fixation screw to obtain direct fixation to the implant body.

Fig. 4b_ Digital image demonstrating the contact surface with the implant body. Antirotation is not required for this fixed partial denture as the whole framework and the implant abutment are joined into a single superstructure.
