Precautions for using zirconia implant abutments

authors Moustafa N Aboushelib*, Egypt, and Rien van Paridon**, Netherlands

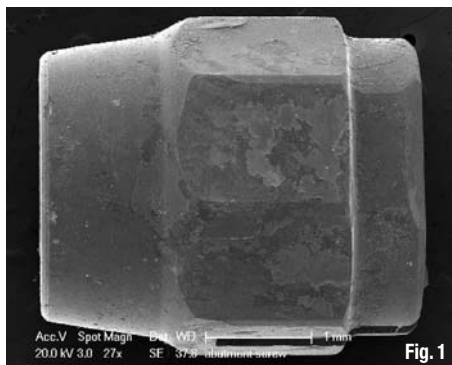
Fig. 1 SEM image, 27x. Internal metallic nut which depends on friction fit inside the zirconia implant abutment.

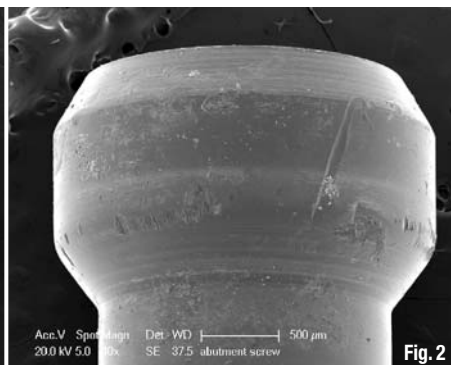
Fig. 2 SEM image, 10x. The metallic fixation screw used to press on the metallic nut for providing adequate retention with the implant body.

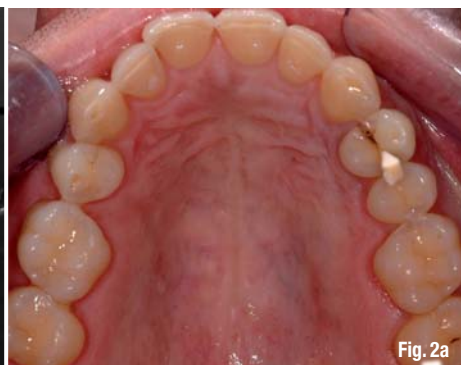
Fig. 2a A broken maxillary premolar was extracted and implant was immediately inserted.

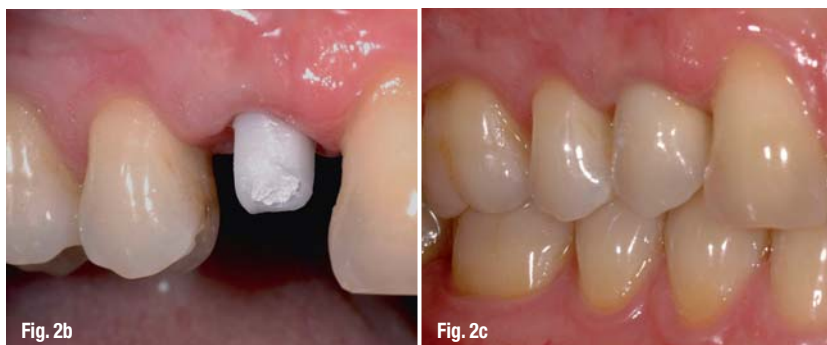
Fig. 2b_ Procera zirconia abutment. **Fig. 2c_** Procera zirconia veneered crown inserted over the zirconia abutment.

records indicated that the patient complained of loosening of the implant supported zirconia veneered crown (tooth 21). The treating dentist also complained that the internal metallic nut lost friction contact with the zirconia abutment and that he had to re-assemble the components before screw fixation. The abutment was fractured after two incidence of screw loosening. The same problem led to fracture of the second abutment after which the dentist decided to insert a titanium abutment. Scanning electron microscopic examination indicated that the abutment was fractured due to pressure from the metallic screw nut.

Once the metallic nut has lost friction fit with the zirconia abutment it can not be correctly reinserted inside the abutment and areas of friction contact between the improperly assembled components could lead to generation of high internal stresses causing fracture of the zirconia implant abutment as was reported for the two examined abutments. A new abutment should be used in such case.

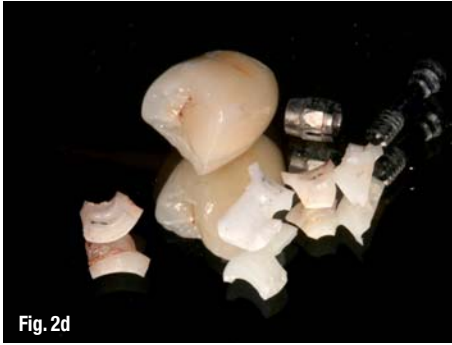
Fig. 2d

Fig. 2d_ The first and the second Procera zirconia abutments were fractured after short period of service intra-orally.

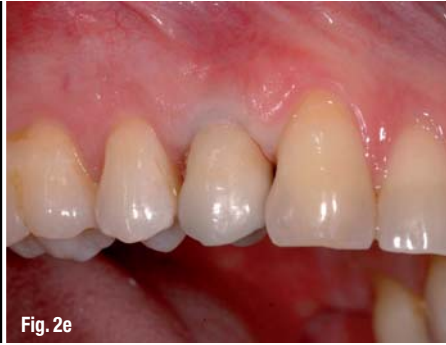
Fig. 2e

Fig. 2e_ A new zirconia veneered crown was inserted over a titanium abutment. Observe the grayish color at the cervical margin.

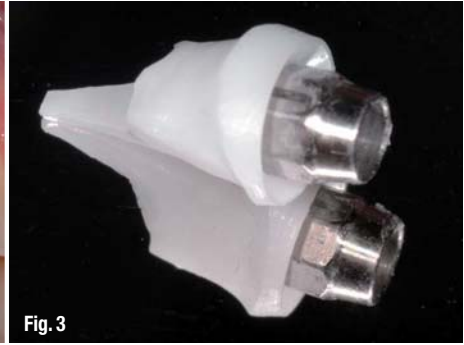
Fig. 3

A broken zirconia implant abutment was examined. SEM analysis revealed that it was an angled abutment which corrected the tilt of an implant replacing a maxillary lateral incisor. The entire buccal wall was fractured beneath the temporarily cemented zirconia veneered crown.

Fig. 3_ Digital image demonstrating a fractured zirconia abutment due to over reduction of the buccal wall.

Zirconia is a brittle ceramic material that must be used in adequate thickness to gain full potential of its high strength. A minimal wall thickness (0.5-0.7mm) is required in the entire structure of the zirconia implant abutment. This thickness must be increased in areas of high stresses to avoid unexpected fracture. Tilt correction—resulted in over reduction of the buccal wall (0.3 mm thickness) which resulted in fracture of the weakened segment. To reduce possibility of fracture, it is recommend to use a metallic abutment for correction of angle of insertion.

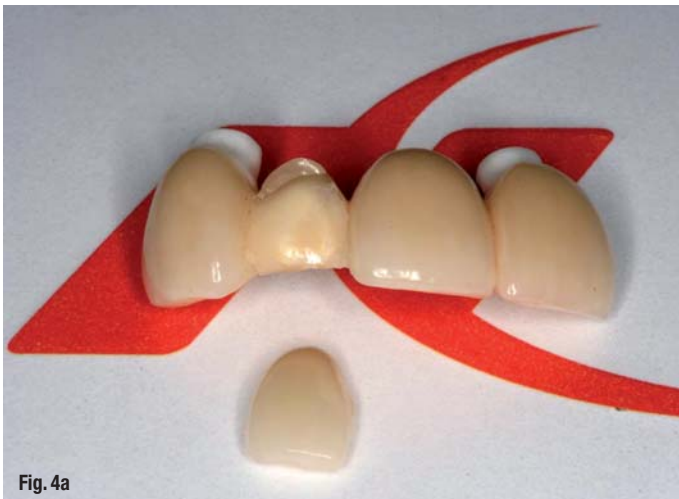
Fig. 4a

A broken veneer porcelain from a Procera zirconia superstructure. This new design combines both the implant abutment and the framework of the restoration in one single structure thus reducing the number of components the dentist uses during the prosthetic phase.

Fig. 4a_ Digital image of a broken veneer porcelain from a four unit implant supported fixed partial denture.

Using single component superstructures has several advantages as it simplify the handling procedure, does not require anti-rotation feature, and reduces the num-

ber of structural interfaces of the entire restoration. On the other hand, it requires careful design to provide adequate support for the veneer ceramic.

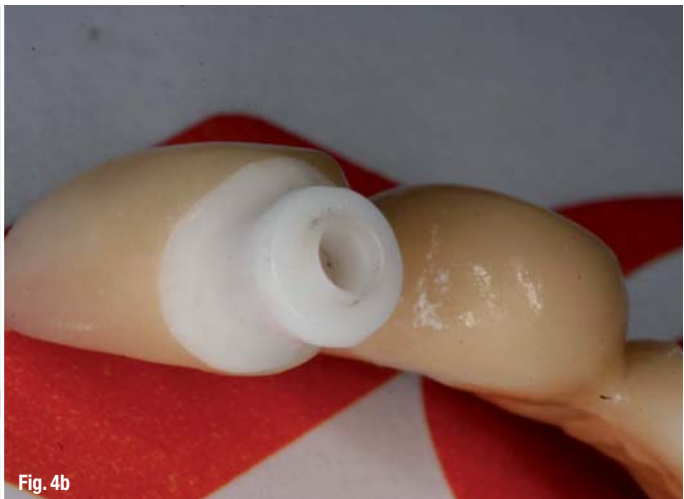
Fig. 4b

This single component zirconia structure does not utilize an internal metallic nut for achieving contact with the implant body. On the contrary, this single component super structure utilizes directly the fixation screw to obtain direct fixation to the implant body.

Fig. 4b_ Digital image demonstrating the contact surface with the implant body. Antirotation is not required for this fixed partial denture as the whole framework and the implant abutment are joined into a single superstructure.
