Immediate implant placement and function in the aesthetic zone

Single-tooth restoration with a narrow-diameter two-piece implant

Dr Roland Glauser, Switzerland

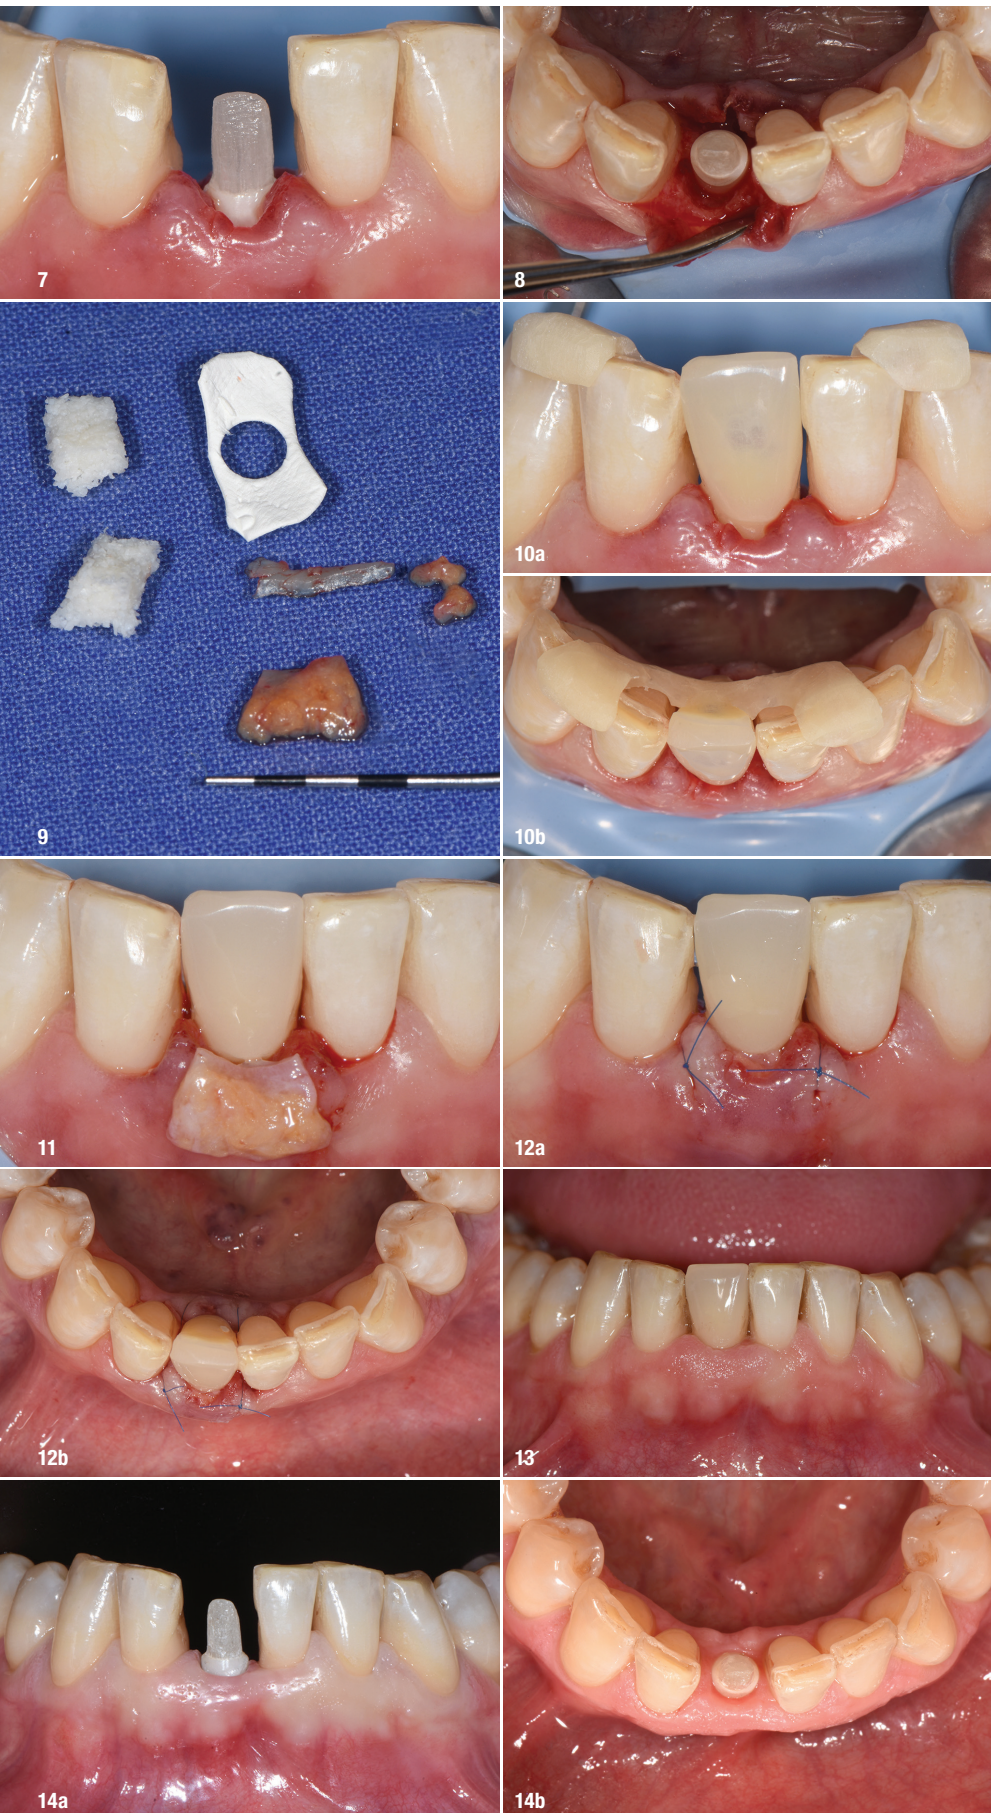
Fig. 7: Frontal clinical view of the glass fiber post cemented in place. **Fig. 8:** Occlusal clinical view prior to guided bone regeneration. **Fig. 9:** Bio-Oss Collagen®, resorbable Bio-Gide® membrane, and connective tissue graft. **Figs. 10a & b:** Frontal (a) and occlusal clinical views of the cemented provisional crown (b). **Fig. 11:** Frontal clinical view of the connective tissue graft *in situ*. **Figs. 12a & b:** Frontal (a) and occlusal clinical views of the sutured grafted site (b). **Fig. 13:** Frontal clinical view three weeks post-op. **Figs. 14a & b:** Frontal (a) and occlusal clinical views at the nine-month follow-up, before final impression taking (b).

Immediately after implant placement, the glass fiber post, which was prepared in advance by the dental laboratory, was inserted into the 3C connection of the implant and cemented in place using RelyX™ Unicem dental cement (3M; Fig. 7). Afterwards, a guided bone regeneration procedure was performed using Bio-Oss Collagen® and a resorbable Bio-Gide® membrane (Geistlich Pharma) to fill the gap between the wall of the extraction socket and the implant (Figs. 8 & 9). A circular hole was punched in the membrane to allow it to be placed over the grafted site with the implant penetrating through, enabling provisionalisation. The post was then isolated to avoid any chemical reaction between the glass fiber post and the composite. The provisional prosthesis was relined on the post with flowable composite (Fig. 10). The wings were subsequently cut off, and the crown was polished. The crown was cemented using a temporary cement (Temp-Bond™, Kerr Dental), and a lingual vent hole allowed for excess cement to be evacuated. A connective tissue graft was placed labially to bulk up the soft tissue and increase volume (Fig. 11). The grafted site was finally sutured closed (Fig. 12).
