# Immediate implant placement and function in the aesthetic zone

## Single-tooth restoration with a narrow-diameter two-piece implant

Dr Roland Glauser, Switzerland

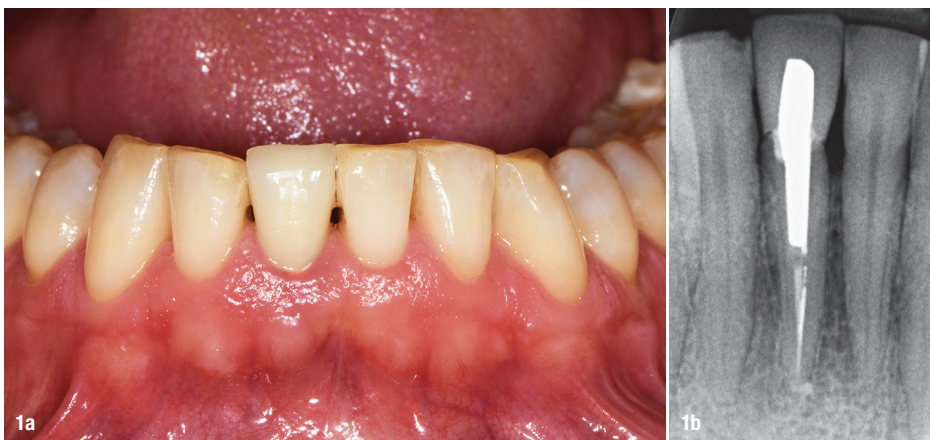
**Figs. 1a & b:** Frontal clinical view (a) and radiograph of the initial situation (b).

The 45-year-old male patient was referred to my practice. He presented for initial consultation complaining about a crown on his endodontically treated tooth #41 that had become loose. The patient had an accident in his youth which resulted in the traumatic fracture of the mandibular right central incisor. As a result, the tooth had to be endodontically treated and was restored with a gold post and core and a veneered ceramic crown (Fig. 1). The crown had been *in situ* without complications for 22 years. Upon removing the failing crown

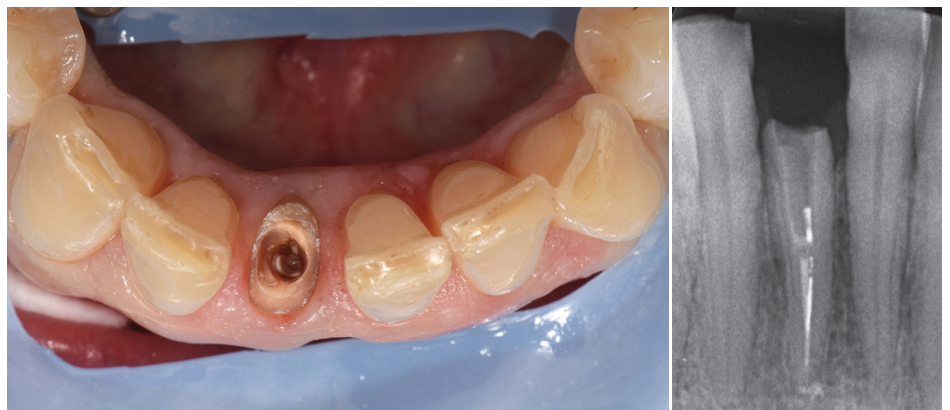
**Figs. 2a & b:** Occlusal clinical view (a) and radiograph after removal of the insufficient crown and post in region #41 (b).

and the post, a vertical root fracture was discovered (Fig. 2). Therefore, the remaining root was deemed unsalvageable.

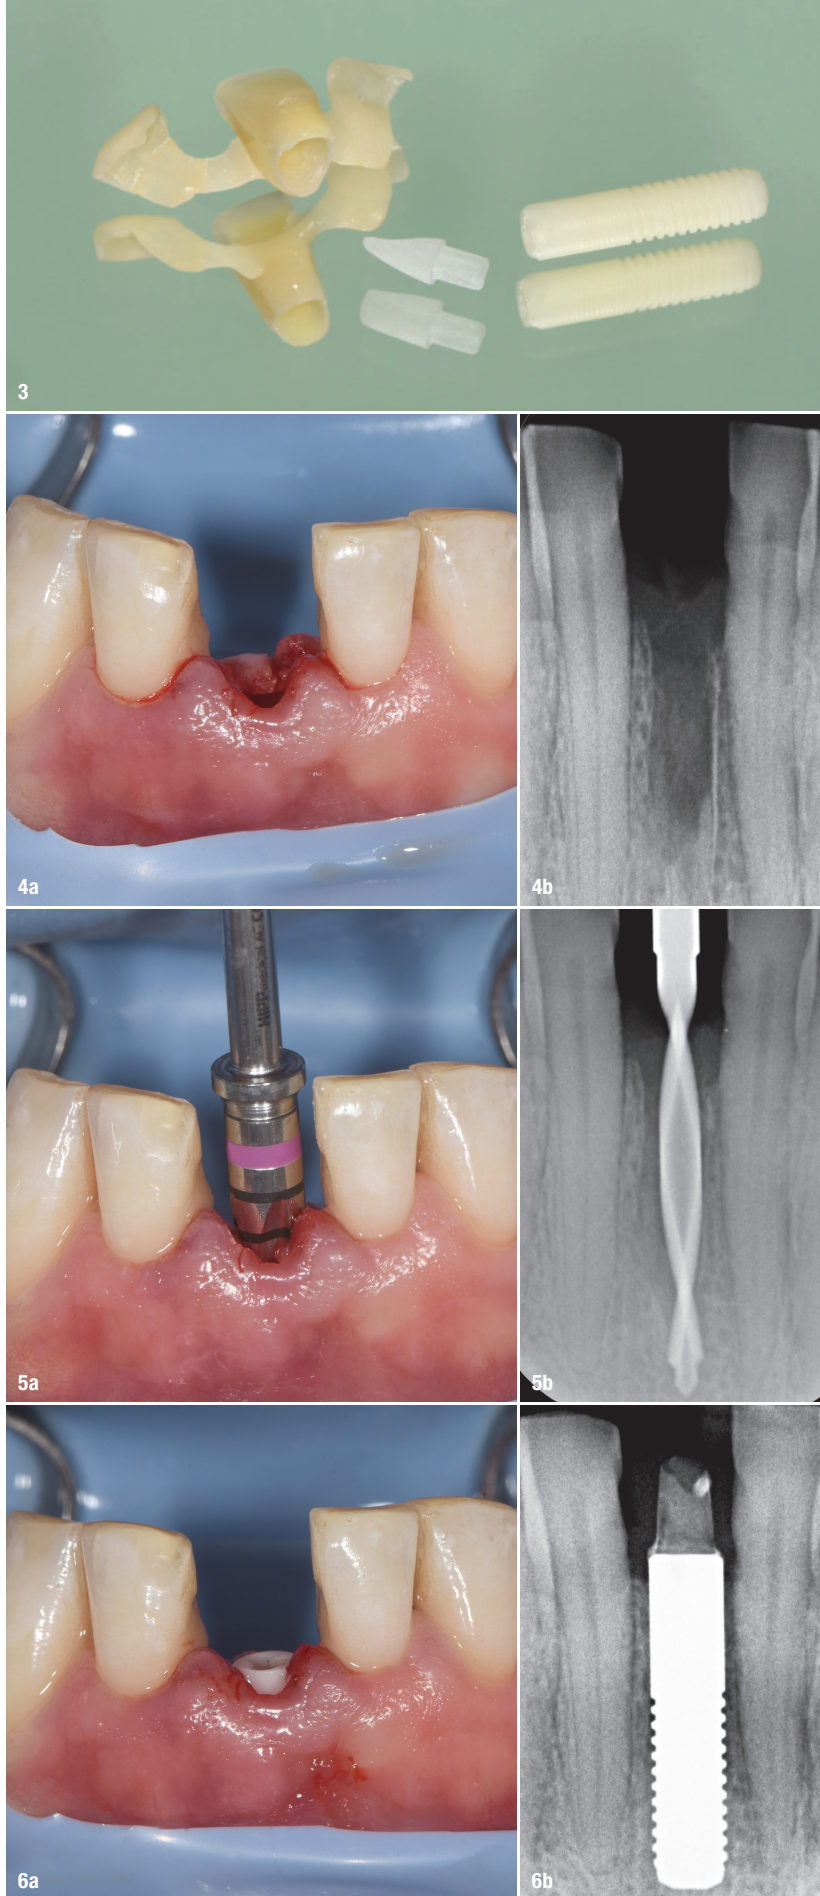
**Fig. 3:** From left: The shell provisional prosthesis with wings to be supported on the neighbouring teeth, the glass fiber post prepared in advance, and the individual narrow-diameter implant. **Figs. 4a & b:** Frontal clinical view (a) and radiograph after root extraction (b). **Figs. 5a & b:** Frontal clinical view (a) and radiograph of the osteotomy preparation (b). **Figs. 6a & b:** Frontal clinical view (a) and radiograph after immediate implant placement (b).

Treatment would involve the extraction of root #41, and the restoration of this area with an immediate implant with immediate function using a provisional crown. Before the surgery, the dental laboratory conducted a spatial analysis on a study model. Additionally, the tooth to be extracted was ground off the stone model, and an implant analogue was placed in the ideal position. Thereafter, the glass fiber post was prepared on the model, and a shell provisional prosthesis was fabricated (Fig. 3). It incorporated wings to be placed on the neighbouring teeth to allow its correct positioning.

After local anaesthesia had been administered, a rubber dam was placed for isolation and optimum control of the operative site. Root #41 was then extracted, and the extraction socket was carefully curetted to remove any fibrous tissue and examined (Fig. 4). The osteotomy for the immediate implant was prepared according to the drilling protocol of the implant manufacturer (Fig. 5). An individual two-piece narrow-diameter zirconia implant of 3.5 mm in diameter and 13.0 mm in length (Patent™ Dental Implant System, Zircon Medical Management), which was designed ahead of surgery, was inserted into the prepared osteotomy to a final torque of 28 Ncm, achieving adequate primary stability to proceed with the provisional prosthesis and immediate function (Fig. 6).

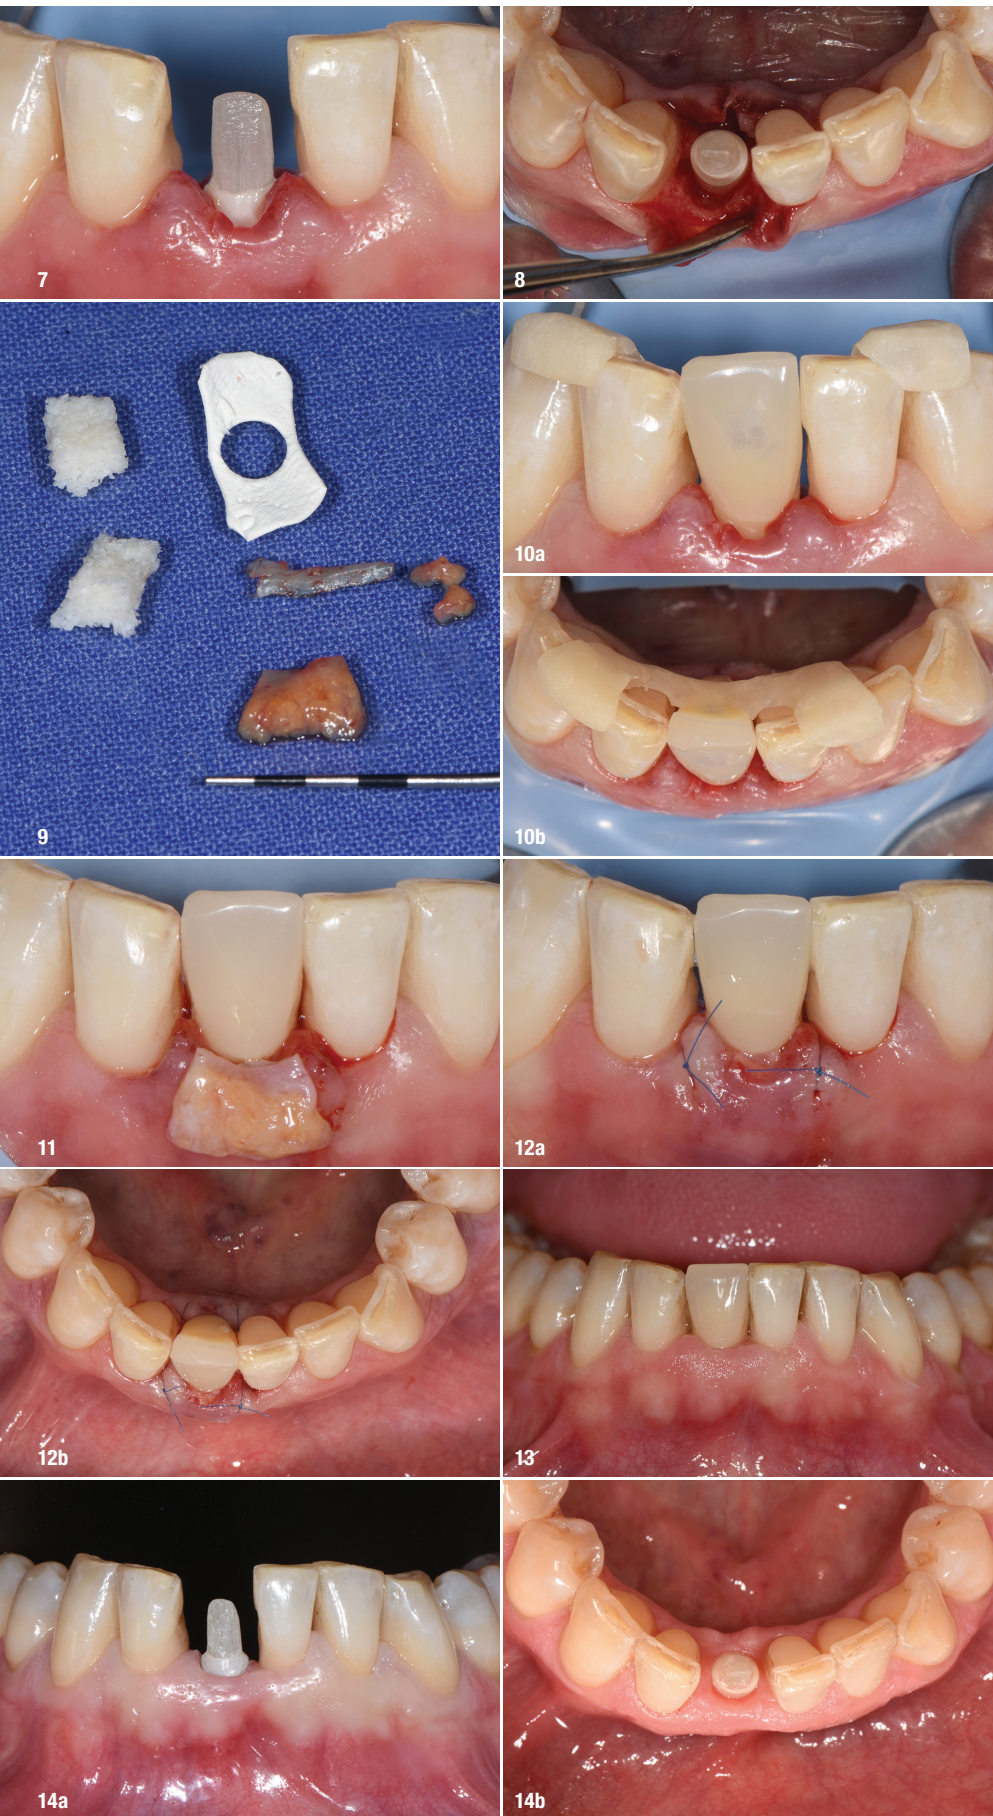
**Fig. 7:** Frontal clinical view of the glass fiber post cemented in place. **Fig. 8:** Occlusal clinical view prior to guided bone regeneration. **Fig. 9:** Bio-Oss Collagen®, resorbable Bio-Gide® membrane, and connective tissue graft. **Figs. 10a & b:** Frontal (a) and occlusal clinical views of the cemented provisional crown (b). **Fig. 11:** Frontal clinical view of the connective tissue graft *in situ*. **Figs. 12a & b:** Frontal (a) and occlusal clinical views of the sutured grafted site (b). **Fig. 13:** Frontal clinical view three weeks post-op. **Figs. 14a & b:** Frontal (a) and occlusal clinical views at the nine-month follow-up, before final impression taking (b).

Immediately after implant placement, the glass fiber post, which was prepared in advance by the dental laboratory, was inserted into the 3C connection of the implant and cemented in place using RelyX™ Unicem dental cement (3M; Fig. 7). Afterwards, a guided bone regeneration procedure was performed using Bio-Oss Collagen® and a resorbable Bio-Gide® membrane (Geistlich Pharma) to fill the gap between the wall of the extraction socket and the implant (Figs. 8 & 9). A circular hole was punched in the membrane to allow it to be placed over the grafted site with the implant penetrating through, enabling provisionalisation. The post was then isolated to avoid any chemical reaction between the glass fiber post and the composite. The provisional prosthesis was relined on the post with flowable composite (Fig. 10). The wings were subsequently cut off, and the crown was polished. The crown was cemented using a temporary cement (Temp-Bond™, Kerr Dental), and a lingual vent hole allowed for excess cement to be evacuated. A connective tissue graft was placed labially to bulk up the soft tissue and increase volume (Fig. 11). The grafted site was finally sutured closed (Fig. 12).

At the three-week follow-up, healing was considered uneventful (Fig. 13). At the nine-month follow-up (Fig. 14), a conventional full-arch impression was taken, which served as the basis for the fabrication of the master model and the definitive crown by the dental laboratory (Figs. 15 & 16). At the ten-month follow-up, the definitive prosthesis was delivered (Fig. 17). At the 12-month follow-up, the definitive prosthesis was considered highly aesthetic, and the peri-implant soft-tissue conditions were stable and healthy (Fig. 18).

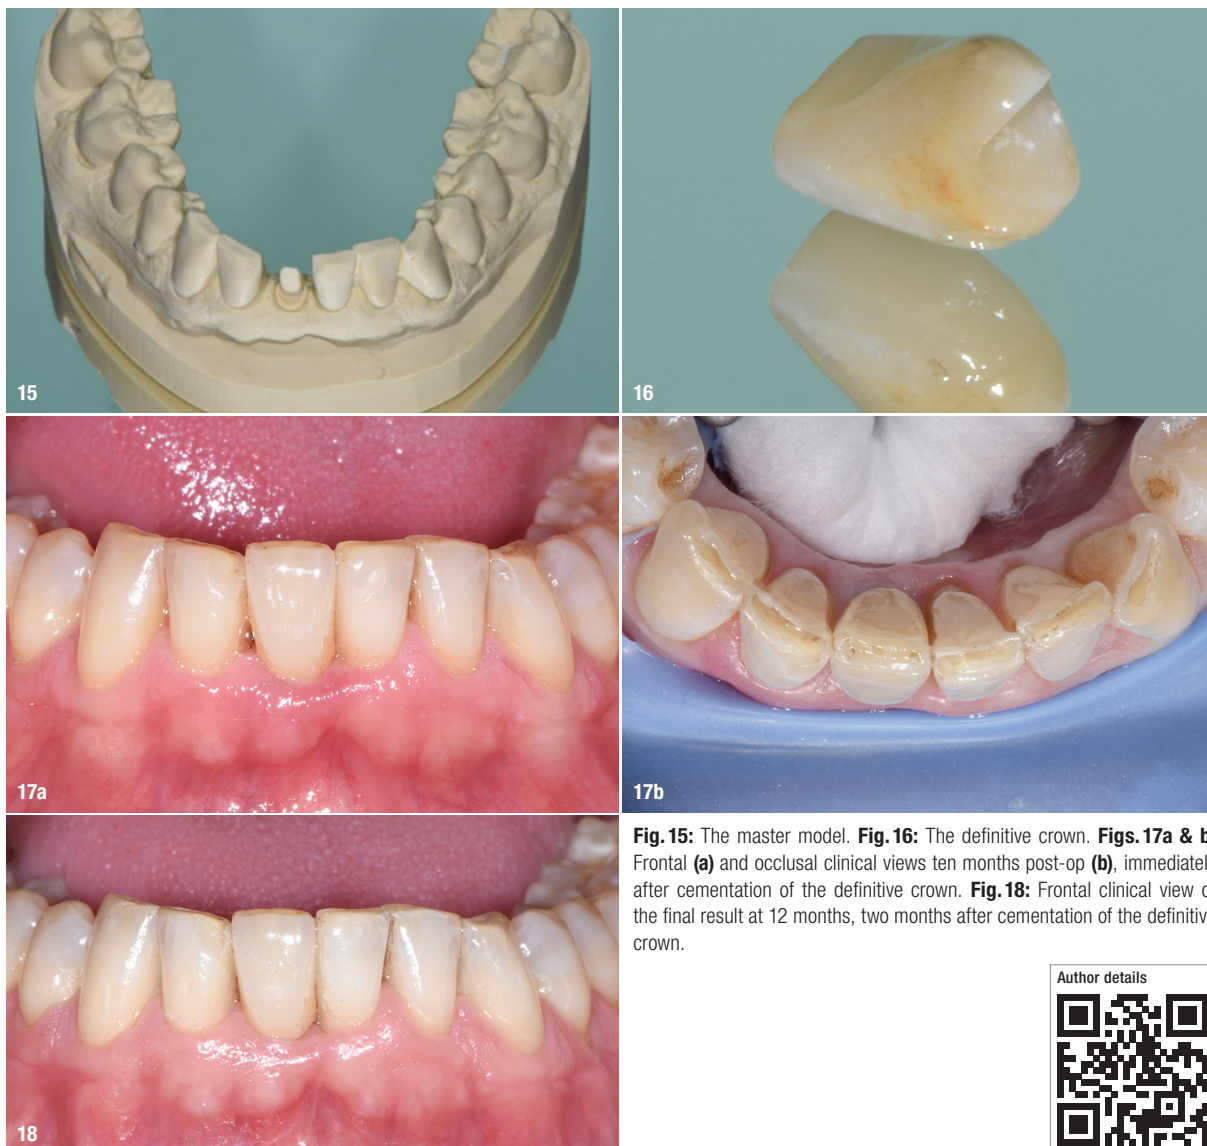
**Fig. 15:** The master model. **Fig. 16:** The definitive crown. **Figs. 17a & b:** Frontal (a) and occlusal clinical views ten months post-op (b), immediately after cementation of the definitive crown. **Fig. 18:** Frontal clinical view of the final result at 12 months, two months after cementation of the definitive crown.
