# Screw-retained restoration of upper right first molar and second premolar

Dr Anthony Bendkowski, UK

In the following case report the intended screw-retained restorations was successfully achieved by using the DS OmniTaper Implant System to restore both the upper right first molar as well as the second premolar. This case report is published as an inspiration for clinicians or technicians, not necessarily as a recommendation from Dentsply Sirona.

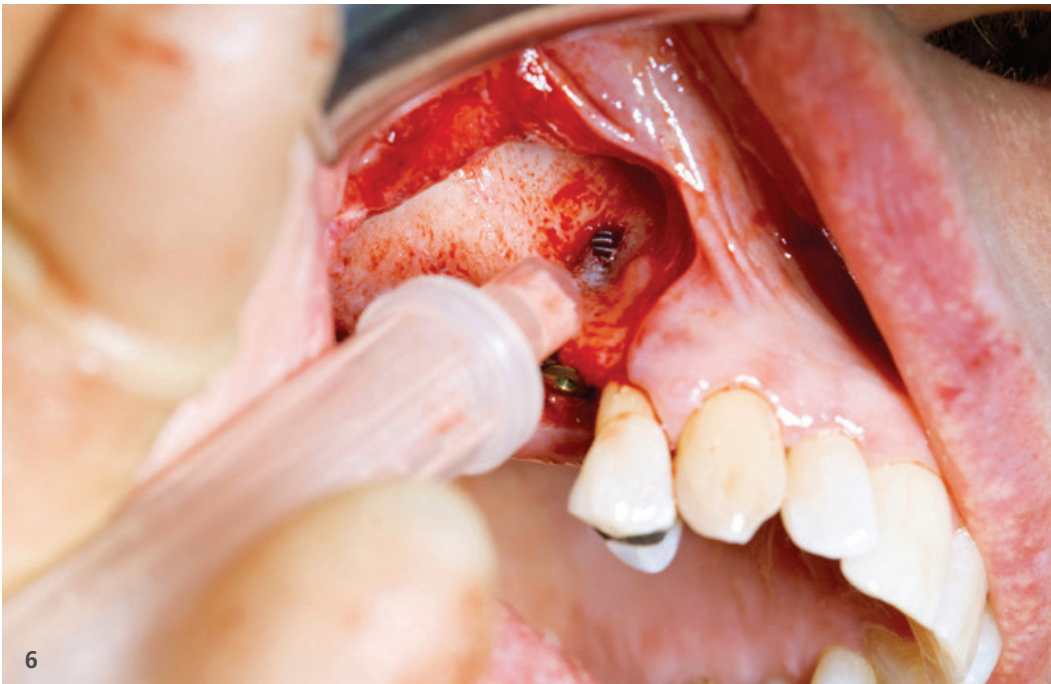
**Fig. 6:** Use of Dentsply Sirona disposable BoneTrap to augment the small bone fenestration.

The small bone fenestration was then augmented by using the Dentsply Sirona disposable BoneTrap (Fig. 6) and a large quantity of autogenous bone collected (Fig. 7).

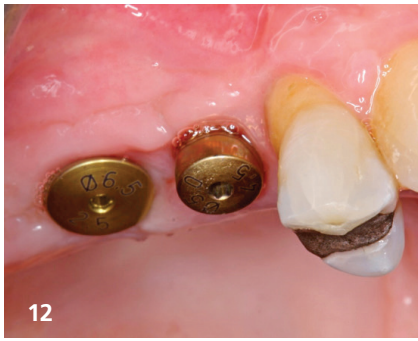
12

**Fig. 12:** Healing Abutment EV (M) placed after three months. **Fig. 13:** Atlantis IO FLO *in situ* ready for Primescan digital impression. **Fig. 14:** Design of Atlantis abutments and zirconia crowns. **Fig. 15:** Well-fitting screw-retained Atlantis CustomBase abutments and zirconia crowns. **Fig. 16:** Radiograph to verify correct seating of restorations. **Fig. 17:** Screw-access channels sealed and amalgam tooth position #5 (FDI 14) replaced with composite. **Fig. 18:** Final restorations completed.

Three months after the initial surgery healing abutments (M) were placed (Fig. 12). Next the Atlantis IO FLO were placed to complete the Primescan digital impression in order to achieve the planned
