Looking for a ceramic solution

Initial situation and treatment planning

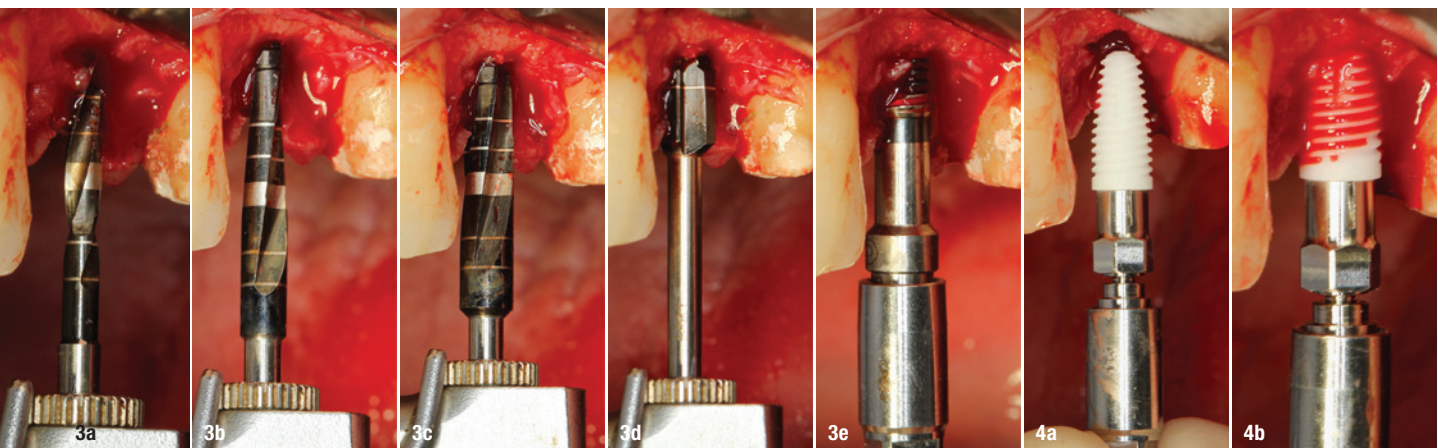
Fig. 1: Radiograph of the initial patient situation. **Fig. 2:** CBCT scan of the initial situation regarding tooth #24. **Figs. 3a–e :** Drilling according to protocol using a 2.0 mm diameter tapered drill (a), a 3.5 mm diameter tapered drill (b), a 4.3 mm diameter tapered drill (c), a countersink drill (d) and a bone tap (e). **Figs. 4a & b:** Placement of the Zi implant.

A 40-year-old patient in good general health came to our practice wishing to replace the bridge extending from pontic #24 to tooth #27 and to place an implant in region #24. An initial digital radiograph and a CBCT scan were performed to analyse the possibility of placing an implant in this area (Figs. 1 & 2). The area did not present with any periapical or intraosseous lesions. The bone width and height were found to be sufficient for implantation, and there was no atrophy. A mucous retention cyst was observed in the left maxillary sinus.

Prior to the surgery, local anaesthesia was administered. Once the gingival flap had been raised, the drilling protocol was followed according to the manufacturer's recommendation for Type D2 bone: initial drill, tapered drills of increasing diameter (2.0, 3.5, 4.3 mm), countersink drill and bone tap (Fig. 3). The implant (4.3 × 10.0 mm) was placed to a final torque of 45 Ncm (Fig. 4) and then a Zi cover screw was placed (Fig. 5). After suturing had been completed, the old bridge was temporarily cemented in place.
