## Multidisciplinary integration of odontology and sleep unit

# Treatment of a patient with severe bruxism, loss of vertical dimension, tooth wear and fracture of dental implants

Dr Eduardo Anitua, DDS, MD, PhD, Spain

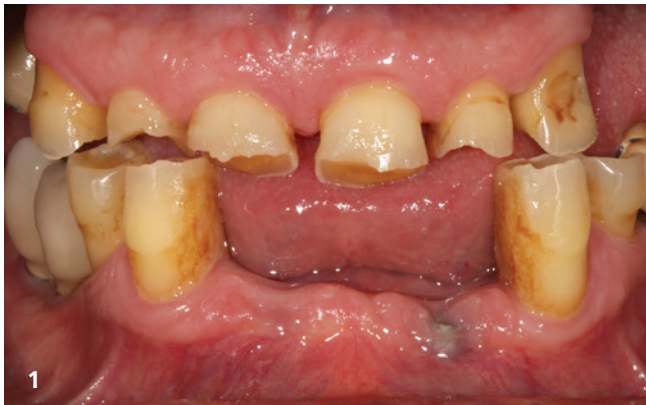
**Fig. 1:** Initial situation: Extreme wear of the upper arch with areas where dental pulp is practically exposed and moderate wear of the lower arch can be observed, as well as an implant without its crown in the mandibular anterior-inferior area. **Figs. 2 & 3:** Images of severe occlusal wear and collapsed bite, with contact only at the level of the anterior teeth, in addition to the extrusion of some pieces of the lower arch such as canines and premolars.

The 62-year-old male patient requested treatment for his very worn and highly sensitive teeth, and to replace missing teeth, some of which had already been replaced and the treatment had failed. In the initial examination, moderate dental wear could be observed in the lower arch, and severe dental wear in the upper arch, with areas where the pulp chamber could even be seen through the dentine. In the area corresponding to the lower left lateral incisor a fractured metal component was visible through the gingiva that the patient indicated to be a dental

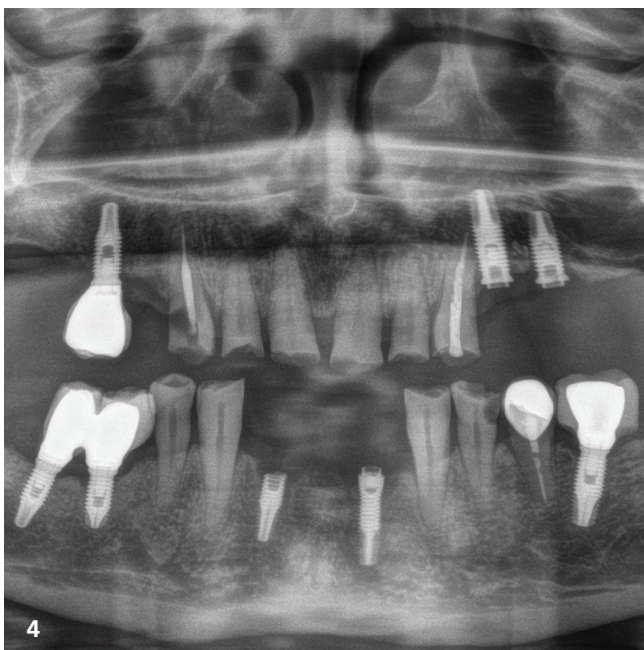
**Fig. 4:** Initial radiograph showing several caries in the remaining teeth as well as implants not loaded for different reasons. Fractured prosthetic components inside the connection within the two upper implants and the implant in position 32. Implant in position 42: fractured at the level of the implant crown. **Fig. 5:** Section of the planning CBCT showing how the extra-short implant can be placed in the second quadrant. **Fig. 6:** Panoramic radiograph after upper endodontics, core build-up and placement of temporary resin crowns to raise the vertical dimension.

implant (Fig. 1). In the lateral images, the evident existing dental wear, a collapse of the occlusion with an evident loss of the vertical dimension and an extrusion of the lower teeth leaving part of their root exposed to the oral milieu was observed. These images also showed that the entire occlusion rested on the anterior area (Figs. 2 & 3). The radiograph also showed several implants without loading: two in the second quadrant, with broken prosthetic components inside the implant and two lower implants, with broken components in one of them and a fracture of the implant head in the other implant. There were also several cavities and some restorations on implants that were currently in function without complications (Fig. 4).

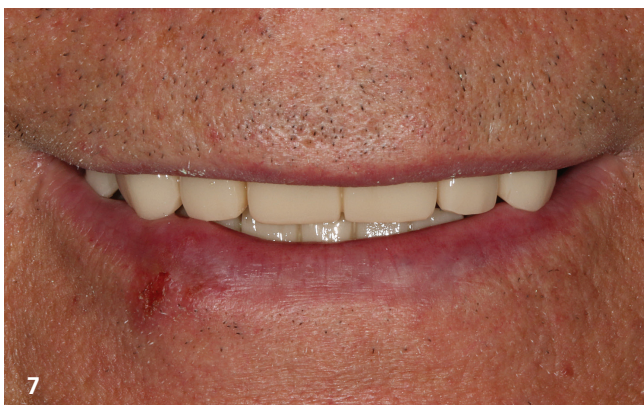
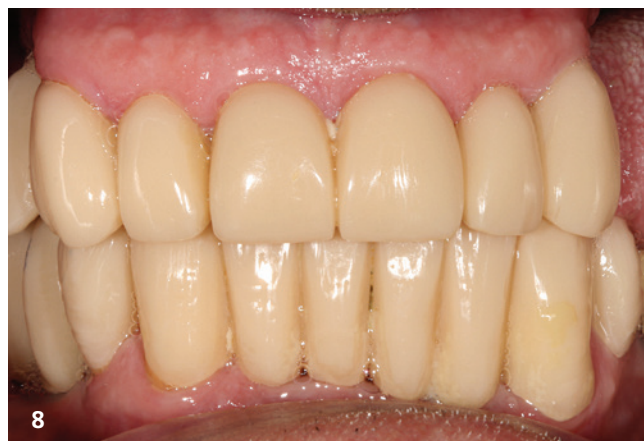
**Figs. 7 & 8:** Temporary situation after elevation of the vertical dimension.

avoiding a sinus lift at this level (Figs. 5 & 6) and reducing the morbidity of the process. This first opening of the vertical dimension with provisional prostheses allowed us to configure the final occlusal pattern and to generate a progressive extension of the masticatory muscles which was very contracted (Figs. 7 & 8).

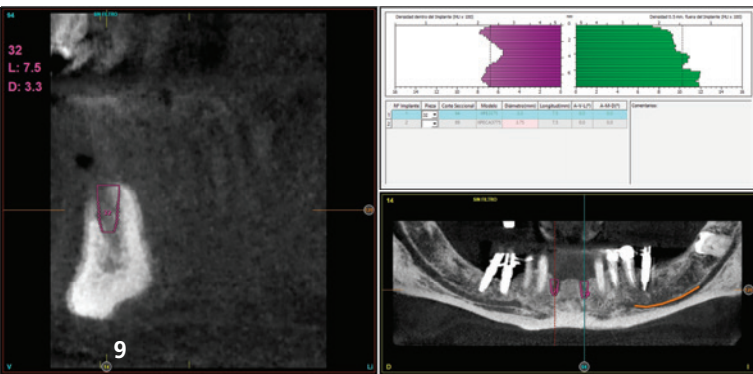
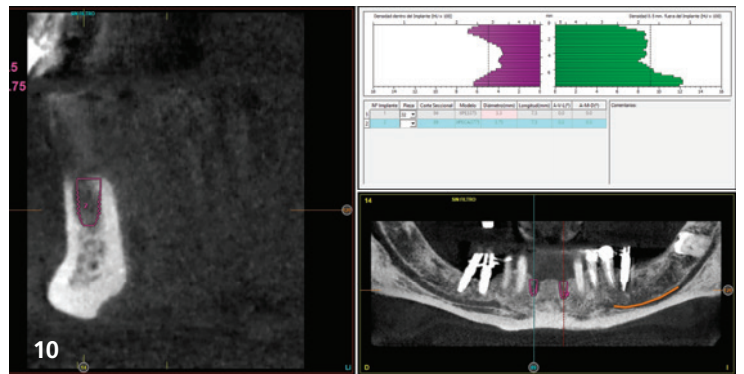
**Figs. 9 & 10:** Planning CBCTs of the implants for the mandibular incisors, showing the area of the removed implants has already regenerated.

Three months later, the implants could be placed in the areas of the explantations that are completely regenerated. For this purpose, the provisional prostheses were removed, and the implant placement surgery was performed in the lower incisor area (Figs. 9 & 10). The second quadrant area was also ready to receive the implant and an additional implant was placed in the first quadrant for greater stability in the future implant-supported rehabilitation of that area (Fig. 11). The patient continued with the provisionals, waiting for the new implants to be loaded,

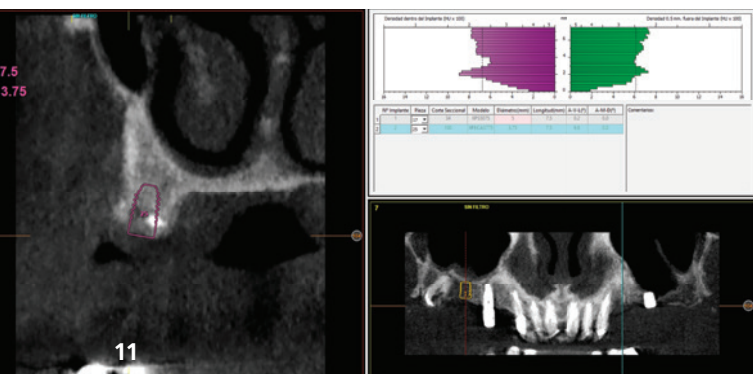
**Fig. 11:** Planning of the second quadrant implant placed in the area of previous implant removal. **Fig. 12:** Panoramic radiograph after insertion of the new implants. The patient continued with his provisional prosthesis while waiting for the new implants to be loaded. **Fig. 13:** Radiograph with the new progressive loading prostheses with all implants integrated.

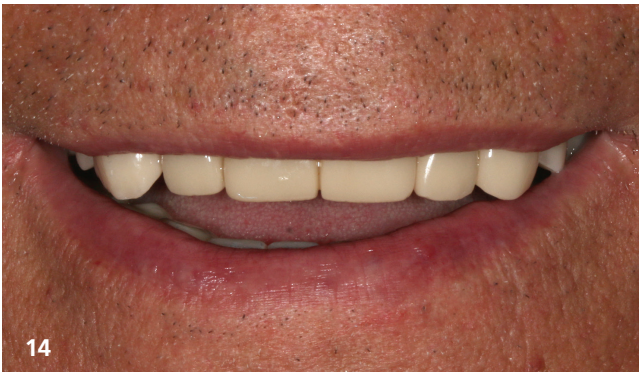
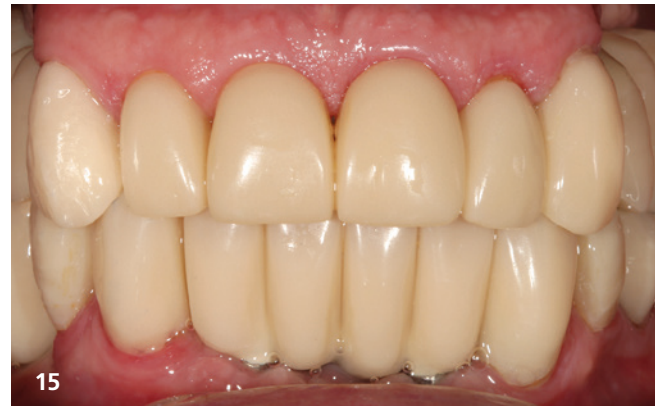
**Figs. 14 & 15:** Intra-oral and smile appearance of the second set of provisionals.

progressively loaded provisionals was made, including all the upper and lower implants. They were still resin prostheses to allow all the necessary adjustments to be made during these planning phases of the vertical dimension. Implant prostheses were also elaborated with a metallic base structure of articulated bars and the resin with the necessary anatomy was loaded on it (Figs. 13–15). These prostheses also provided the opportunity to carry out the aesthetic adjustments requested by the patient for the final prosthesis.

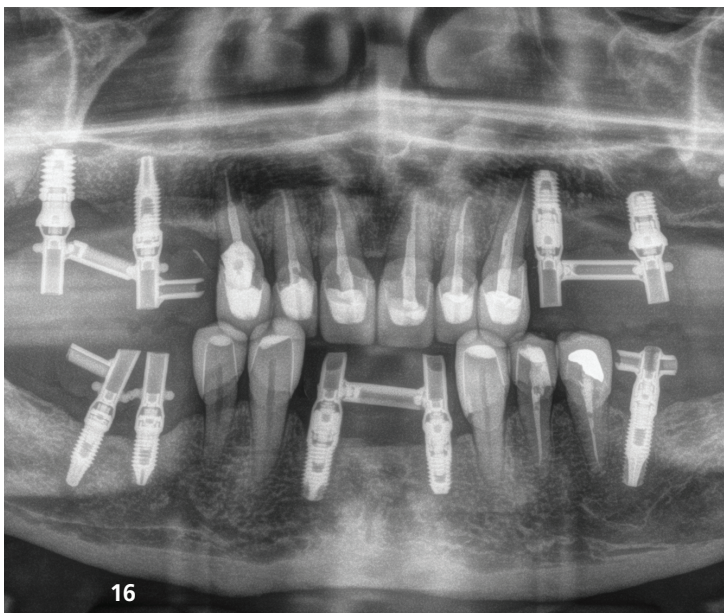
**Fig. 16:** Radiograph with the definitive crowns and the provisional prostheses on implants adapted to them. **Figs. 17 & 18:** Clinical images of the final crowns on teeth and implants. The aesthetic parameters achieved in this phase can be observed and the occlusion, vertical dimension and occlusal plane are stable.

Two months later, a stable vertical dimension was achieved, and the definitive crowns were placed. These crowns were made of ceramic (e.max) and cemented with resin cement. Once in place, the implant-supported temporaries were leveled for the final provisional phase (Fig. 16). One month later, the definitive crowns for the implants were placed, thus completing the case. The crowns on implants were screwed on multiple transepithelial (Multi-im) in metal-ceramic with metal drilling by CAD/CAM and subsequent addition of the ceramic by hand (Figs. 17–19). The aesthetic parameters achieved in this phase can be observed and the occlusion, vertical dimension and occlusal plane are stable.

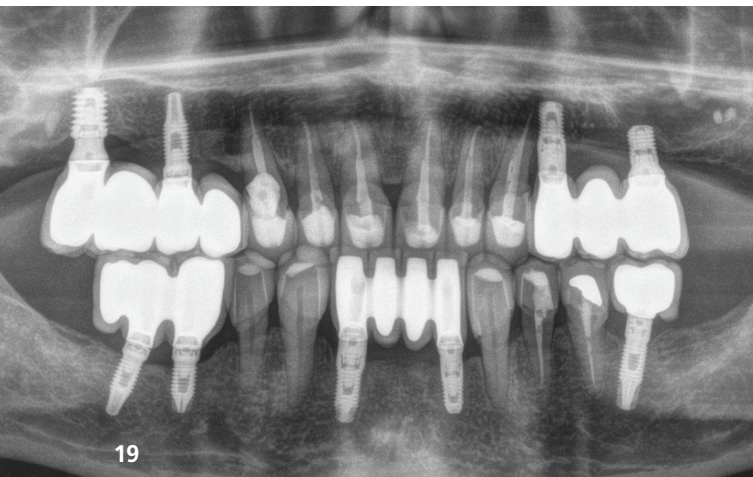
**Fig. 19:** Final radiograph of the patient with the complete prostheses and the definitive crowns. **Figs. 20 & 21:** Initial and final radiograph at one year follow-up with total stability of the treatment achieved.

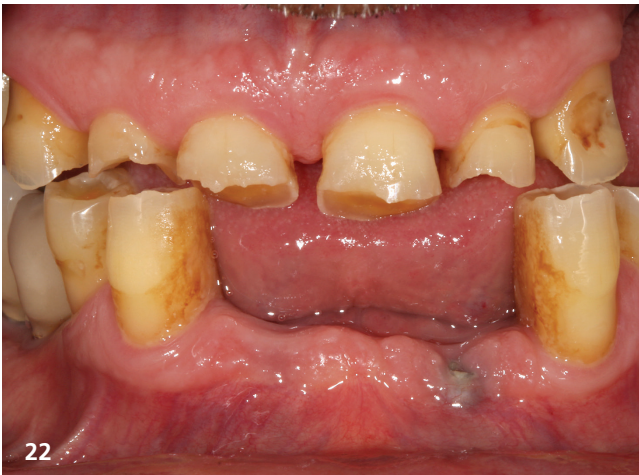
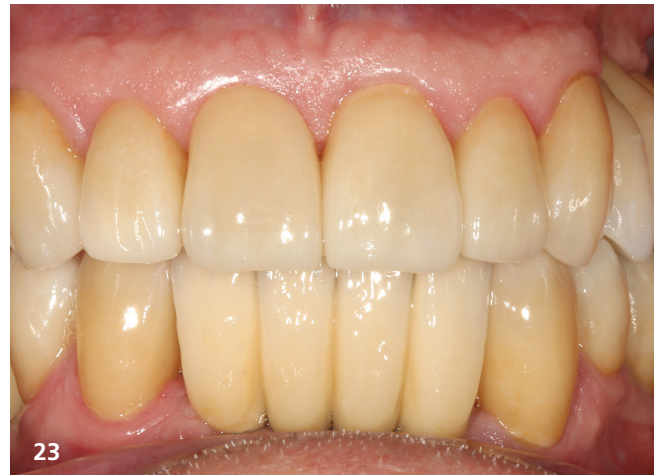
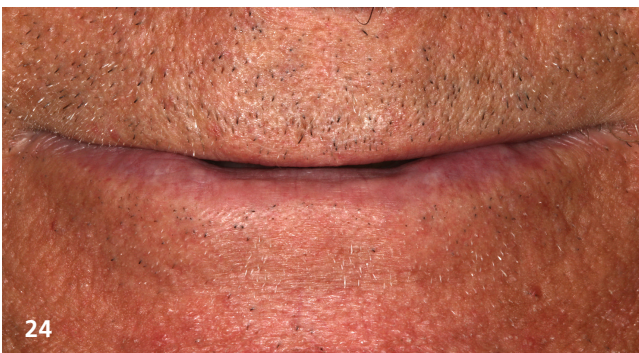
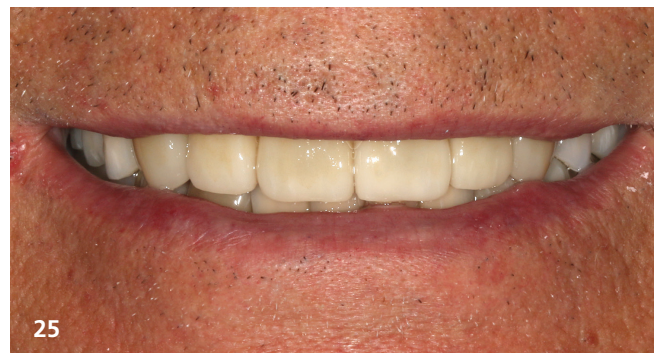
**Figs. 22–25:** Images before and after treatment at one year of follow-up showing the stability achieved and the preservation of the rehabilitation.

At this point the patient was referred to the sleep unit, to treat his SAHS as good anterior and posterior stability and a recovered vertical dimension were achieved. The patient was treated with the mandibular advancement device and after two titrations with a change of tensor (to achieve the minimum effective protrusion) the patient's AHI was reduced to 3. The patient continued to undergo revisions and there were no prosthetic complications or fractures of the rehabilitation components one year later (Figs. 20–25).
