## Multidisciplinary integration of odontology and sleep unit

# Treatment of a patient with severe bruxism, loss of vertical dimension, tooth wear and fracture of dental implants

Dr Eduardo Anitua, DDS, MD, PhD, Spain

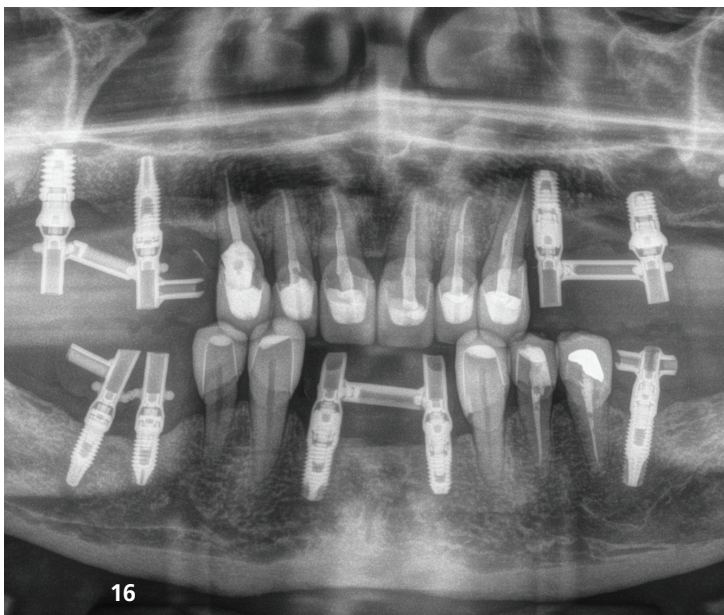
**Fig. 16:** Radiograph with the definitive crowns and the provisional prostheses on implants adapted to them. **Figs. 17 & 18:** Clinical images of the final crowns on teeth and implants. The aesthetic parameters achieved in this phase can be observed and the occlusion, vertical dimension and occlusal plane are stable.

Two months later, a stable vertical dimension was achieved, and the definitive crowns were placed. These crowns were made of ceramic (e.max) and cemented with resin cement. Once in place, the implant-supported temporaries were leveled for the final provisional phase (Fig. 16). One month later, the definitive crowns for the implants were placed, thus completing the case. The crowns on implants were screwed on multiple transepithelial (Multi-im) in metal-ceramic with metal drilling by CAD/CAM and subsequent addition of the ceramic by hand (Figs. 17–19). The aesthetic parameters achieved in this phase can be observed and the occlusion, vertical dimension and occlusal plane are stable.
