Immediate placement and loading of ceramic implants in the aesthetic region: One-year follow-up—two case reports

Drs Alexandre Marques Paes da Silva, Dennis de Carvalho Ferreira, Thamires Alves Silva, Mayla Kezy Silva Teixeira, Daniel de Moraes Telles & Eduardo José Veras Lourenço, Brazil

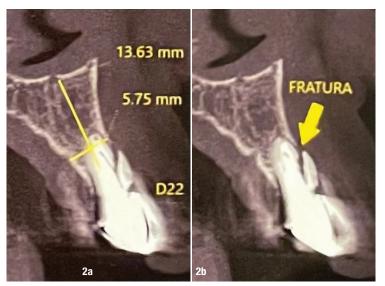
Fig. 1: Situation on initial clinical examination.

A 66-year-old female patient who was a smoker presented with the main complaint of a broken anterior tooth. On clinical examination, it was noted that the maxillary left lateral incisor had a metal-ceramic crown with a partially displaced cast metallic core (Fig. 1). The CBCT examination showed the presence of a vertical root fracture due to recurrent caries (Fig. 2). Given the clinical and radiographic situation, the proposed treatment was the extraction of the tooth in question, followed by immediate placement of a ceramic implant and immediate restoration with a crown.

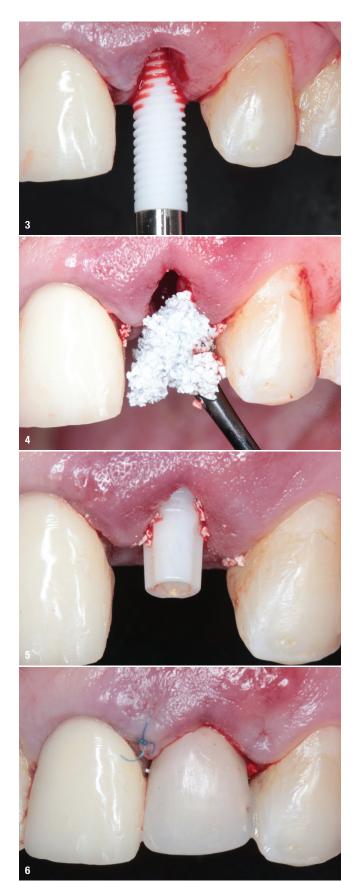
Fig. 3: Placement of the Zi implant. **Fig. 4:** Filling of the gap with bone grafting material. **Fig. 5:** Cemented zirconia abutment. **Fig. 6:** Immediate post-op situation with the provisional crown cemented.

The extraction was performed atraumatically with the aid of periotomes and forceps and a 3.75×13.0 mm two-piece ceramic implant (Zi, Neodent) was placed in the fresh alveolus (Fig. 3). The insertion torque was 35 Ncm, and this primary stability allowed for immediate loading. It should be noted that the implant was placed according to the manufacturer's recommendations at the level of the bone crest, and the gap was filled with bone substitute (maxresorb, botiss biomaterials; 0.5 cm² of 0.5–1.0 mm; Fig. 4). A $4.5 \times 5.0 \times 2.5$ mm (regular) zirconia abutment (Zi CR abutment) was seated (Fig. 5), and a provisional restoration was made with light-polymerising composite resin and cemented on the abutment (Fig. 6). At the end of the surgical procedure, a radiograph was taken (Fig. 7).

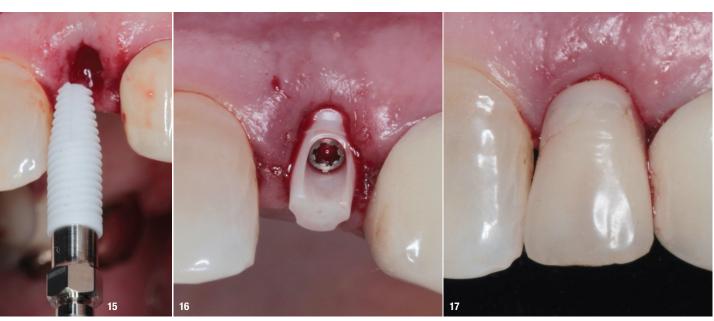
Fig. 15: Placement of the Zi implant. Fig. 16: Cemented zirconia abutment. Fig. 17: Immediate post-op situation with the provisional crown cemented.

Like in the previous clinical case, the extraction was performed atraumatically, and curettage and cleaning of the fresh alveolus was performed. After that, a $4.3 \times 13.0\,\mathrm{mm}$ two-piece ceramic implant (Zi) was placed to an insertion torque of $45\,\mathrm{Ncm}$ (Fig. 15). A $4.0 \times 5.0 \times 2.5\,\mathrm{mm}$ (narrow) 17° angulated zirconia abutment (Zi CR abutment) was seated (Fig. 16), and a provisional restoration was made with self-polymerising resin and cemented on to the abutment (Fig. 17). At the end of the surgical procedure, a radiograph was taken (Fig. 18).

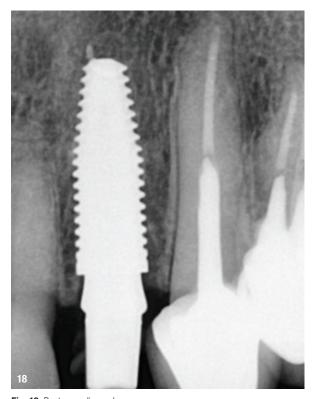
Fig. 18: Post-op radiograph.

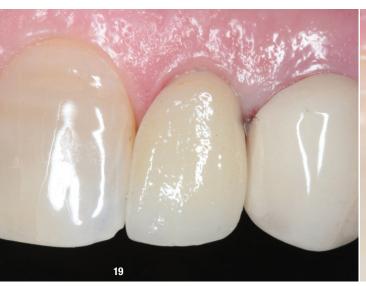
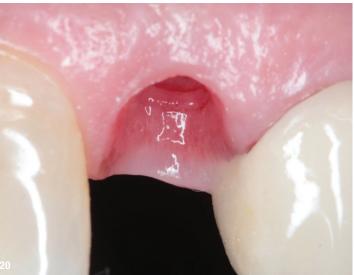
$\textbf{Fig. 19:} \ \ \textbf{Cementation of the final lithium disilicate crown. } \textbf{Fig. 20:} \ \ \textbf{Healthy soft tissue around the implant.}$

The three-month postoperative period was uneventful, and after this period, the patient returned to begin the final prosthetic phase. The final prosthesis was fabricated from lithium disilicate (IPS e.max, Ivoclar Vivadent) using an analogue workflow with impression material (addition-cured silicone, Yller) and cemented on to the abutment with a dual resin cement (RelyX U200; Fig. 19). Prior to cementation, the health of the peri-implant tissue around the ceramic implant was observed, as was the maintenance of the soft tissue, including the mesial and distal papillae (Fig. 20). After 12 months, the patient returned and a radiograph was taken, on which the maintenance of the bone around the implant was observed (Fig. 21).

tanium implants.^{12,13} Furthermore, zirconia, like titanium, is a biocompatible material and favours the health of the peri-implant soft tissue,¹⁴ as was observed after 12 months of follow-up in the two cases reported here. In Case 2, we observed the health of the soft tissue around the ceramic implant, particularly the collagen fibres present in the region.

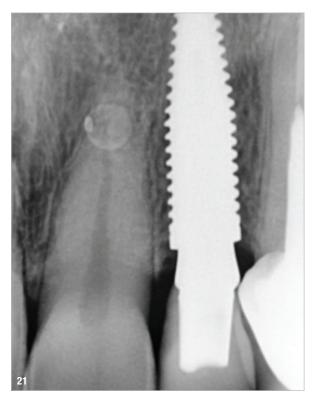
Fig. 21: Final radiograph.
