Z-SYSTEMS—a 17-year follow-up

We aim to illustrate the outstanding long-term performance of Z-SYSTEMS' zirconia implant through two clinical cases. In both instances, a one-piece zirconia implant was utilised for a single-tooth restoration in the mandibular posterior region 17 years ago. Following surgical insertion of the implant and adaptation of the wound margin with single sutures, the exposed implant abutment was shortened by wearing off the outer hexagon. To protect the implant and its transgingival portion during the healing phase, an impression of the situation was taken in the same session to fabricate a protective temporary restoration. The protective temporary restoration, made of non-precious metal, was designed in the form of a double brace. It was manufactured in the dental laboratory within 24 hours and bonded to the adjacent teeth of the interdental gap on the subsequent day. The temporary restoration was designed with a depression in the area of the implant abutment to prevent external forces from acting on the implant during the healing process.

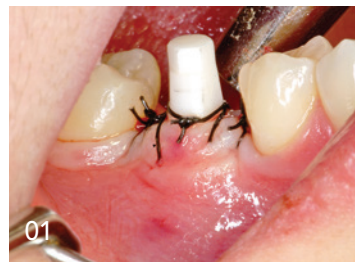
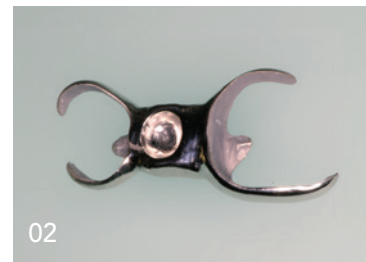
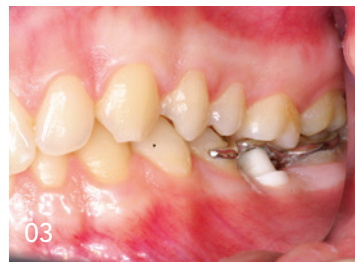
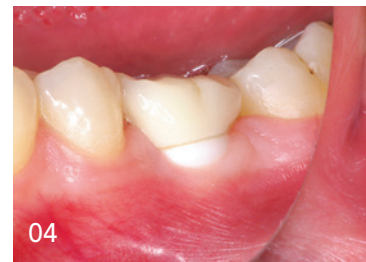
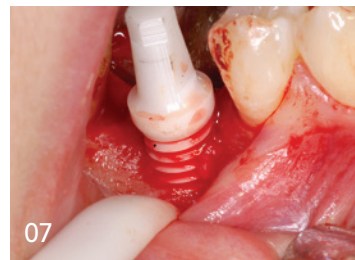
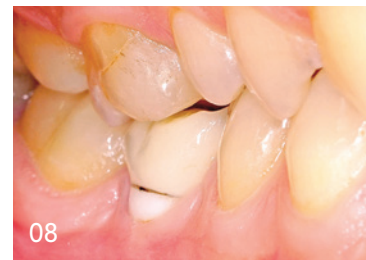
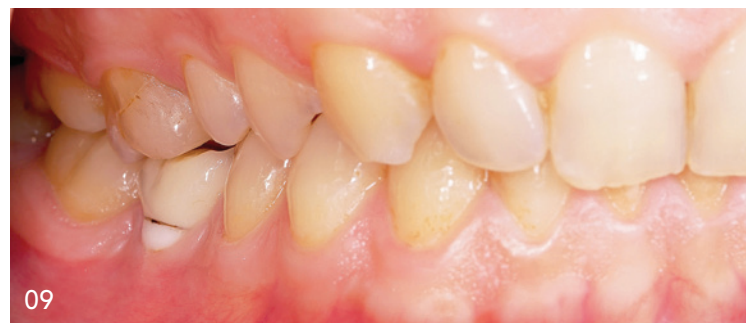
Case 1

In patient No. 1, the implant site in region 46 exhibited a vestibular bone deficit. While efforts were made to augment the defect using autologous bone obtained during site preparation, which was covered with a mucoperiosteal flap, the primary complete wound closure was not possible due to the transgingival portion of the implant. A comparable procedure with a titanium implant would be inconceivable. Additionally, the vertical position of the implant was suboptimal as it could have been placed 1.5 mm lower.

These two clinical cases demonstrate that long-term success was achieved due to the surface quality and implant geometry of Z-SYSTEM implants. Despite suboptimal implant placement, vestibular bone supply and prosthetic restoration, both implants have maintained functionality for a period of 17 years!

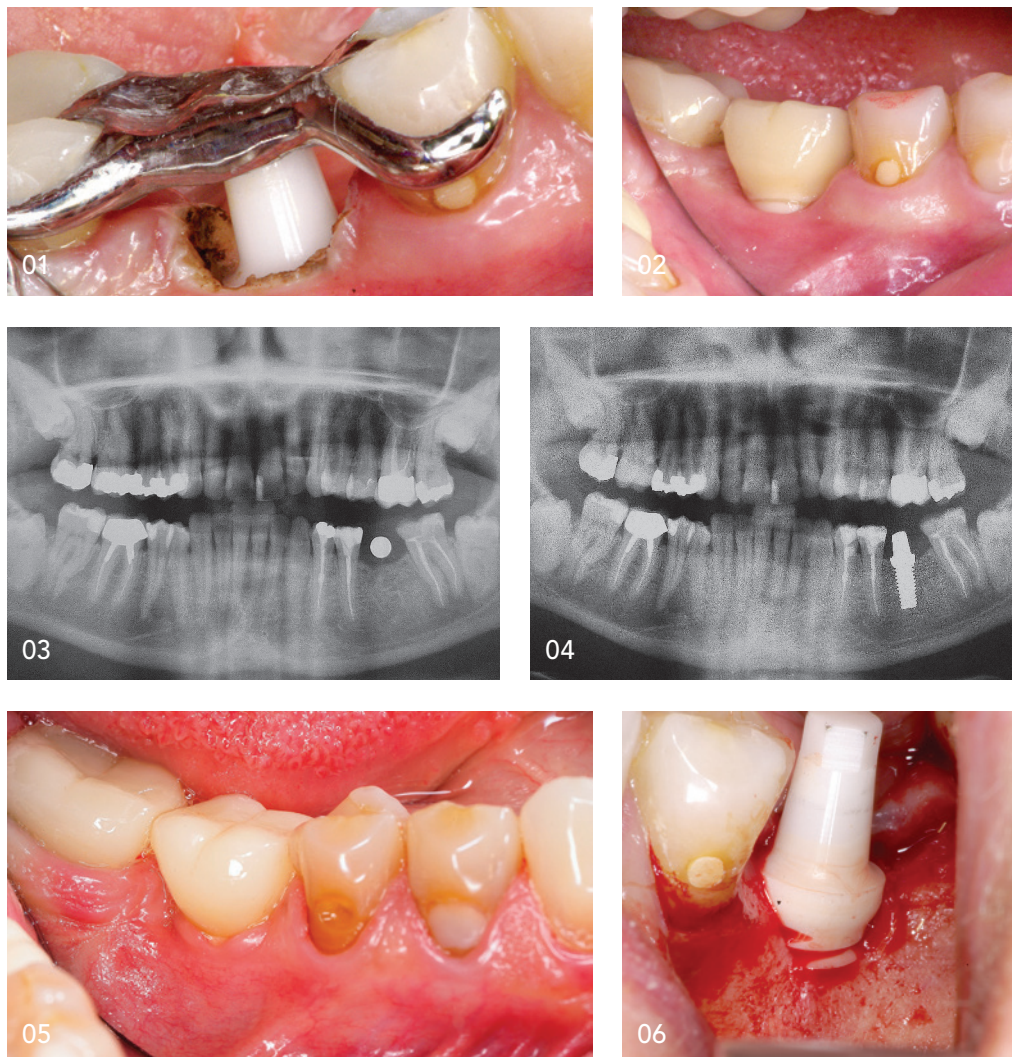
Case 2

In contrast to patient No. 1, the implant in patient No. 2 was positioned approximately 1.5 mm under the recommended margin. Consequently, the transition from the implant crown to the implant shoulder was lower than the optimal biological

width of the adjacent teeth. Exposure of the implant shoulder by lasering is not recommended, as this provokes unnecessary mucosal scarring and reduces moisture penetration.

This underscores the exceptional biocompatibility of Z-SYSTEMS' zirconia implants, which demonstrate remarkable resilience, even in cases where suboptimal conditions were inadvertently created. Indeed, this is a positive indication of the long-term stability of the implant site.
