Therapy of an infra-bony peri-implant defect

Successful regenerative treatment using modern alloplastic bone graft material

Dr Hussein Asaria, UK

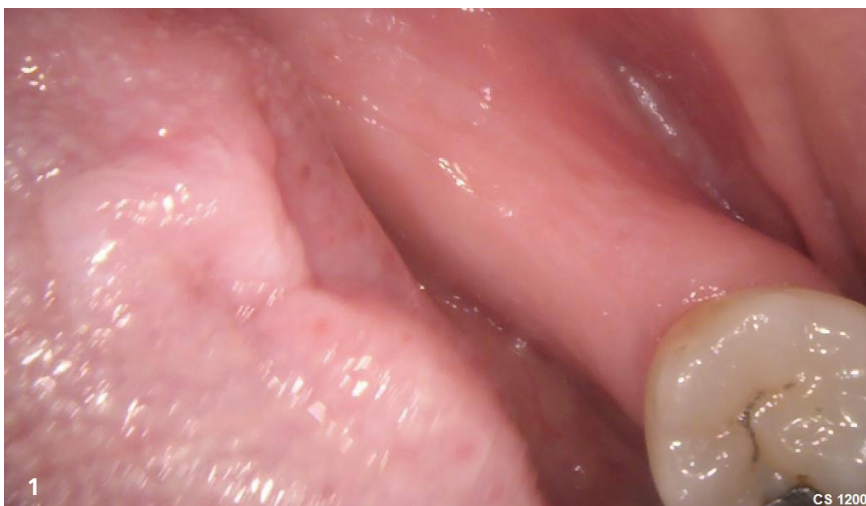
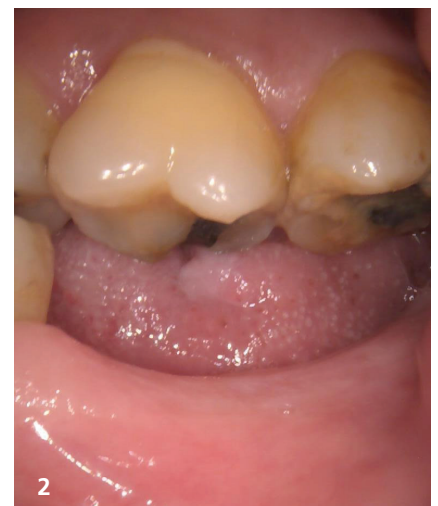
Figs. 1 & 2: Initial clinical situation.

In January 2022, a 58-year-old woman presented with a long-standing concern about her inability to bite effectively on her lower left side due to the absence of her first and second molars (Figs. 1 & 2). She expressed interest in exploring dental implant options to restore her bite functionality.

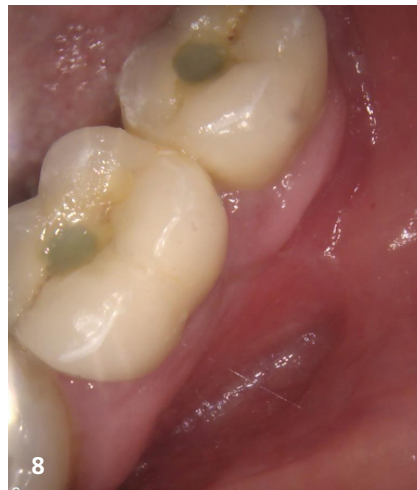
Fig. 7: Radiograph at nine months post-op. **Fig. 8:** Buccal swelling can be observed. **Fig. 9:** Removal of the restoration. **Fig. 10:** Three-sided flap revealing the defect.

However, seven months post-implantation, the patient reported a strange, swollen sensation in her gum over the past six weeks. Her general dentist prescribed Amoxicillin 500 mg, to be taken three times daily for five days. Clinical examination and radiographs revealed bleeding on probing, suppuration, increased probing depths, and progressive bone loss around implant #37 only (Figs. 7 & 8).
