## Therapy of an infra-bony peri-implant defect

# Successful regenerative treatment using modern alloplastic bone graft material

Dr Hussein Asaria, UK

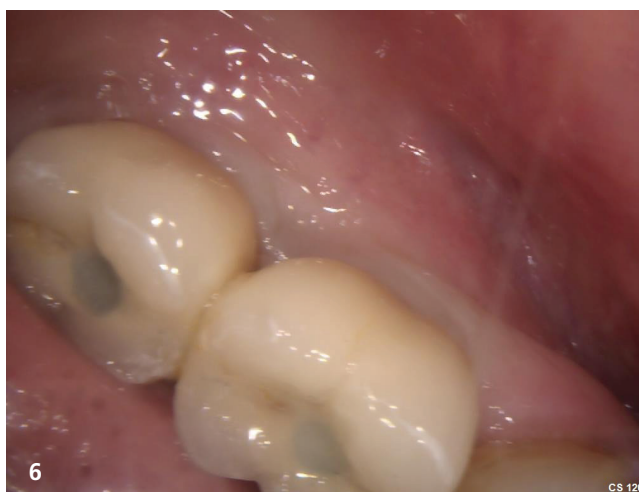
**Fig. 6:** Condition of the tissues at the time of fit.
