Therapy of an infra-bony peri-implant defect

Successful regenerative treatment using modern alloplastic bone graft material

Dr Hussein Asaria, UK

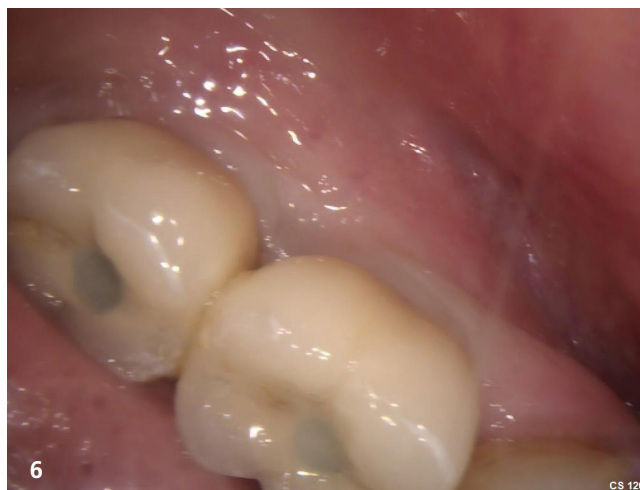
Fig. 3: CBCT scan for treatment planning.
Fig. 4: Implants at the time of placement.
Fig. 5: Radiograph taken during the impression phase.
Fig. 6: Condition of the tissues at the time of fit.

Her medical history revealed high blood pressure and borderline type 2 diabetes, for which she was regularly taking amlodipine and metformin. A cone beam computed tomography (CBCT) scan was conducted for planning purposes (Fig. 3). Subsequently, implant placement was performed three months later (Fig. 4). The patient was pre-medicated with 3g of Amoxicillin, and a full-thickness flap was raised to place two GM Helix Neodent implants, each 3.5 x 10 mm, with a torque of 45 Ncm. Healing abutments were also placed, and no grafting was necessary. The surgical procedure was uneventful, and the patient returned a week later for suture removal, with healing progressing as expected.

Four months post-implantation, multi-unit abutments (GM Mini Conical) were fitted, and impressions were taken for linked crowns (Fig. 5). The crowns were placed one month later (Fig. 6). Six weeks after crown placement, the patient was recalled for an assessment, which revealed no issues, with baseline probing depths around the implants being satisfactory.

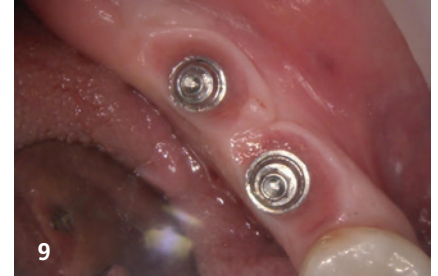
Fig. 7: Radiograph at nine months post-op. **Fig. 8:** Buccal swelling can be observed. **Fig. 9:** Removal of the restoration. **Fig. 10:** Three-sided flap revealing the defect.

However, seven months post-implantation, the patient reported a strange, swollen sensation in her gum over the past six weeks. Her general dentist prescribed Amoxicillin 500mg, to be taken three times daily for five days. Clinical examination and radiographs revealed bleeding on probing, suppuration, increased probing depths, and progressive bone loss around implant #37 only (Figs. 7 & 8).

To address this, the patient was instructed to follow an intense oral hygiene regimen, including interdental brushing and salt rinses, for two weeks. Following this regimen, the restoration was removed (Fig. 9), and the #37 abutment was replaced with a flat cover screw. A full-thickness three-sided flap was performed to avoid disturbing implant #36 (Fig. 10). The granulation tissue was meticulously removed using hand instruments and EthOss® degranulation burs, and the implant was cleaned with a stainless steel hand curette. After thoroughly removing the infected tissue, the implant surface was disinfected with 6% hydrogen peroxide gel for two minutes, followed by saline rinsing. This decontamination process was repeated five times (Figs. 11–16).

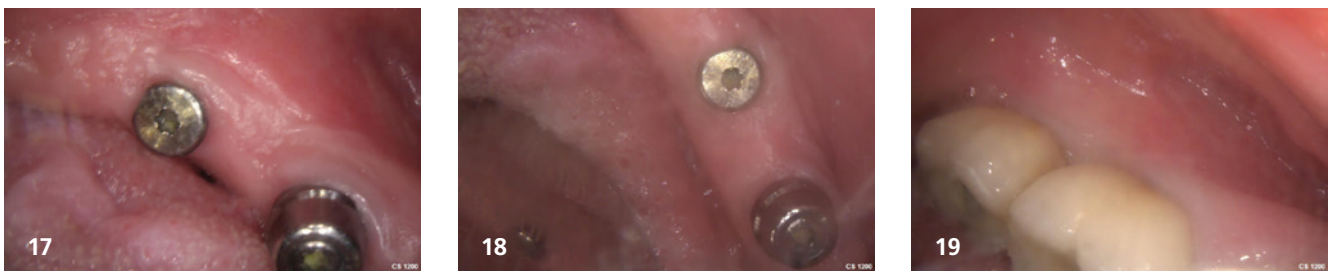
Figs. 17 & 18: Healing progress around the healing abutment. **Fig. 19:** Placing of the original restoration. **Fig. 20:** Condition of the tissues at the time of re-fit. **Fig. 21:** Radiograph taken at re-fit. **Fig. 22:** Condition of the tissues at the six-month review. **Fig. 23:** Lingual tissue condition at the six-month review. **Fig. 24:** Radiograph taken at the six-month review.

Four months later, the patient returned for a follow-up, reporting no pain or issues. Probing depths around implant #37 were 112/111 around the protection cylinder, and around implant #36 were 101/101 around the healing abutment. The healing abutment was replaced with the initially used MUA, and the same restoration was reattached (Figs. 17–24).
