Therapy of an infra-bony peri-implant defect

Successful regenerative treatment using modern alloplastic bone graft material

Dr Hussein Asaria, UK

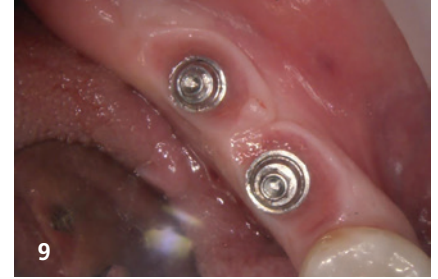
However, seven months post-implantation, the patient reported a strange, swollen sensation in her gum over the past six weeks. Her general dentist prescribed Amoxicillin 500mg, to be taken three times daily for five days. Clinical examination and radiographs revealed bleeding on probing, suppuration, increased probing depths, and progressive bone loss around implant #37 only (Figs. 7 & 8).

Fig. 7: Radiograph at nine months post-op. **Fig. 8:** Buccal swelling can be observed. **Fig. 9:** Removal of the restoration. **Fig. 10:** Three-sided flap revealing the defect.

To address this, the patient was instructed to follow an intense oral hygiene regimen, including interdental brushing and salt rinses, for two weeks. Following this regimen, the restoration was removed (Fig. 9), and the #37 abutment was replaced with a flat cover screw. A full-thickness three-sided flap was performed to avoid disturbing implant #36 (Fig. 10). The granulation tissue was meticulously removed using hand instruments and EthOss® degranulation burs, and the implant was cleaned with a stainless steel hand curette. After thoroughly removing the infected tissue, the implant surface was disinfected with 6% hydrogen peroxide gel for two minutes, followed by saline rinsing. This decontamination process was repeated five times (Figs. 11–16).
