Immediate two-piece ceramic implants with immediate provision-alisation in the posterior region

Drs Alexandre Marques Paes da Silva, Alice Maria de Oliveira Silva, Lissya Tomaz da Costa Gonçalves, Rodrigo Franco Motta, Daniel Moraes Telles, Mayla Kezy Silva Teixeira & Eduardo Veras Lourenço, Brazil

The present case report aims to describe the clinical and radiographic performance of ceramic implants placed in the posterior regions of two patients who visited the private SobreImplantes clinical study centre in Rio de Janeiro in Brazil. CBCT was used to carry out surgical planning, and periapical radiographs were used in the immediate postoperative period and in the follow-up consultations. The implants were placed into fresh sockets (immediate) and immediately provisionised. After receiving the implants, the patients remained under follow-up for three months after surgery. The temporary prostheses were then removed and replaced with definitive crowns. The patients remained under follow-up for 18 months, over which time it was possible to observe clinical and radiographic success in relation to osseointegration, stability of the marginal bone level and peri-implant health of both i

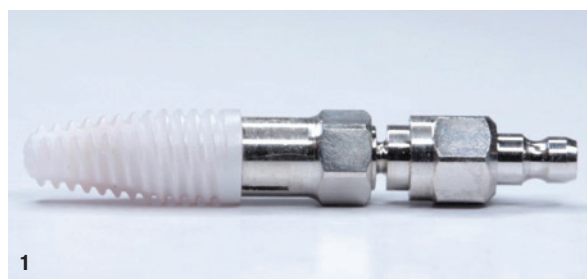
Fig. 1: Neodent Zi Ceramic Implant System.

The objective of this case report is to demonstrate the clinical and radiographic performance of a two-piece ceramic implant system (Neodent Zi, Straumann; Fig. 1) employed in two patients who visited the SobreImplantes private clinic located in the city of Rio de Janeiro in Brazil in order to undergo oral rehabilitation of posterior teeth with single implants and to report the degree of satisfaction of these patients in relation to the aesthetics of the treatment. Both patients were non-smokers and had good general health or controlled systemic conditions. For planning and diagnosis, the patients were asked to undergo CBCT (Figs. 2 & 3).

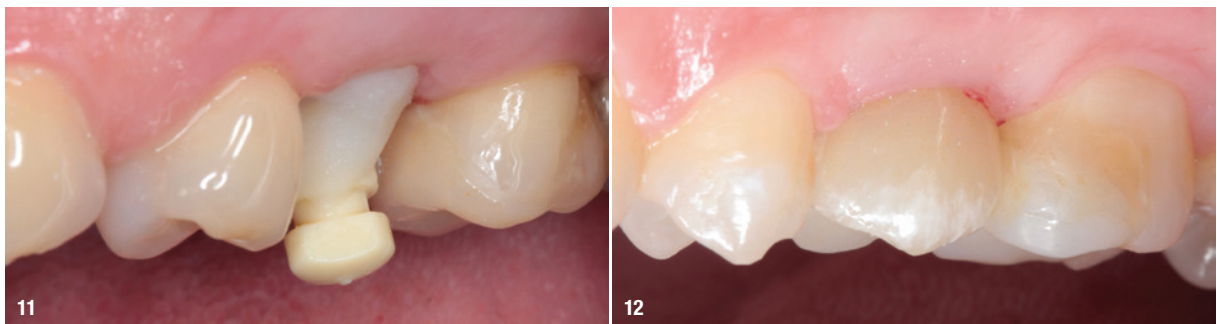
Fig. 11: Analog flow—emergency profile molding. **Fig. 12:** Cemented definitive crown (e.max).

After three months, the patients were re-evaluated, and there had been no complications during the healing period. Following a conventional workflow, the definitive crowns were manufactured. It is important to highlight that the gingival emergence profile was carefully copied, using a light-polymerised flowable resin (Master Flow, Biodinamica; Fig. 11). One patient received a milled crown (IPS e.max, Ivoclar Vivadent; Fig. 12) and the other a milled monolithic zirconia crown (Fig. 13), and the pros-
