# Immediate two-piece ceramic implants with immediate provision- alisation in the posterior region

Drs Alexandre Marques Paes da Silva, Alice Maria de Oliveira Silva, Lissy Tomaz da Costa Gonçalves, Rodrigo Franco Motta, Daniel Moraes Telles, Mayla Kezy Silva Teixeira & Eduardo Veras Lourenço, Brazil

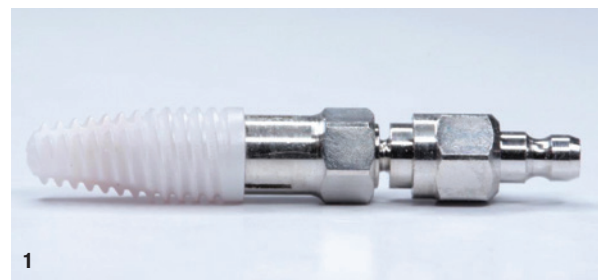
Fig. 1: Neodent Zi Ceramic Implant System.

The objective of this case report is to demonstrate the clinical and radiographic performance of a two-piece ceramic implant system (Neodent Zi, Straumann; Fig. 1) employed in two patients who visited the SobreImplantes private clinic located in the city of Rio de Janeiro in Brazil in order to undergo oral rehabilitation of posterior teeth with single implants and to report the degree of satisfaction of these patients in relation to the aesthetics of the treatment. Both patients were non-smokers and had good general health or controlled systemic conditions. For planning and diagnosis, the patients were asked to undergo CBCT (Figs. 2 & 3).

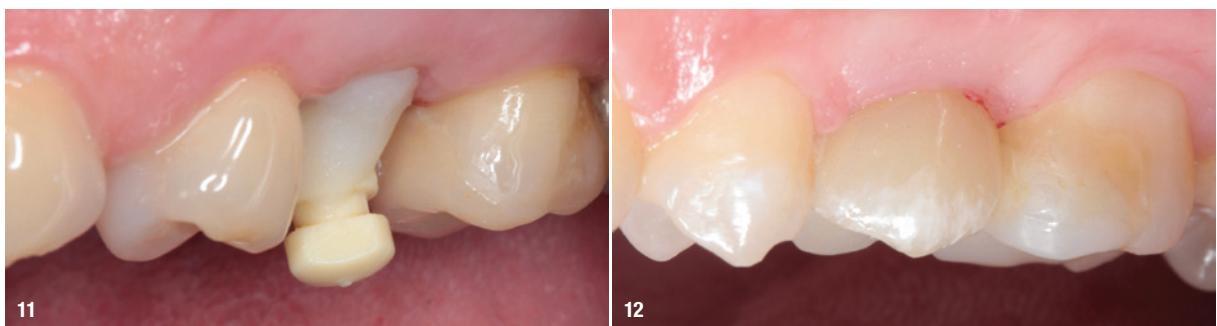
**Fig. 11:** Analog flow—emergency profile molding. **Fig. 12:** Cemented definitive crown (e.max).

After three months, the patients were re-evaluated, and there had been no complications during the healing period. Following a conventional workflow, the definitive crowns were manufactured. It is important to highlight that the gingival emergence profile was carefully copied, using a light-polymerised flowable resin (Master Flow, Biodinamica; Fig. 11). One patient received a milled crown (IPS e.max, Ivoclar Vivadent; Fig. 12) and the other a milled monolithic zirconia crown (Fig. 13), and the pros-
