Successful treatment of peri-implantitis with GalvoSurge® dental implant cleaning system

Impact of advanced surgical techniques on tissue health

Dr Algirdas Puišys, Lithuania

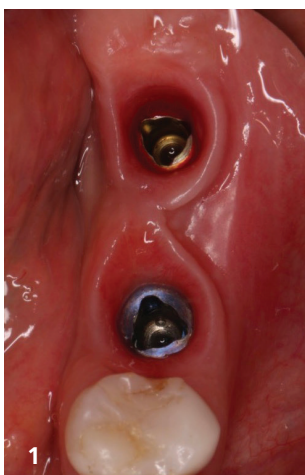
Fig. 1: Conservative treatment approach with prosthesis removed. **Fig. 2:** Healing abutments positioned for tissue adaptation. **Fig. 3:** Radiograph of implants placed in positions #36 and #37.

The initial phase involved conservative treatment, wherein the prosthetic restoration was removed, and healing abutments were placed (Figs. 1 & 2). Non-surgical mechanical debridement was performed utilising standard ultrasonic instruments and an air flow device. This was supplemented by irrigation with chlorhexidine 0.12% and metronidazole at a concentration of 5 mg/ml, followed by the application of a local antibiotic solution enriched with hyaluronic acid. Post-procedural radiographs were obtained for implants located in positions #36 and #37 after the healing abutments were screwed in place (Fig. 3).

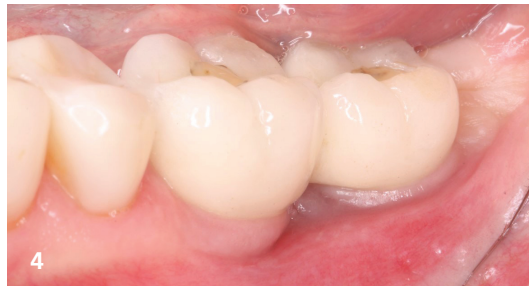
Fig. 4: Clinical reevaluation prior to surgical intervention. **Fig. 5:** Preoperative radiograph conducted before surgery. **Fig. 6:** Fixed prosthesis removed to facilitate access to the surgical site. **Fig. 7:** GalvoSurge® spray head equipped with a sponge to maintain maximum contact of the cleaning solution with the implant surface.

Prior to surgery, a comprehensive re-evaluation was conducted (Figs. 4 & 5). The fixed prosthesis was first removed (Fig. 6), after which the patient rinsed with

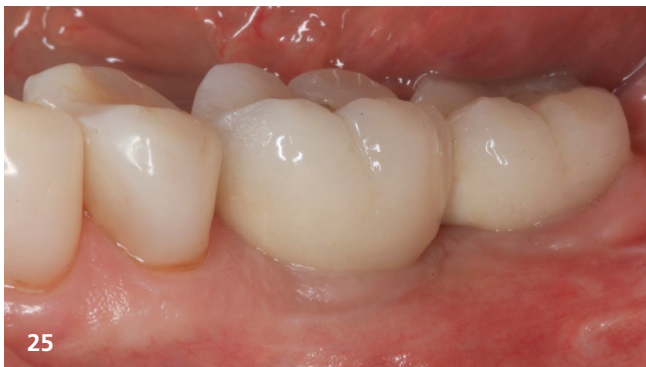
Fig. 25: Follow-up visit in 2023 indicating continued stability and no biological complications observed.

During follow-up visits in 2021 (Figs. 22 & 23), 2022 (Fig. 24), and 2023 (Fig. 25), no biological or radiographic complications were found. These evaluations confirmed excellent health in both hard and soft tissues, showcasing the effectiveness of the surgical approach. The GalvoSurge® system and guided bone regeneration (GBR) significantly contributed to these outcomes, emphasising the importance of these advanced techniques in achieving optimal patient results and long-term stability.
