Successful treatment of peri-implantitis with GalvoSurge® dental implant cleaning system

Impact of advanced surgical techniques on tissue health

Dr Algirdas Puišys, Lithuania

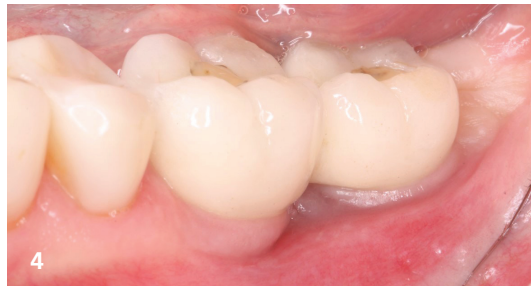
Fig. 4: Clinical reevaluation prior to surgical intervention. **Fig. 5:** Preoperative radiograph conducted before surgery. **Fig. 6:** Fixed prosthesis removed to facilitate access to the surgical site. **Fig. 7:** GalvoSurge® spray head equipped with a sponge to maintain maximum contact of the cleaning solution with the implant surface.

Prior to surgery, a comprehensive re-evaluation was conducted (Figs. 4 & 5). The fixed prosthesis was first removed (Fig. 6), after which the patient rinsed with
