Successful treatment of peri-implantitis with GalvoSurge® dental implant cleaning system

Impact of advanced surgical techniques on tissue health

Dr Algirdas Puišys, Lithuania

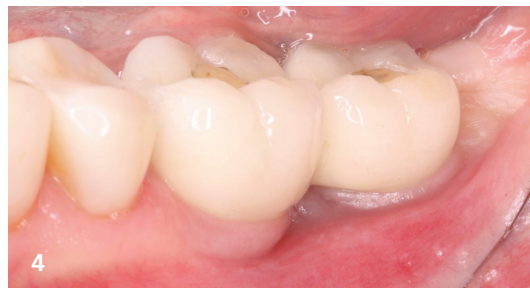
Fig. 4: Clinical reevaluation prior to surgical intervention. **Fig. 5:** Preoperative radiograph conducted before surgery. **Fig. 6:** Fixed prosthesis removed to facilitate access to the surgical site. **Fig. 7:** GalvoSurge® spray head equipped with a sponge to maintain maximum contact of the cleaning solution with the implant surface.

Prior to surgery, a comprehensive re-evaluation was conducted (Figs. 4 & 5). The fixed prosthesis was first removed (Fig. 6), after which the patient rinsed with

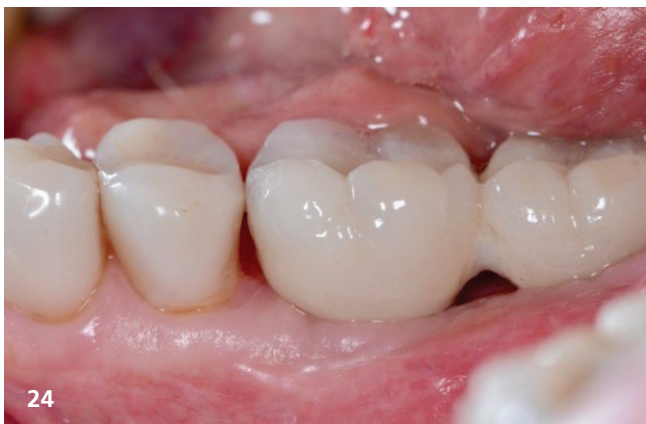
Fig. 24: Clinical stability and favourable outcome observed at the 2022 follow-up.

During follow-up visits in 2021 (Figs. 22 & 23), 2022 (Fig. 24), and 2023 (Fig. 25), no biological or radiographic complications were found. These evaluations confirmed excellent health in both hard and soft tissues, showcasing the effectiveness of the surgical approach. The GalvoSurge® system and guided bone regeneration (GBR) significantly contributed to these outcomes, emphasising the importance of these advanced techniques in achieving optimal patient results and long-term stability.
