## Successful treatment of peri-implantitis with GalvoSurge® dental implant cleaning system

# Impact of advanced surgical techniques on tissue health

Dr Algirdas Puišys, Lithuania

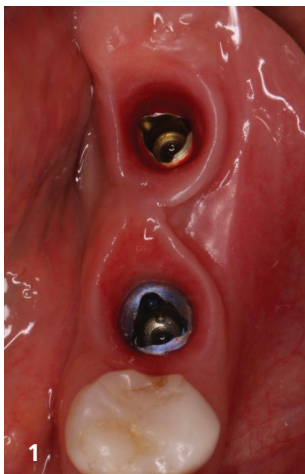
**Fig. 1:** Conservative treatment approach with prosthesis removed. **Fig. 2:** Healing abutments positioned for tissue adaptation. **Fig. 3:** Radiograph of implants placed in positions #36 and #37.

The initial phase involved conservative treatment, wherein the prosthetic restoration was removed, and healing abutments were placed (Figs. 1 & 2). Non-surgical mechanical debridement was performed utilising standard ultrasonic instruments and an air flow device. This was supplemented by irrigation with chlorhexidine 0.12% and metronidazole at a concentration of 5 mg/ml, followed by the application of a local antibiotic solution enriched with hyaluronic acid. Post-procedural radiographs were obtained for implants located in positions #36 and #37 after the healing abutments were screwed in place (Fig. 3).

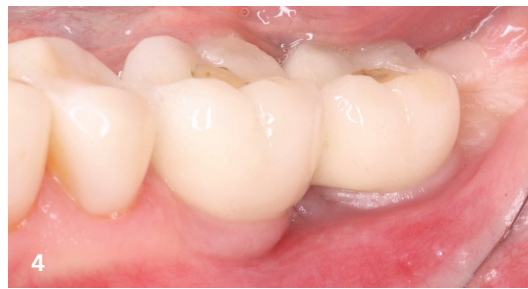
**Fig. 4:** Clinical reevaluation prior to surgical intervention. **Fig. 5:** Preoperative radiograph conducted before surgery. **Fig. 6:** Fixed prosthesis removed to facilitate access to the surgical site. **Fig. 7:** GalvoSurge® spray head equipped with a sponge to maintain maximum contact of the cleaning solution with the implant surface.

Prior to surgery, a comprehensive re-evaluation was conducted (Figs. 4 & 5). The fixed prosthesis was first removed (Fig. 6), after which the patient rinsed with

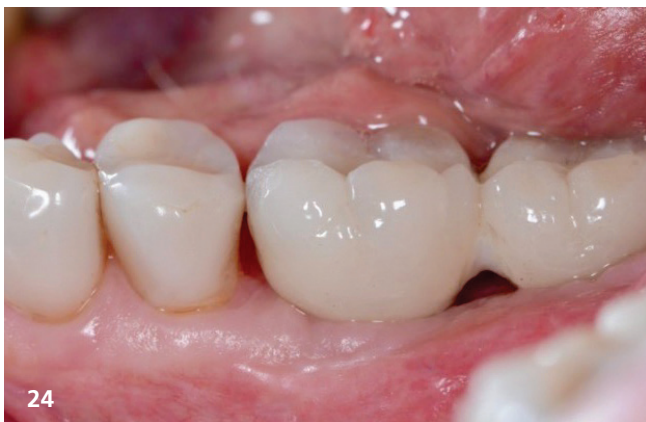
**Fig. 24:** Clinical stability and favourable outcome observed at the 2022 follow-up.

During follow-up visits in 2021 (Figs. 22 & 23), 2022 (Fig. 24), and 2023 (Fig. 25), no biological or radiographic complications were found. These evaluations confirmed excellent health in both hard and soft tissues, showcasing the effectiveness of the surgical approach. The GalvoSurge® system and guided bone regeneration (GBR) significantly contributed to these outcomes, emphasising the importance of these advanced techniques in achieving optimal patient results and long-term stability.

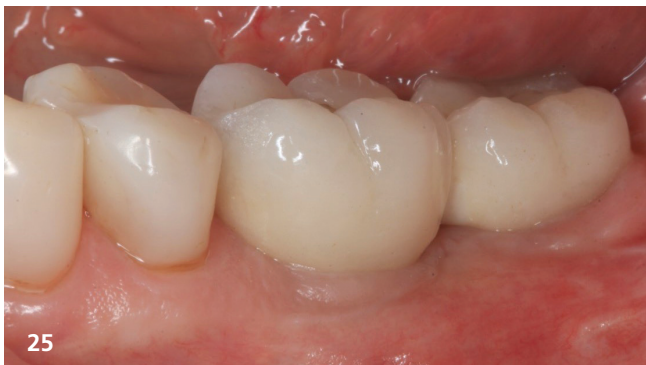
**Fig. 25:** Follow-up visit in 2023 indicating continued stability and no biological complications observed.
