Successful treatment of peri-implantitis with GalvoSurge® dental implant cleaning system

Impact of advanced surgical techniques on tissue health

Dr Algirdas Puišys, Lithuania

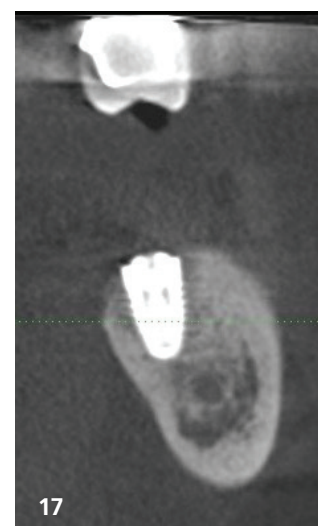
Fig. 18: Flap elevated to access and remove residual excess bone from the healing abutment. **Fig. 19:** Clinical situation following removal of excess bone around the healing abutment. **Fig. 20:** Prosthesis reattached to its designated position post-treatment. **Fig. 21:** Follow-up visit ten days post-procedure, with the clinical situation evaluated. **Fig. 22:** Clinical evaluation at the 2021 follow-up, showing maintained tissue health.

After a six-month healing period, a follow-up tomography was performed, revealing optimal bone levels around the implants (Figs. 16 & 17). A flap was then elevated to access and remove any residual excess bone from the healing abutment area (Figs. 18 & 19). Closure of the incision was achieved using 4/0 Vicryl and 6/0 Prolene sutures to ensure a se-

cure and effective wound closure. The prosthetic component was then carefully reattached and secured in its designated position (Fig. 20).

Ten days later, the patient returned for a follow-up assessment, during which a thorough evaluation of the treatment site was conducted. At this visit, the sutures were carefully removed, and a radiograph was taken to assess the ongoing healing and integration at the treatment site. The patient expressed satisfaction with the results, indicating a successful and favourable response to the procedure (Fig. 21).
