## Six-year case report

# Fully guided immediate implant restoration in the aesthetic zone

Dr Guilherme Moreira, Brazil

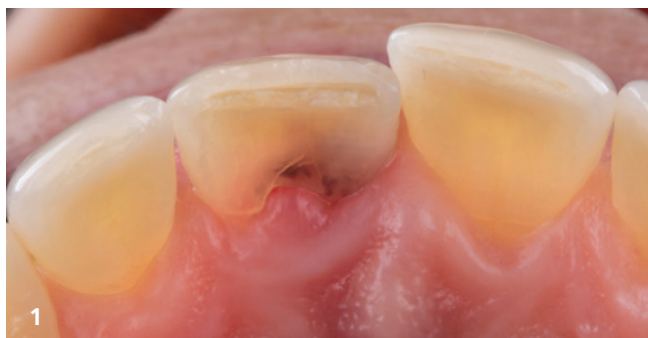
**Fig. 1:** Initial intra-oral examination showing external root resorption on the palatal surface of tooth #11. – **Fig. 2:** Tooth #11 appears darker and slightly intruded compared to its contralateral tooth.

The extra-oral examination showed a high smile line. The intra-oral examination of tooth #11 revealed signs of external root resorption on the palatal surface (Fig. 1). The tooth appeared darker and slightly intruded compared to its contralateral tooth (Fig. 2), raising suspicion of ankylosis. The tooth was non-sensitive to percussion, and the CO<sub>2</sub> test was negative. No signs of local infection, occlusal trauma, or periodontal inflammation were observed.

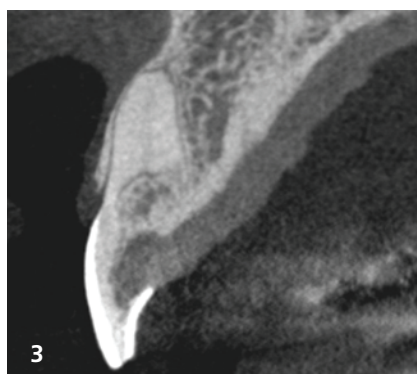
**Fig. 3:** CBCT scan confirming the extent of root resorption. – **Fig. 4:** SAC classification categorising the patient's surgical case as complex and prosthodontic case as advanced.

The CBCT scan confirmed the extent of the root resorption with no loss of alveolar height detected (Fig. 3).

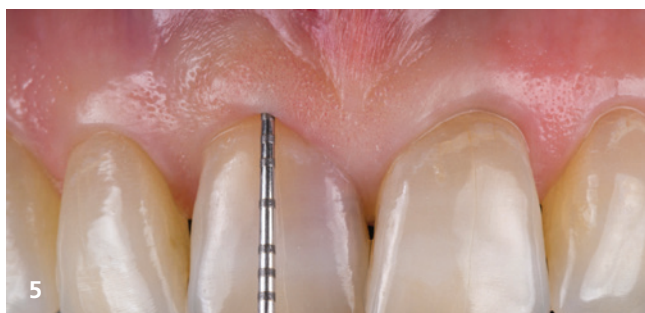
**Fig. 5:** Evaluation of tooth #11 showing absence of increased probing depth. – **Fig. 6:** Implant bed preparation following the extraction of tooth #11. – **Fig. 7:** Confirming complete preparation depth and correct orientation of the implant axis. – **Fig. 8:** Insertion of Straumann® Bone Level Tapered SLActive® implant using the surgical guide.

We initiated the evaluation of the tooth, noting the absence of dental plaque, bleeding on probing, or increased probing depth (Fig. 5). Local anaesthesia with 4% articaine and 1:100,000 epinephrine was administered, and tooth #11 was extracted atraumatically.

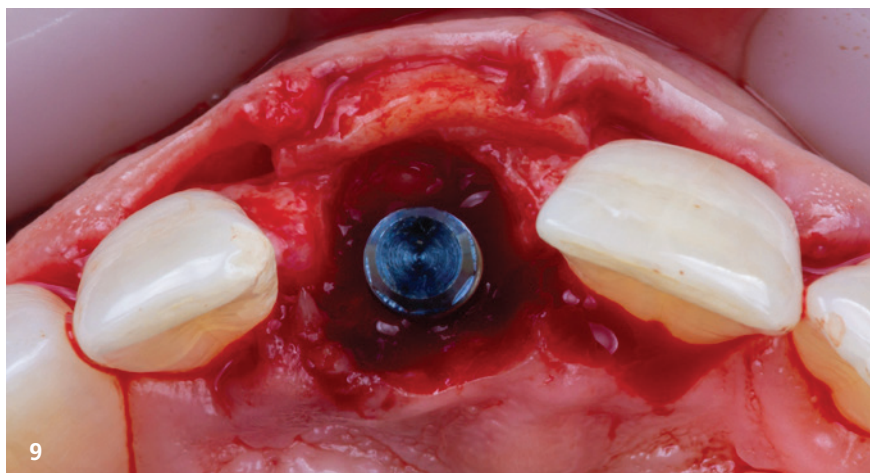
**Fig. 9:** Soft-tissue augmentation in the buccal zone with a connective tissue graft.

aid of the handpiece in a clockwise direction at a speed of 15rpm torqued to 35Ncm (Fig. 8). Soft-tissue augmentation was performed in the buccal zone with a connective tissue graft (Fig. 9).

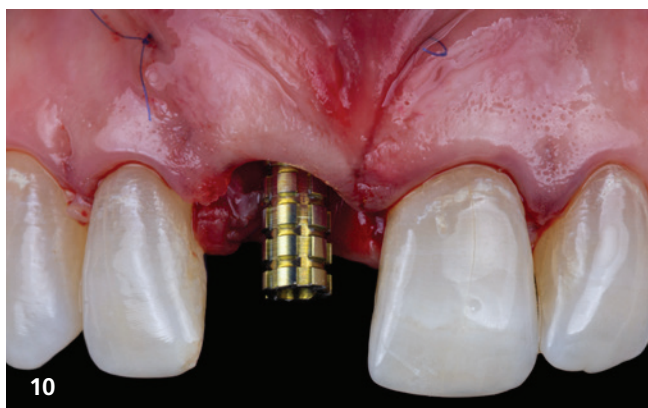
**Fig. 10:** Placement of the provisional abutment. – **Fig. 11:** Immediate temporary crown.

A tension-free closure of the soft tissue was achieved, and a provisional abutment was placed (Fig. 10). A radiograph was taken to confirm the precise positioning of implant #11 in relation to teeth #21 and #12, as well as the placement of the abutment. Subsequently, the abutment was torqued to 35Ncm using a torque wrench, followed by the placement of an immediate temporary crown (Fig. 11). Proximal contacts and occlusion were verified, and all occlusal contacts were adjusted to eliminate interference during lateral and excursive movements. The patient received instructions on care and hygiene.

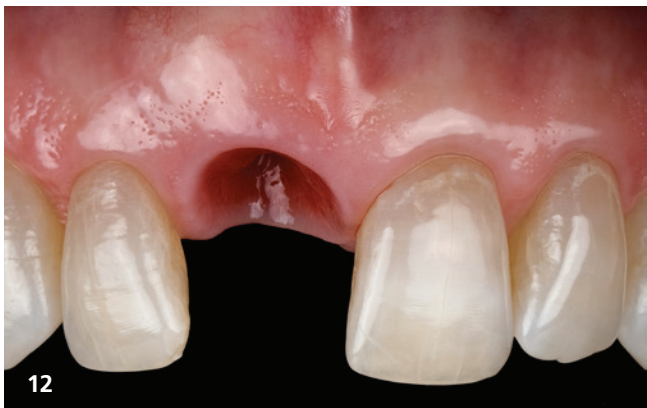
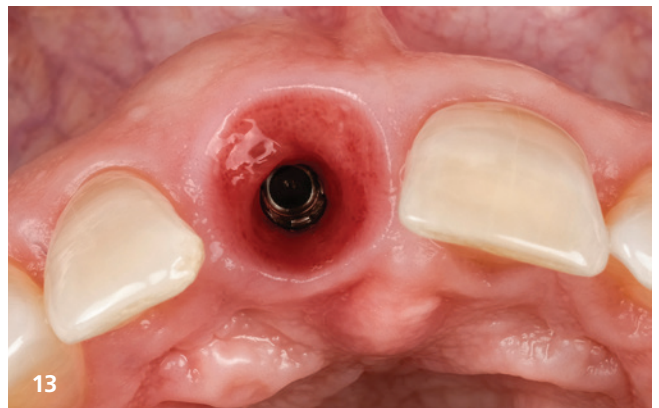
**Figs. 12+13:** Four months after the surgery, presence of sufficient interdental papilla and buccal contours similar to those of the adjacent teeth. – **Fig. 14:** Radiographic examination of the final crown. – **Fig. 15:** Two-year follow-up showing well-maintained gingival tissues. – **Figs. 16+17:** Six-year follow-up showing stable gingival margin around the implant. – **Fig. 18:** Six-year follow-up radiographic evaluation.

Four months after the implant had healed and osseointegration was confirmed, the temporary crown was removed. The gingiva was examined for healing, showing sufficient interdental papilla and buccal contours similar to those of the adjacent teeth (Figs. 12+13).
