Six-year case report

Fully guided immediate implant restoration in the aesthetic zone

Dr Guilherme Moreira, Brazil

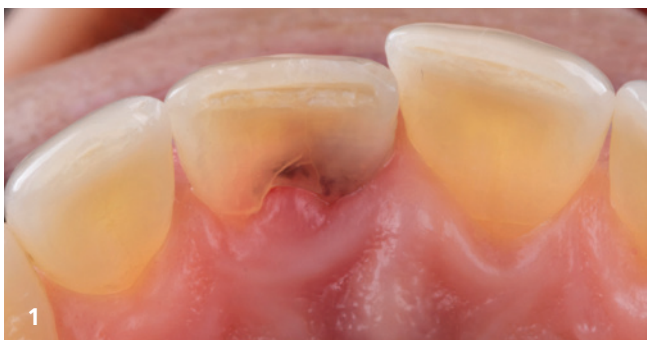
Fig. 1: Initial intra-oral examination showing external root resorption on the palatal surface of tooth #11. – **Fig. 2:** Tooth #11 appears darker and slightly intruded compared to its contralateral tooth.

The extra-oral examination showed a high smile line. The intra-oral examination of tooth #11 revealed signs of external root resorption on the palatal surface (Fig. 1). The tooth appeared darker and slightly intruded compared to its contralateral tooth (Fig. 2), raising suspicion of ankylosis. The tooth was non-sensitive to percussion, and the CO₂ test was negative. No signs of local infection, occlusal trauma, or periodontal inflammation were observed.

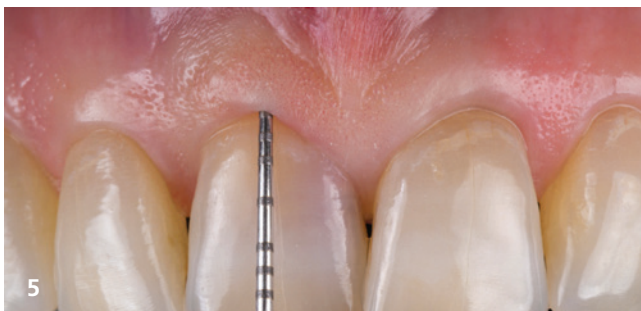
Fig. 5: Evaluation of tooth #11 showing absence of increased probing depth. – **Fig. 6:** Implant bed preparation following the extraction of tooth #11. – **Fig. 7:** Confirming complete preparation depth and correct orientation of the implant axis. – **Fig. 8:** Insertion of Straumann® Bone Level Tapered SLActive® implant using the surgical guide.

We initiated the evaluation of the tooth, noting the absence of dental plaque, bleeding on probing, or increased probing depth (Fig. 5). Local anaesthesia with 4% articaine and 1:100,000 epinephrine was administered, and tooth #11 was extracted atraumatically.

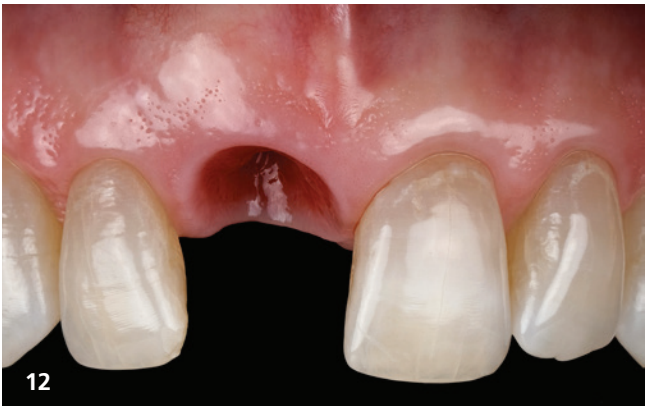
Figs. 12+13: Four months after the surgery, presence of sufficient interdental papilla and buccal contours similar to those of the adjacent teeth. – **Fig. 14:** Radiographic examination of the final crown. – **Fig. 15:** Two-year follow-up showing well-maintained gingival tissues. – **Figs. 16+17:** Six-year follow-up showing stable gingival margin around the implant. – **Fig. 18:** Six-year follow-up radiographic evaluation.

Four months after the implant had healed and osseointegration was confirmed, the temporary crown was removed. The gingiva was examined for healing, showing sufficient interdental papilla and buccal contours similar to those of the adjacent teeth (Figs. 12+13).
