A nine-year follow-up case report

Long-term success of implant-supported rehabilitation in the aesthetic zone

Dres Léon Pariente and Karim Dada, France

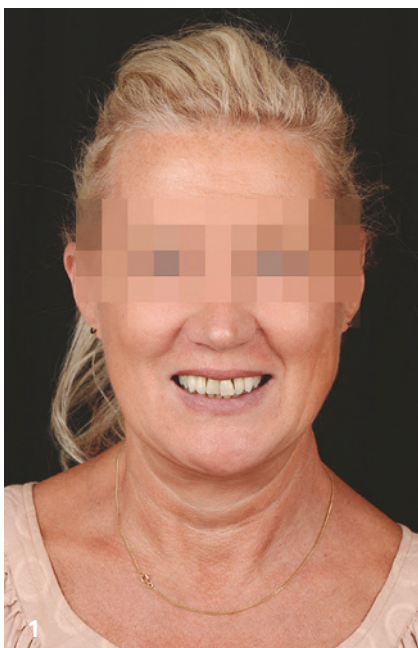
Fig. 1: The patient's extra-oral examination revealed a medium smile line. – **Fig. 2:** Misalignment observed in the maxillary front teeth. – **Fig. 3:** Intra-oral examination shows periodontal attachment loss and mobility in the upper left central incisor and lateral incisors. – **Fig. 4:** CBCT scan reveals the absence of buccal bone.

The patient's extra-oral examination revealed a medium smile line and misalignment of the front teeth (Figs. 1+2).

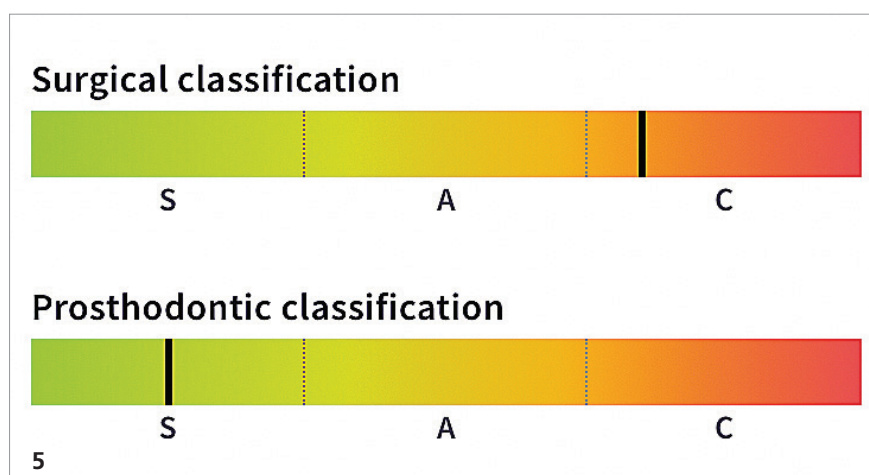
Fig. 5: Based on SAC classification, the patient was classified as surgically complex and prosthodontically straightforward.

According to the SAC classification, the patient was classified surgically as complex and prosthodontically as straightforward (Fig. 5).

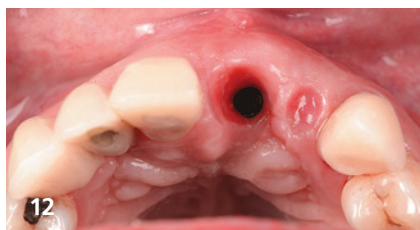
Fig. 12: Successful soft-tissue healing observed at the seven-month follow-up. – **Fig. 13:** Placement of the final restorations. – **Fig. 14:** The aesthetically pleasing appearance of the final crowns. – **Fig. 15:** Radiographic assessment at the time of final impression confirmed precise implant placement and verified bone structure integrity.

Soft-tissue conformation was evaluated seven months after the delayed loading of implant #21, with the aim to assess the maturation and adaptation of the surrounding soft tissues to the implant site (Fig. 12).

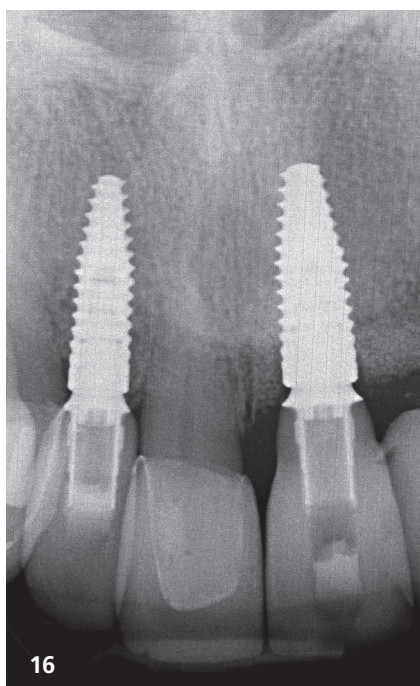
Fig. 16: A follow-up radiographic evaluation assessed the long-term stability and health of the implant sites. – **Fig. 17:** Six-year follow-up showing favourable aesthetic results. – **Fig. 18:** Six-year follow-up demonstrating a satisfactory clinical outcome.

Radiographic control was conducted at the time of the final impression to ensure an accurate assessment of the implant placement and surrounding structures (Fig. 15). Additionally, a follow-up radiographic evaluation was performed six years after the completion of the treatment to monitor the long-term stability and health of the treated area (Fig. 16).

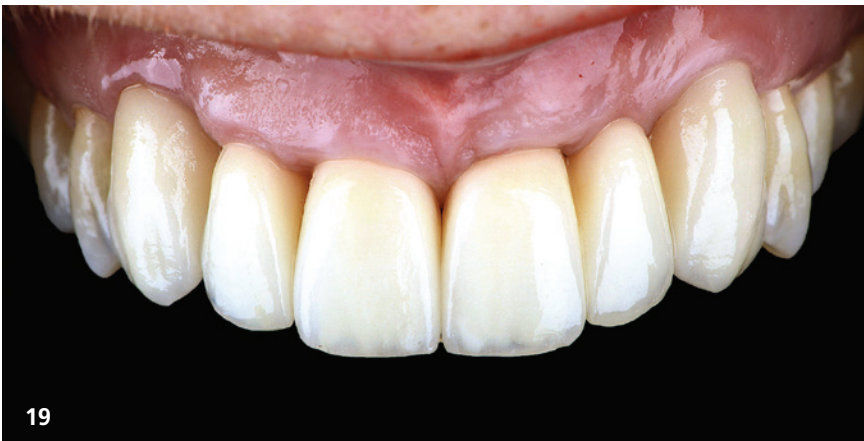
Fig. 19: Nine-year follow-up revealing successful results, with healthy soft and hard tissues maintained.

At the six-year (Figs. 17+18) and nine-year (Fig. 19) follow-ups, comprehensive clinical and radiographic assessments underscored favourable outcomes, including osseointegration, the maintenance of bone density around the implants, and pleasing aesthetics. These findings collectively indicated the success of the long-term treatment.
