# Effective electrolytic cleaning and regenerative therapy for peri-implantitis

Dr Algirdas Puišys, Lithuania

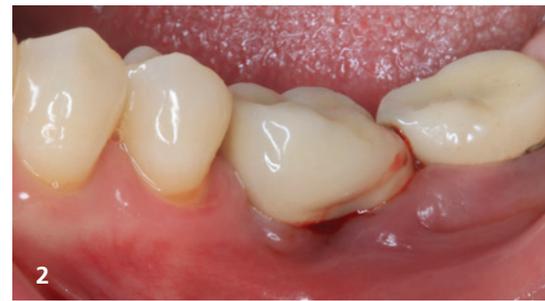
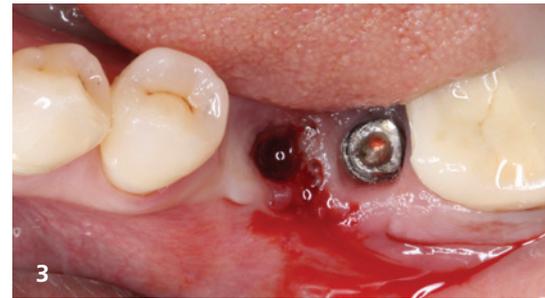
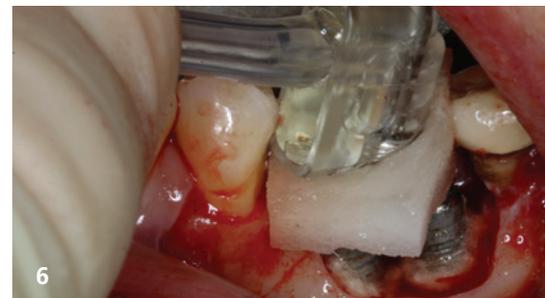
After the non-surgical treatment, clinical examination in 2021 showed a decrease in inflammation, though it was not completely resolved (Fig. 2). Lidocaine 2 % with epinephrine 1:100,000 was administered. Upon removal of the prosthesis, the peri-implant mucosa surrounding the implants in positions #36 and #37 exhibited localised inflammation with evident redness, swelling and bleeding (Fig. 3).

A full-thickness flap was elevated to access the defect and mechanically remove the granulation tissue surrounding the implants (Fig. 4). The bone defect was assessed using the modified criteria established by Monje et al., and was classified as a Class 3b defect, making it suitable for reconstructive therapy. First, implant disinfection was done with ablative mechanical debridement, CHX 0.12 %, met-

**Fig. 2:** Clinical view after non-surgical therapy, showing partial reduction of peri-implant inflammation. – **Fig. 3:** Peri-implant mucosa following prosthesis removal, with redness, swelling, and bleeding on probing. – **Fig. 4:** Full-thickness flap elevated to access peri-implant defect and remove granulation tissue. – **Fig. 5:** Mechanical debridement with chlorhexidine, metronidazole, and local antibiotic/hyaluronic acid solution. – **Fig. 6:** Electrolytic implant cleaning using GalvoSurge®, with hydrogen bubbles detaching biofilm.

ronidazole 5 mg/ml, and a solution of local antibiotic and hyaluronic acid (Fig. 5).

The implant cleaning and disinfection were done with CHX 0.12 % and the GalvoSurge®. Implant disinfection was performed using GalvoSurge®, applying only gentle pressure to the implant being treated. In this two-minute process, hydrogen ions interact with captured electrons to produce hydrogen bubbles that lift the biofilm off the implant surface (Fig. 6). Additionally, regenerative therapy was performed through GBR. Autogenous bone chips, combined with bone harvested from the tuber, were placed into the defect as grafts. These materials helped in bone augmentation and covered the exposed implant threads, thereby enhancing the healing and re-osseointegration at the implant site (Figs. 7–9).

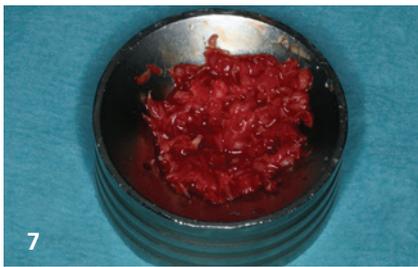
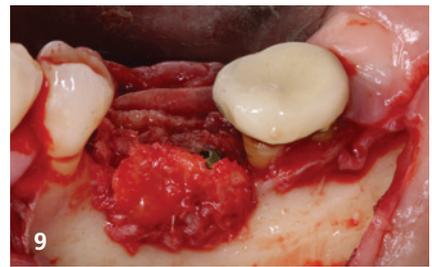
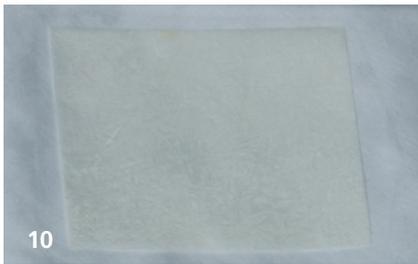
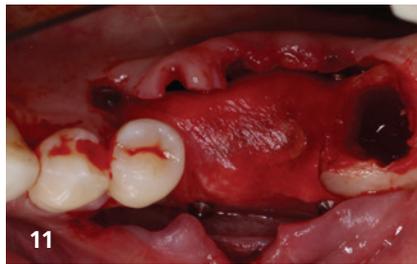
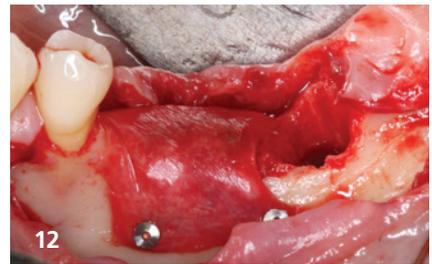
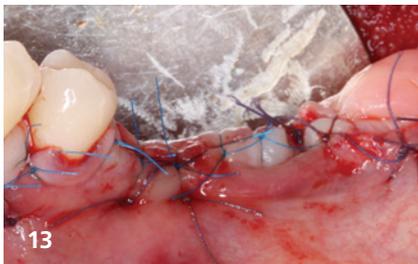
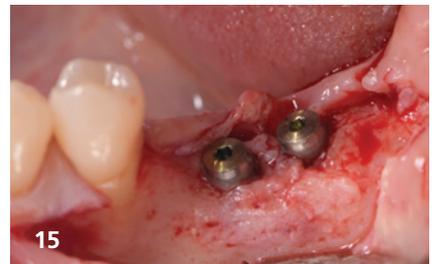
**Fig. 7:** Autogenous bone chips and graft material. – **Fig. 8:** Grafted defect covering exposed implant threads to support re-osseointegration. – **Fig. 9:** Fully grafted defect prior to placement of collagen membrane. – **Fig. 10:** Extraction of tooth #38 to allow proper defect management and grafting. – **Fig. 11:** Placement of Straumann® Membrane Flex to prevent soft-tissue ingrowth. – **Fig. 12:** Membrane secured with pins to protect the graft during healing. – **Fig. 13:** Flap closure with 4/0 Vicryl and 6/0 Prolene sutures, allowing submerged healing. – **Fig. 14:** Six-month postoperative view showing regenerated peri-implant bone around implants #36 and #37. – **Fig. 15:** Close-up of regenerated peri-implant bone prior to healing abutment placement. – **Fig. 16:** Healing abutments inserted to shape gingival tissue and protect implants.

Tooth #38 was extracted. Closure caps were placed, and the Straumann® Membrane Flex, a minimally-crosslinked porcine peritoneum collagen membrane, was fixed in place with pins. This protects the graft area from unwanted soft-tissue infiltration during the healing phase (Figs. 10–12).

Suturing was performed with 4/0 Vicryl and 6/0 Prolene, using interrupted sutures to facilitate primary intention wound healing, while the implant remained without the prosthetic crown for six months (Fig. 13). After this period of submerged healing, the reinstallation of the suprastructures was planned.

In 2021, six months after the initial surgery, a full-thickness flap was elevated, revealing that the implants were surrounded by bone (Figs. 14+15). Healing abutments were then inserted, and interrupted sutures were inserted using 6/0 Prolene (Fig. 16). The healing abutments play an essential role in facilitating proper healing of the gingival tissue around the implant, shaping the tissue for an optimal

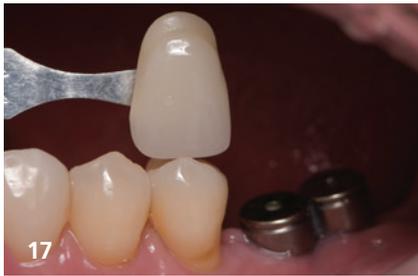
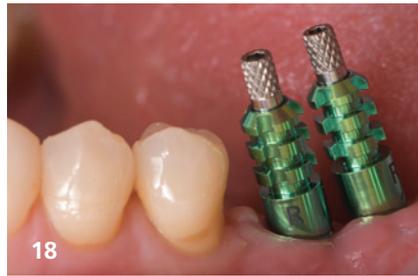
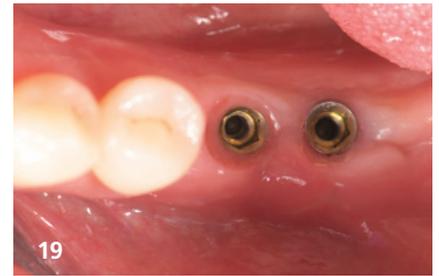
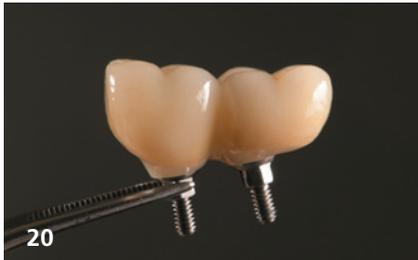
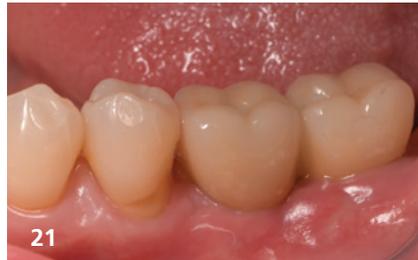
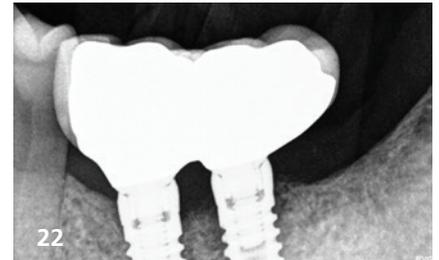
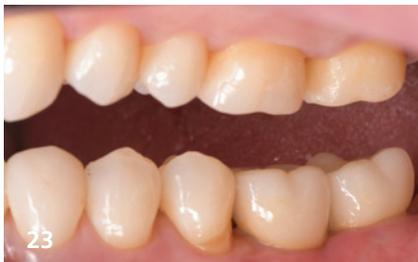
**Fig. 17:** Shade selection for zirconia prosthesis to match adjacent dentition. – **Fig. 18:** Open-tray impression using addition silicone for accurate prosthetic fabrication. – **Fig. 19:** Evaluation of peri-implant soft tissue before final prosthetic placement. – **Fig. 20:** Fully polished zirconia crowns. – **Fig. 21:** Final prosthesis torqued to 35Ncm for stability. – **Fig. 22:** Post-insertion radiograph confirming correct seating of prosthesis. – **Fig. 23:** Follow-up showing healthy peri-implant soft tissues without inflammation. – **Fig. 24:** One-year radiograph demonstrating stable marginal bone levels around implants. – **Fig. 25:** Radiograph in 2023 showing preserved peri-implant bone and long-term treatment success. – **Fig. 26:** Clinical evaluation in 2023 confirming healthy peri-implant tissues and gingival architecture.

After the healing period, the next step involved selection of the appropriate shade for the fully polished zirconia prosthesis to ensure aesthetic integration with the surrounding natural dentition. To achieve a precise match and optimal visual outcome, a shade guide was used, and the selected shade was confirmed with the patient (Fig. 17). An impression was taken with the open-tray technique, using additional silicone material for its high dimensional stability and accuracy (Fig. 18).

The gingiva was evaluated before the placement of the final prosthetics (Fig. 19). A fully polished zirconia prosthesis was then carefully fabricated and inserted and torqued to 35 Ncm (Figs. 20+21) and the subsequent x-ray revealed satisfactory results (Fig. 22).

At the follow-up recall in 2021, the clinical evaluation indicated that the peri-implant soft tissues were in good health, with no signs of inflammation. Additionally, the marginal levels were appropriately maintained (Fig. 23).

implant soft tissues remaining healthy. The radiographic examination also showed that the peri-implant marginal bone levels were stable, with no evidence of bone resorption (Fig. 24).

In 2023, similar results were observed, with the peri-implant tissues remaining healthy. The radiographic examination confirmed that marginal bone levels were intact. The treatment was successful, and the patient reported satisfaction with the aesthetic and functional outcomes. (Figs. 25+26).
