# Implant-prosthetic troubleshooting

When dental technicians and dentists break into a sweat!

**Authors**\_Dr Georg Bach & Christian Müller, Germany

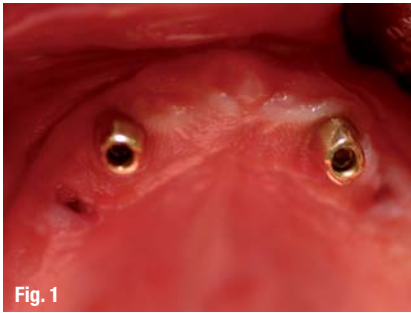
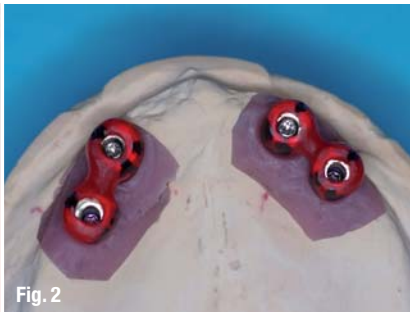
**Unidentified jaw misalignment**  
**Figs. 1–4** The former prosthesis (with two maxillary implants); note the discrepancy between the translucent templates and the axis of the plastic front teeth.

Just by looking at the maxillary prosthesis it was easy to notice the metal portions of the prosthesis, which were placed extremely palatally, showing through. An examination of the oral cavity revealed a considerable discrepancy between the implant placement and the axis of the plastic front teeth!

A wax-up marked the beginning of the actual treatment. It was modified until the patient was satisfied with the placement of his teeth and his subsequent appearance. Based on the results of this treatment planning, we were able to determine which position and alignment would be required for two additional implants (distally of the existing ones).

This in turn resulted in the creation of a drilling template, which was used during the insertion of the two additional artificial abutment teeth. After osseointegration of these two implants in regions #14 and 24, the new partial prosthesis (now supported by four implants (two existing and two new ones) was produced and integrated step by step.

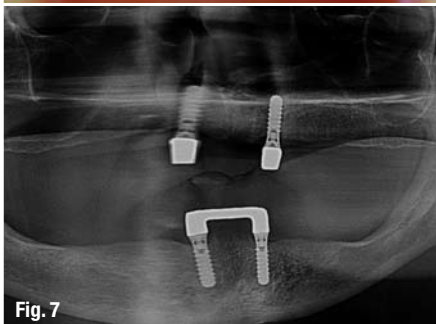
**Fig. 7** Initial X-ray image (panoramic tomography) with two implants (treated with telescopes) in the maxilla.

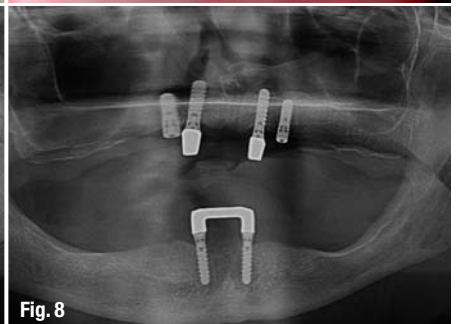
**Fig. 8** Condition after the increase of abutment teeth in the maxilla, each inserted distally of the previous implants.

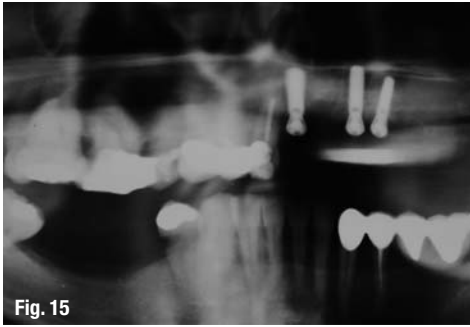
Fig. 15

**Fig. 15**\_ Three implants had originally been inserted to treat anodontia in the second quadrant.

A bridge structure in the second quadrant had been in place without any problems in a 50-year-old female patient for 10 years. Therefore, she only came to recall and follow-up examinations sporadically. The problem-free period ended abruptly when swelling and bite pain occurred in the left half of the maxilla. A panoramic tomography revealed radiological indications of a profound osseous defect around the mesial implant, which had to be removed on the same day. The issue then was the entire supra-structure. The patient insisted that this structure be preserved owing to the financial cost of having a new structure created after re-implantation.

A new implant was inserted after the soft tissue and bone had healed in the area where the lost implant had previously been in place. The bridge structure that had been temporarily affixed on the remaining implant was used as guidance for incorporation of a replacement implant and then removed for the actual implant procedure.

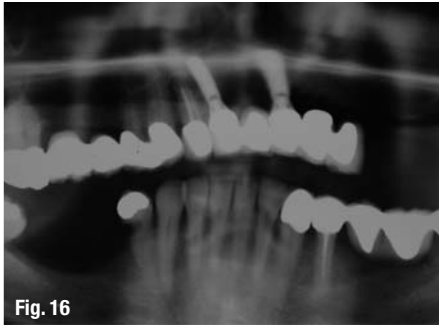
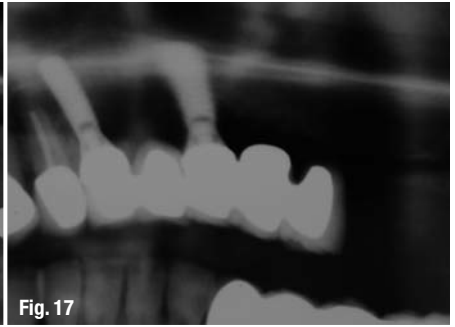
Fig. 16

**Figs. 16 & 17**\_ The distal implant was lost; the detailed view shows the non-functional crown #25.

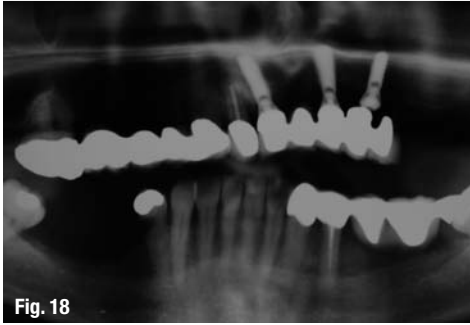
Fig. 18

**Fig. 18**\_ Condition after re-implantation distally of the implant localization.

After osseointegration of the artificial abutment tooth, we inserted a plastic abutment and made a casting of the integrated bridge structure with polyether casting material. This customised abutment was transformed into metal and the bridge structure finally cemented in place after a trial insertion.

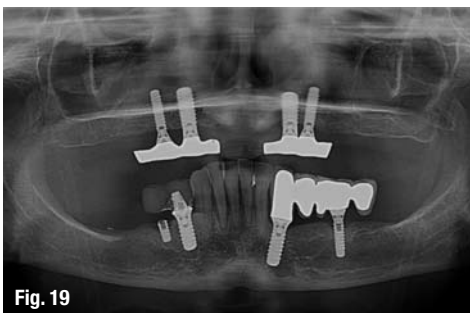
Fig. 19

**Fig. 19**\_ The distal (diameter-reduced) implant of a bridge supported entirely by fractured implants.

The case presented here reflects the typical progress of this early phase. A purely implant-supported (two abutments) extension bridge was incorporated into the fourth quadrant. A diameter-reduced implant was used in spite of an orovestibular bone dimension that would have been sufficient for supporting a standard implant. The result was that the distal implant fractured after eight years.

In one surgical session, we removed both the implant fragment remaining in the bone by way of an osteotomy and placed a further distal im-

plant. After its osseointegration, we incorporated a completely new bridge using the existing mesial implant.

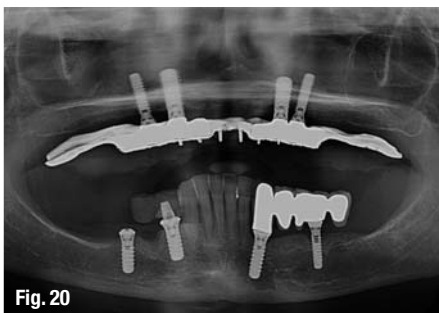
Fig. 20

**Fig. 20**\_ An additional implant was inserted distally after removal of the fragment that had remained in the bone. After integration of the implant, a new bridge supported entirely by implants was created, while incorporating the former implant.

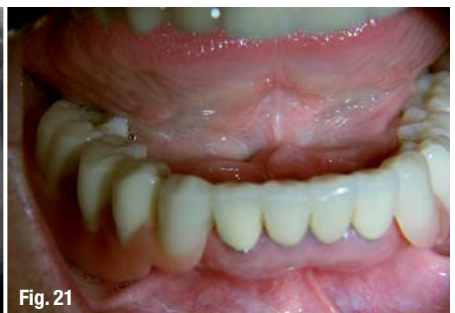
Fig. 21

**Figs. 21–25** Owing to the loss of prospective abutment teeth #43 and 33 during the prosthetic treatment phase, the remaining front teeth #42, 41, 31 and 32 received telescopic crowns.

#43 and 33, while preserving the front teeth #42 to 32, which had been caries-free and without fillings until then, and replacement of teeth #47 to 44 and 34 to 37). First, tooth #33 fractured and had to be extracted, in spite of the fact that preparation and casting had already been done. Treatment was replanned after this event, and teeth #42, 41, 31 and 32 were also prepared (the goal being telescopic crowns). Shortly before implementation, tooth #43 also had to be extracted. The patient was unable to give the exact reasons for this. This left her with four teeth—#42, 41, 31 and 32—which all had telescopic crowns.

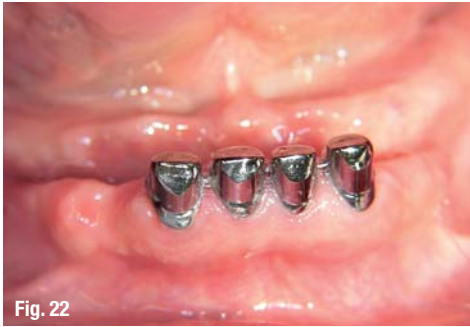
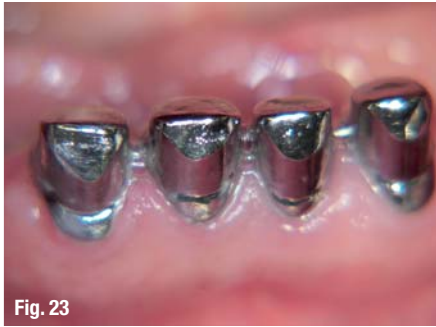
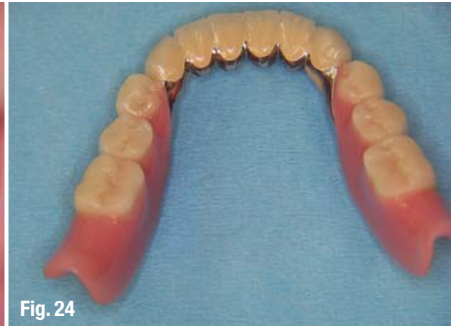
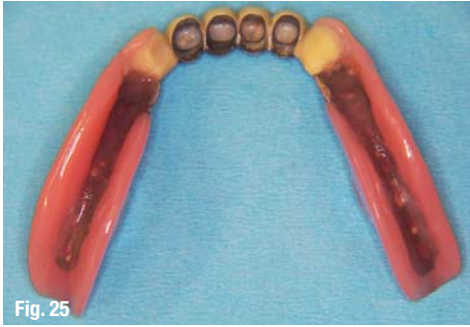
Anchoring of the partial prosthesis was poor; the patient was able to loosen it with minimal tongue-applied pressure. The pronounced tendency of the prosthesis saddles to cave in also resulted in complications in the form of multiple recurrent pressure sores. The patient was referred to us at this point. The reason for this according to her dentist was that implants, which the patient had inquired about, could be inserted

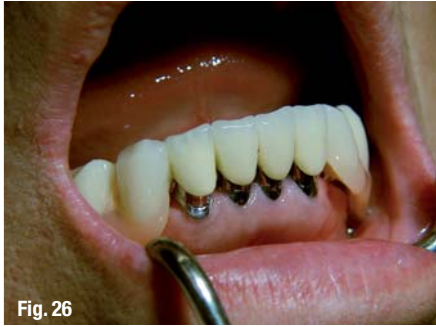
Fig. 26

**Fig. 26** The partial prosthesis showed insufficient mounting.

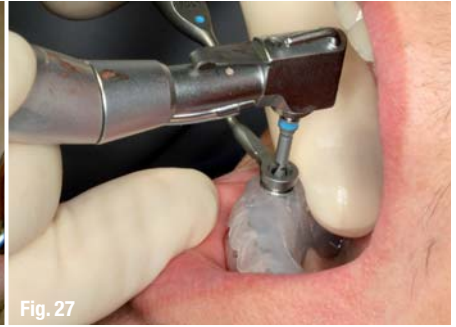
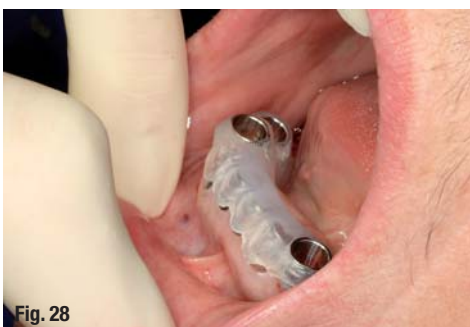
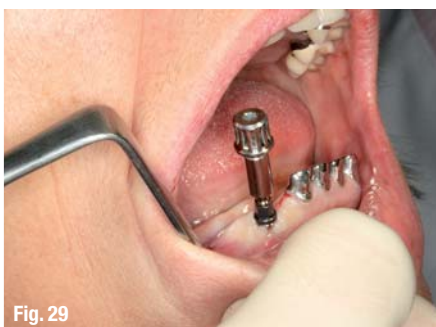
Fig. 27

**Figs. 27–29** With the aid of 3-D imaging and planning, four implants were inserted in regions #46, 43, 33 and 36—without any augmentative treatment.

The insertion of four implants in the regions of teeth #46, 43, 33 and 36 and their osseointegration were followed by treatment with the supra-structures, which consisted of two bridges in regions #46 to 43 and 33 to 36, entirely supported by implants, and four individual crowns on the

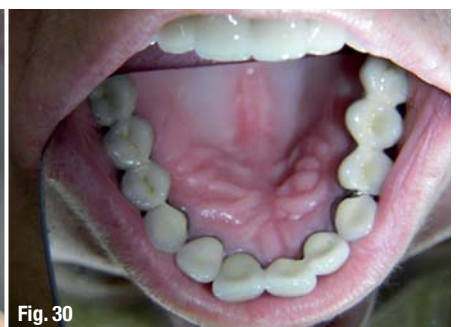
Fig. 30

**Fig. 30** After osseointegration of the artificial abutment teeth, two side-tooth bridges entirely supported by implants and four individual crowns were integrated with the remaining mandibular teeth.

front teeth. The restorations were temporarily af- fixed for six months and then cemented in place.

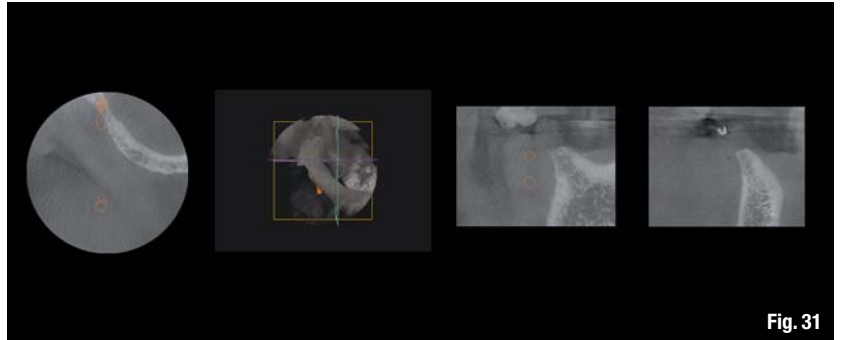
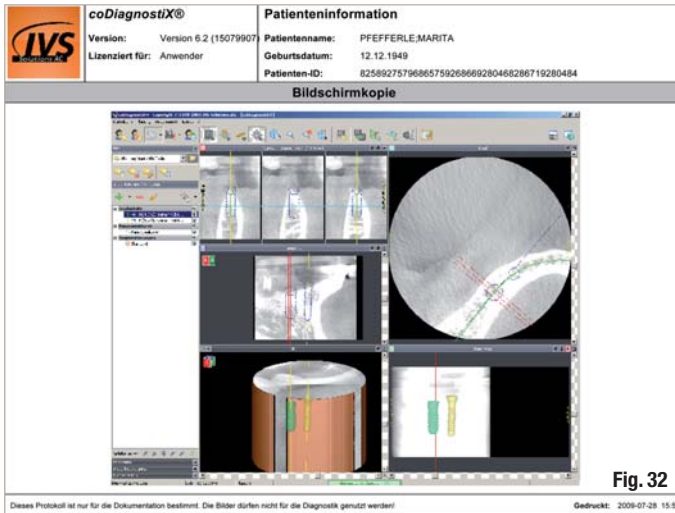
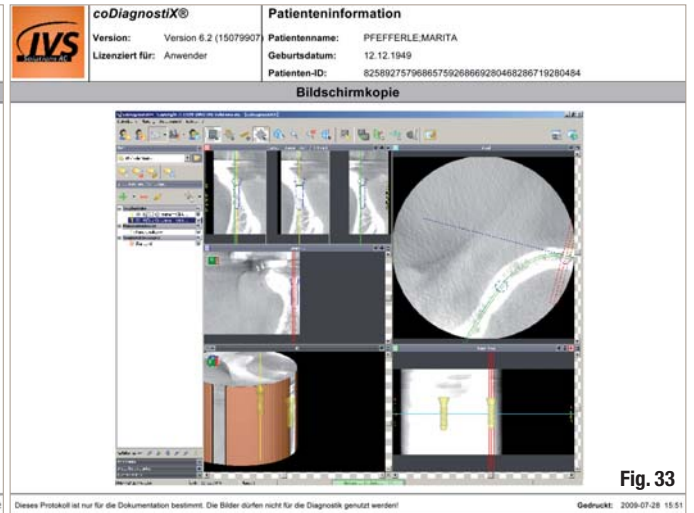
The patient thus showed considerable osseous deficits in both the oro-vestibular and horizontal dimension. In order to assess the basic possibilities of oral implants, we decided to perform 3-D imaging, which proved extremely helpful in this complex patient case. After illustration of the osseous situation, there were indications that implantation would be possible without carrying out augmentation procedures. We then prepared a virtual implant plan, the results of which led us to prepare a drilling template.

**Figs. 31–33**\_Three-dimensional diagnosis and planning (see dental pins) of the third and fourth quadrant. **Fig. 34**\_Orthopantomogram after incorporation of four implants, three of which were diameter-reduced Roxolid (Straumann) implants.

The remaining front teeth proved very helpful as a place for securely anchoring the template. By opting for a shortened row of teeth with one implant each in the region of the former six-year molars and an additional artificial abutment in each of the former cuspid areas, we were able to keep the dimensions of the template relatively small.
