# Implant-prosthetic troubleshooting

When dental technicians and dentists break into a sweat!

Authors\_Dr Georg Bach & Christian Müller, Germany

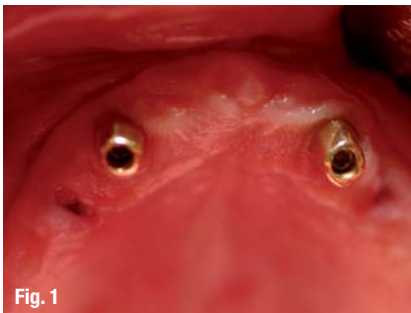
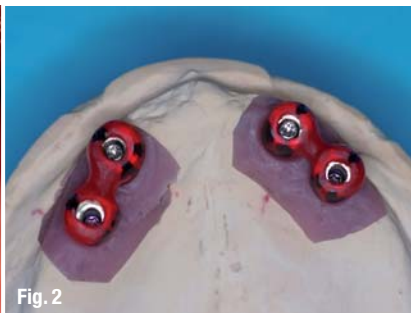
**Unidentified jaw misalignment**  
Figs. 1–4 The former prosthesis (with two maxillary implants); note the discrepancy between the translucent templates and the axis of the plastic front teeth.

Just by looking at the maxillary prosthesis it was easy to notice the metal portions of the prosthesis, which were placed extremely palatally, showing through. An examination of the oral cavity revealed a considerable discrepancy between the implant placement and the axis of the plastic front teeth!

A wax-up marked the beginning of the actual treatment. It was modified until the patient was satisfied with the placement of his teeth and his subsequent appearance. Based on the results of this treatment planning, we were able to determine which position and alignment would be required for two additional implants (distally of the existing ones).

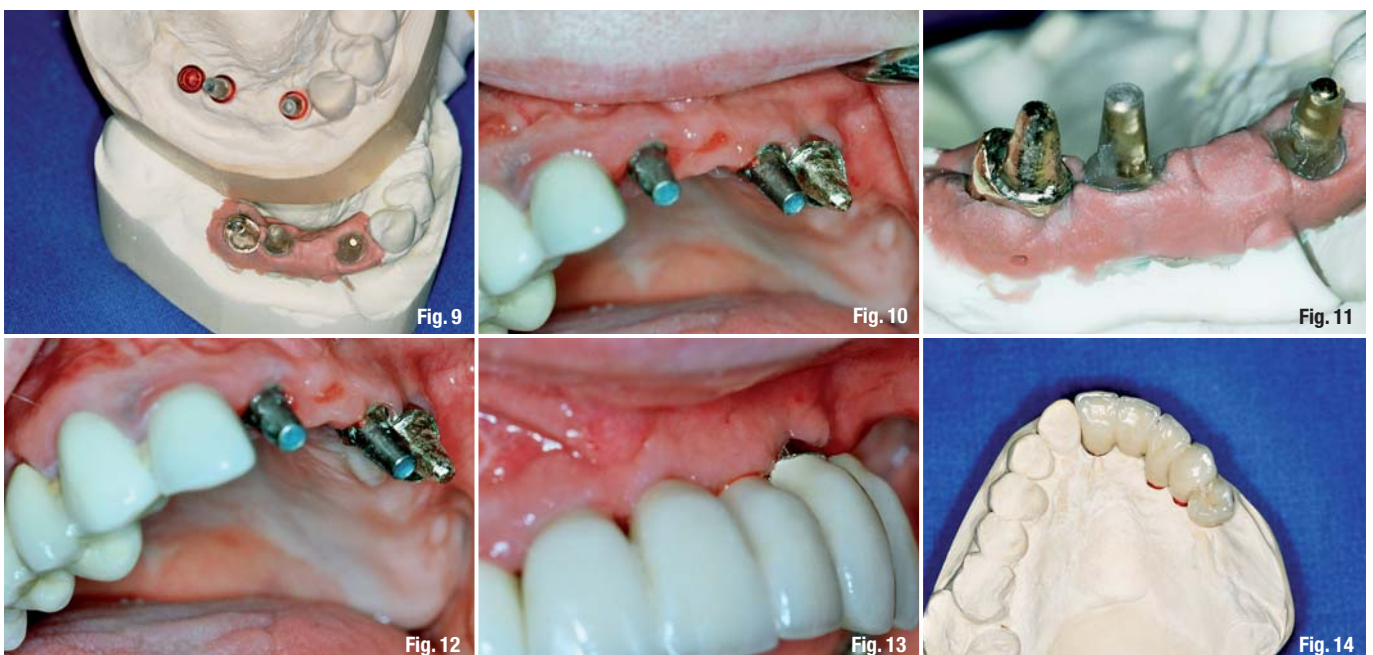
**Fig. 9** The mesial abutment tooth of a bridge entirely supported by implants in the left maxilla was lost. After healing of the soft tissue, a further implant was inserted in a position as close as possible to the former implant position. The illustration shows the dental master model with the customised abutment.

**Fig. 10** The former bridge structure was used as a customised "spoon" for the newly added implant so that a customised abutment could be created for the additional implant to be mounted distally (note the loss of vertical distance) for use in the existing restoration.

**Fig. 11**\_Customised abutment tooth as a terminal abutment.

**Fig. 12**\_Patient's oral condition.

**Figs. 13 & 14**\_We were able to preserve the bridge in the left maxilla.

A bridge structure in the second quadrant had been in place without any problems in a 50-year-old female patient for 10 years. Therefore, she only came to recall and follow-up examinations sporadically. The problem-free period ended abruptly when swelling and bite pain occurred in the left half of the maxilla. A panoramic tomography revealed radiological indications of a profound osseous defect around the mesial implant, which had to be removed on the same day. The issue then was the entire supra-structure. The patient insisted that this structure be preserved owing to the financial cost of having a new structure created after re-implantation.

A new implant was inserted after the soft tissue and bone had healed in the area where the lost implant had previously been in place. The bridge structure that had been temporarily affixed on the remaining implant was used as guidance for incorporation of a replacement implant and then removed for the actual implant procedure.

After osseointegration of the artificial abutment tooth, we inserted a plastic abutment and made a casting of the integrated bridge structure with polyether casting material. This customised abutment was transformed into metal and the bridge structure finally cemented in place after a trial insertion.

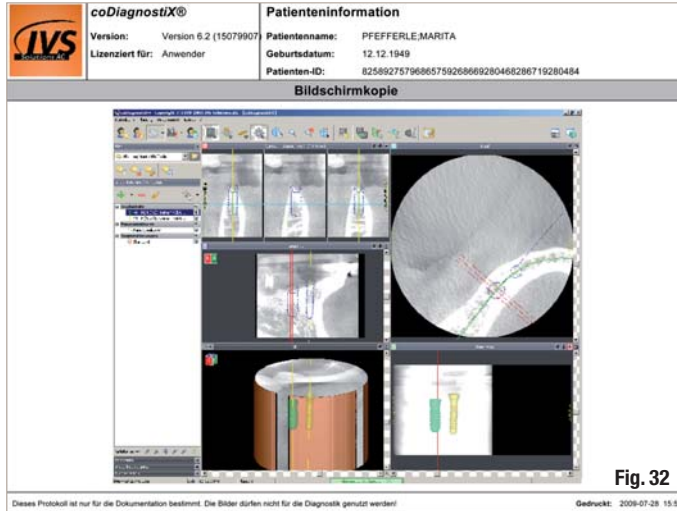
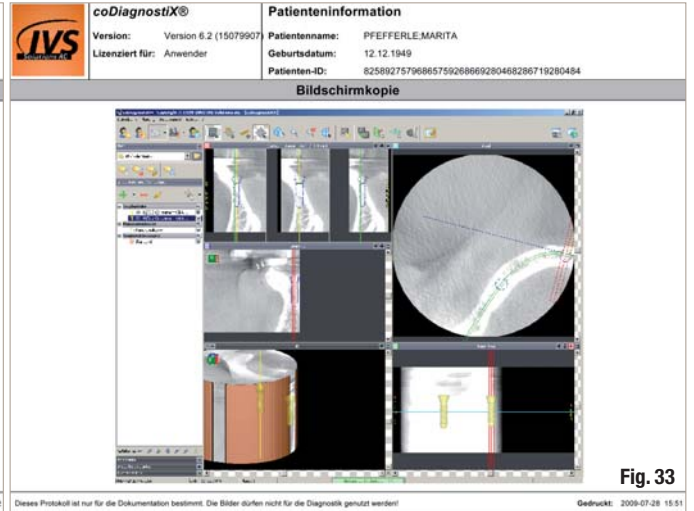
The patient thus showed considerable osseous deficits in both the oro-vestibular and horizontal dimension. In order to assess the basic possibilities of oral implants, we decided to perform 3-D imaging, which proved extremely helpful in this complex patient case. After illustration of the osseous situation, there were indications that implantation would be possible without carrying out augmentation procedures. We then prepared a virtual implant plan, the results of which led us to prepare a drilling template.

The remaining front teeth proved very helpful as a place for securely anchoring the template. By opting for a shortened row of teeth with one implant each in the region of the former six-year molars and an additional artificial abutment in each of the former cuspid areas, we were able to keep the dimensions of the template relatively small.

**Figs. 31–33** Three-dimensional diagnosis and planning (see dental pins) of the third and fourth quadrant. **Fig. 34** Orthopantomogram after incorporation of four implants, three of which were diameter-reduced Roxolid (Straumann) implants.
