Implant-prosthetic troubleshooting

When dental technicians and dentists break into a sweat!

Authors_Dr Georg Bach & Christian Müller, Germany

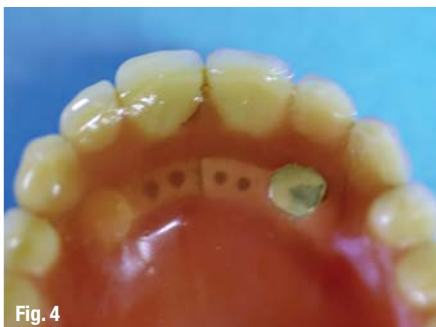
Figs. 5 & 6 After interdisciplinary planning between dental technician and dentist, two additional distally located implants were inserted; the four artificial abutment teeth each received a telescopic crown. We used individual insertion keys to facilitate incorporation of the telescopes.

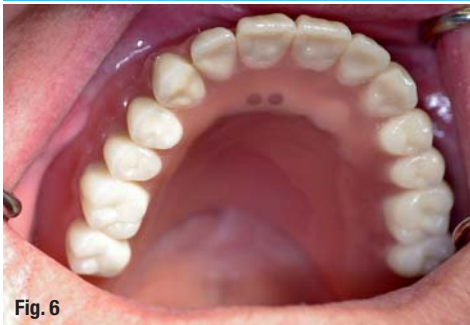
Fig. 8 Condition after the increase of abutment teeth in the maxilla, each inserted distally of the previous implants.
