Implant-prosthetic troubleshooting

When dental technicians and dentists break into a sweat!

Authors _Dr Georg Bach & Christian Müller, Germany

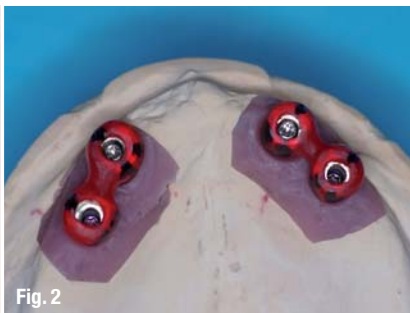
Unidentified jaw misalignment
Figs. 1–4 The former prosthesis (with two maxillary implants); note the discrepancy between the translucent templates and the axis of the plastic front teeth.

Just by looking at the maxillary prosthesis it was easy to notice the metal portions of the prosthesis, which were placed extremely palatally, showing through. An examination of the oral cavity revealed a considerable discrepancy between the implant placement and the axis of the plastic front teeth!

A wax-up marked the beginning of the actual treatment. It was modified until the patient was satisfied with the placement of his teeth and his subsequent appearance. Based on the results of this treatment planning, we were able to determine which position and alignment would be required for two additional implants (distally of the existing ones).

This in turn resulted in the creation of a drilling template, which was used during the insertion of the two additional artificial abutment teeth. After osseointegration of these two implants in regions #14 and 24, the new partial prosthesis (now supported by four implants (two existing and two new ones) was produced and integrated step by step.

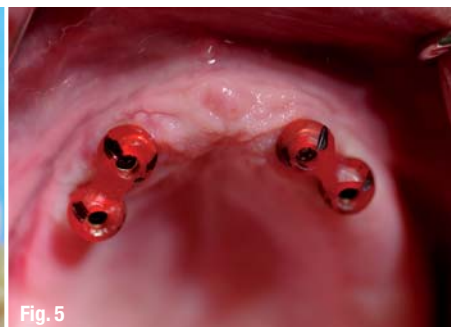
Figs. 5 & 6 After interdisciplinary planning between dental technician and dentist, two additional distally located implants were inserted; the four artificial abutment teeth each received a telescopic crown. We used individual insertion keys to facilitate incorporation of the telescopes.

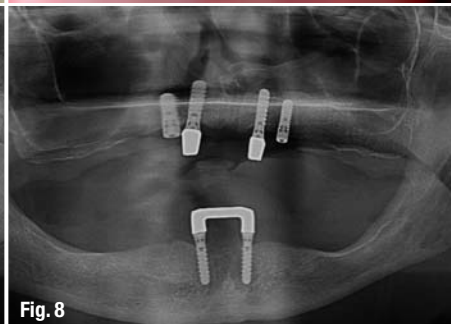
Fig. 8 Condition after the increase of abutment teeth in the maxilla, each inserted distally of the previous implants.

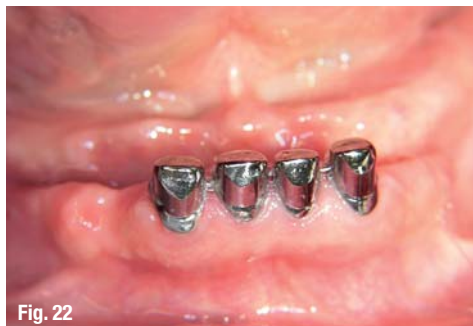
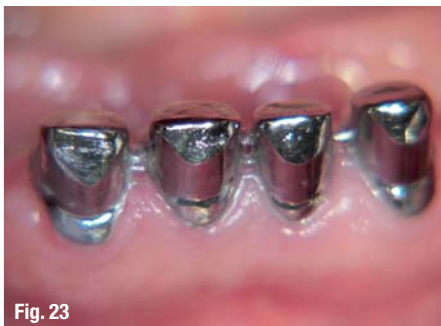
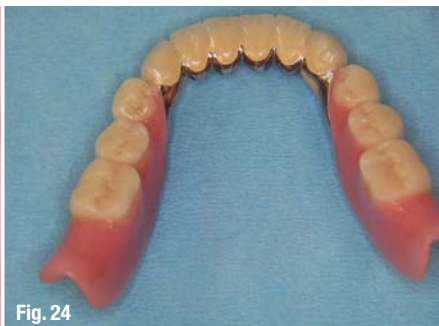
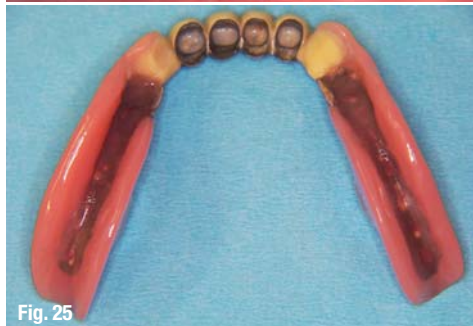
Figs. 21–25 Owing to the loss of prospective abutment teeth #43 and 33 during the prosthetic treatment phase, the remaining front teeth #42, 41, 31 and 32 received telescopic crowns.

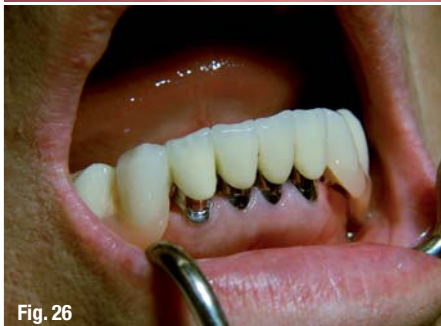
Fig. 26 The partial prosthesis showed insufficient mounting.

Anchoring of the partial prosthesis was poor; the patient was able to loosen it with minimal tongue-applied pressure. The pronounced tendency of the prosthesis saddles to cave in also resulted in complications in the form of multiple recurrent pressure sores. The patient was referred to us at this point. The reason for this according to her dentist was that implants, which the patient had inquired about, could be inserted

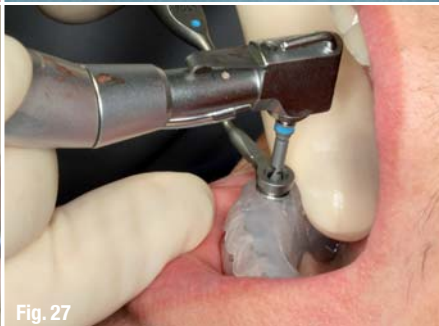
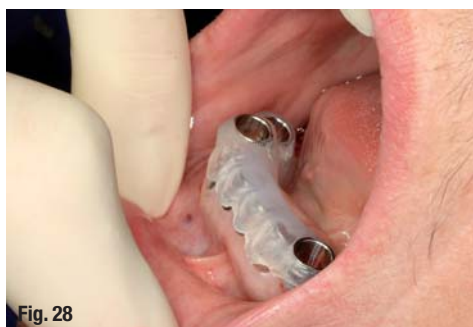
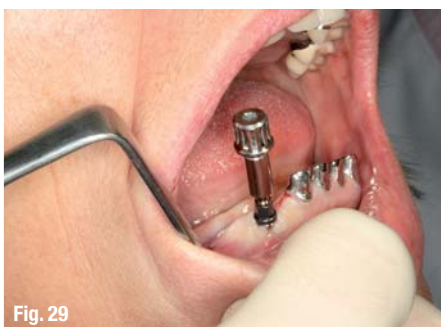
Figs. 27–29 With the aid of 3-D imaging and planning, four implants were inserted in regions #46, 43, 33 and 36—without any augmentative treatment.

The insertion of four implants in the regions of teeth #46, 43, 33 and 36 and their osseointegration were followed by treatment with the supra-structures, which consisted of two bridges in regions #46 to 43 and 33 to 36, entirely supported by implants, and four individual crowns on the

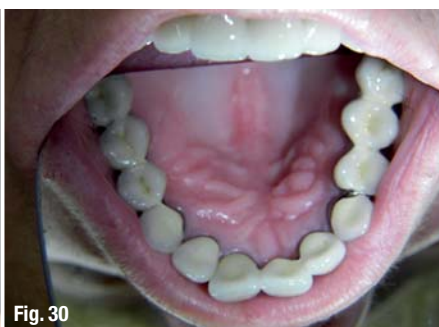
Fig. 30 After osseointegration of the artificial abutment teeth, two side-tooth bridges entirely supported by implants and four individual crowns were integrated with the remaining mandibular teeth.

front teeth. The restorations were temporarily affixed for six months and then cemented in place.

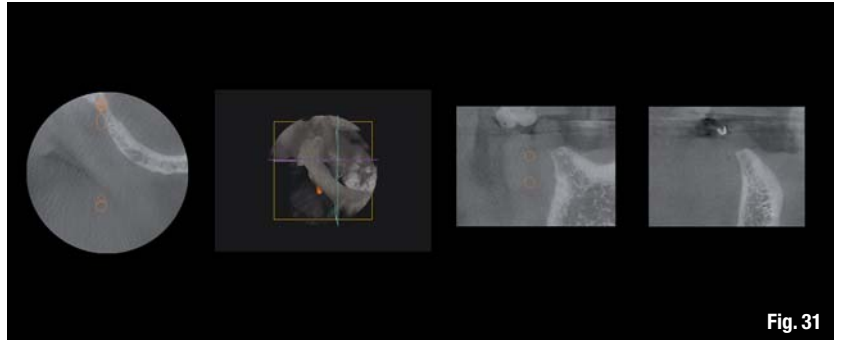
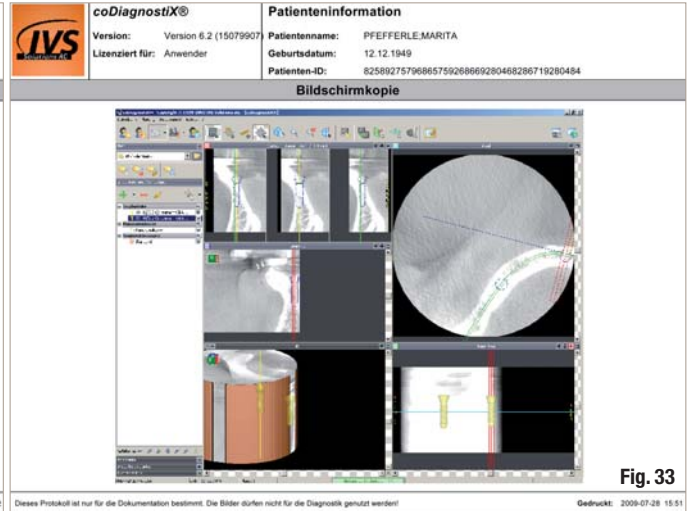
The patient thus showed considerable osseous deficits in both the oro-vestibular and horizontal dimension. In order to assess the basic possibilities of oral implants, we decided to perform 3-D imaging, which proved extremely helpful in this complex patient case. After illustration of the osseous situation, there were indications that implantation would be possible without carrying out augmentation procedures. We then prepared a virtual implant plan, the results of which led us to prepare a drilling template.

Figs. 31–33_Three-dimensional diagnosis and planning (see dental pins) of the third and fourth quadrant. **Fig. 34**_Orthopantomogram after incorporation of four implants, three of which were diameter-reduced Roxolid (Straumann) implants.

The remaining front teeth proved very helpful as a place for securely anchoring the template. By opting for a shortened row of teeth with one implant each in the region of the former six-year molars and an additional artificial abutment in each of the former cuspid areas, we were able to keep the dimensions of the template relatively small.
