Implant-prosthetic troubleshooting

When dental technicians and dentists break into a sweat!

Authors_Dr Georg Bach & Christian Müller, Germany

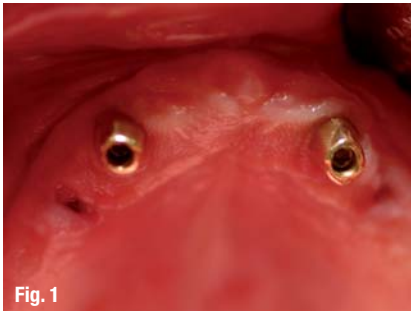
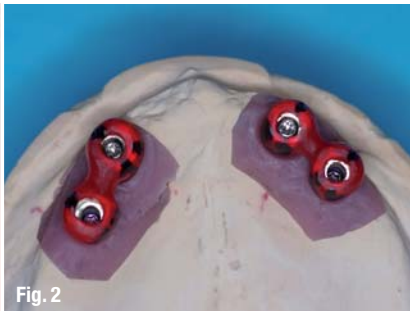
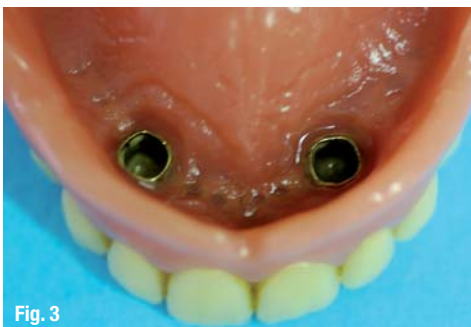
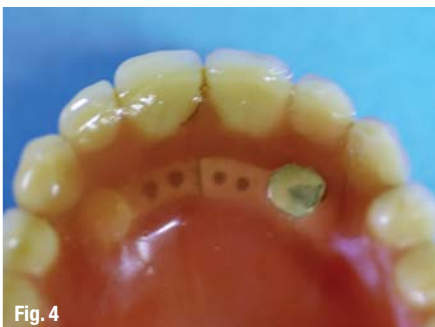
Figs. 1–4 The former prosthesis (with two maxillary implants); note the discrepancy between the translucent templates and the axis of the plastic front teeth.

Just by looking at the maxillary prosthesis it was easy to notice the metal portions of the prosthesis, which were placed extremely palatally, showing through. An examination of the oral cavity revealed a considerable discrepancy between the implant placement and the axis of the plastic front teeth!

A wax-up marked the beginning of the actual treatment. It was modified until the patient was satisfied with the placement of his teeth and his subsequent appearance. Based on the results of this treatment planning, we were able to determine which position and alignment would be required for two additional implants (distally of the existing ones).

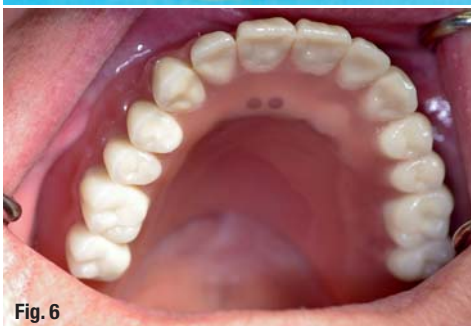
Fig. 5

Figs. 5 & 6 After interdisciplinary planning between dental technician and dentist, two additional distally located implants were inserted; the four artificial abutment teeth each received a telescopic crown. We used individual insertion keys to facilitate incorporation of the telescopes.

This in turn resulted in the creation of a drilling template, which was used during the insertion of the two additional artificial abutment teeth. After osseointegration of these two implants in regions #14 and 24, the new partial prosthesis (now supported by four implants (two existing and two new ones) was produced and integrated step by step.

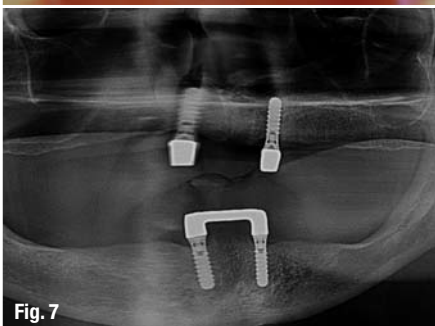
Fig. 7 Initial X-ray image (panoramic tomography) with two implants (treated with telescopes) in the maxilla.

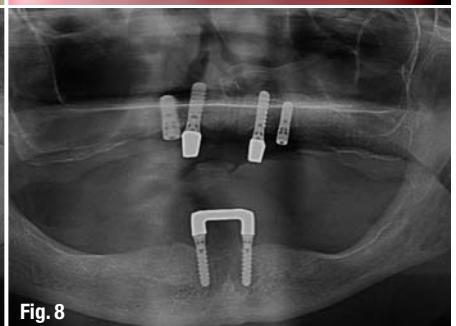
Fig. 8 Condition after the increase of abutment teeth in the maxilla, each inserted distally of the previous implants.

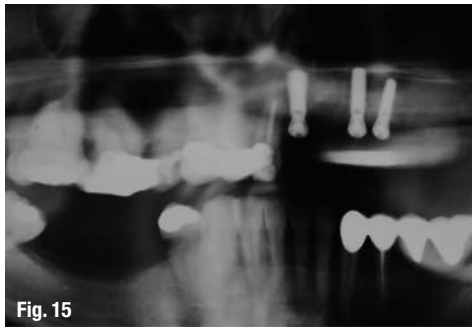
Fig. 15 _ Three implants had originally been inserted to treat anodontia in the second quadrant.

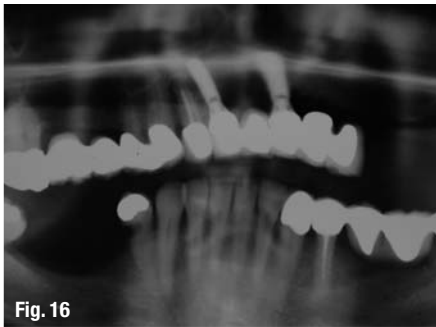
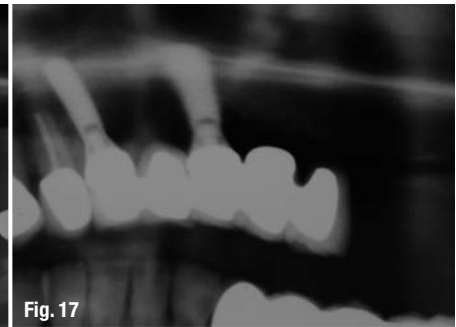
Figs. 16 & 17 _ The distal implant was lost; the detailed view shows the non-functional crown #25.

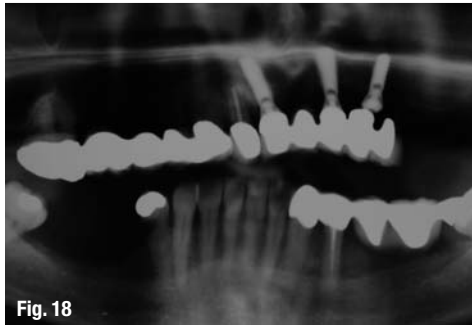
Fig. 18 _ Condition after re-implantation distally of the implant localization.

A new implant was inserted after the soft tissue and bone had healed in the area where the lost implant had previously been in place. The bridge structure that had been temporarily affixed on the remaining implant was used as guidance for incorporation of a replacement implant and then removed for the actual implant procedure.

After osseointegration of the artificial abutment tooth, we inserted a plastic abutment and made a casting of the integrated bridge structure with polyether casting material. This customised abutment was transformed into metal and the bridge structure finally cemented in place after a trial insertion.

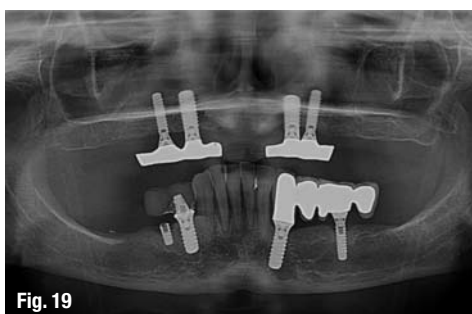
Fig. 19 _ The distal (diameter-reduced) implant of a bridge supported entirely by fractured implants.

The case presented here reflects the typical progress of this early phase. A purely implant-supported (two abutments) extension bridge was incorporated into the fourth quadrant. A diameter-reduced implant was used in spite of an oro-vestibular bone dimension that would have been sufficient for supporting a standard implant. The result was that the distal implant fractured after eight years.

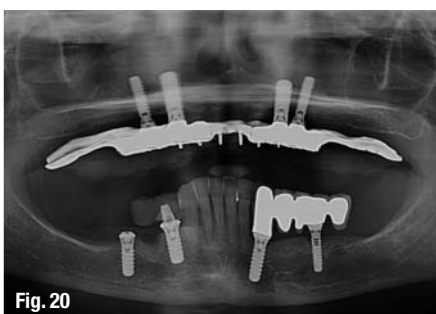
Fig. 20 _ An additional implant was inserted distally after removal of the fragment that had remained in the bone. After integration of the implant, a new bridge supported entirely by implants was created, while incorporating the former implant.

In one surgical session, we removed both the implant fragment remaining in the bone by way of an osteotomy and placed a further distal im-

plant. After its osseointegration, we incorporated a completely new bridge using the existing mesial implant.

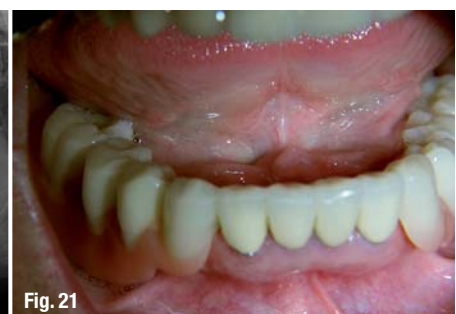
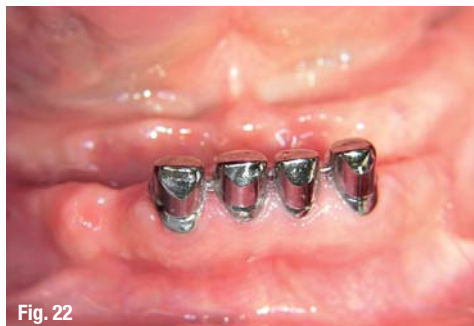
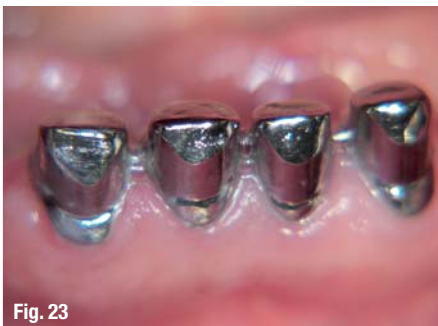
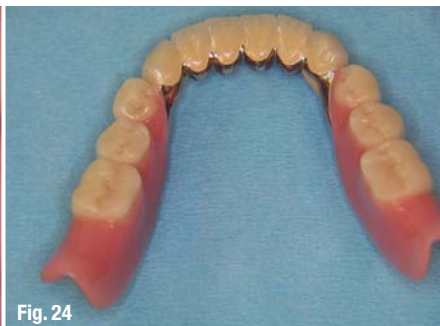
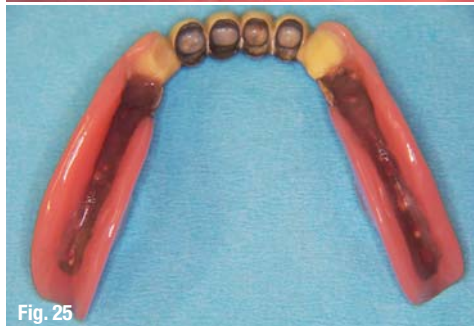
Figs. 21–25 Owing to the loss of prospective abutment teeth #43 and 33 during the prosthetic treatment phase, the remaining front teeth #42, 41, 31 and 32 received telescopic crowns.

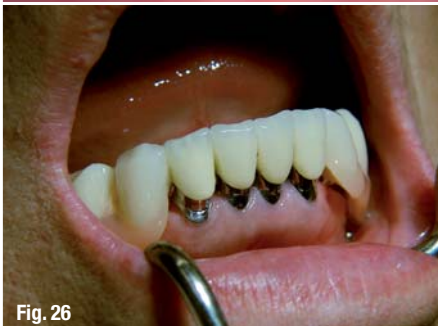
Fig. 26 The partial prosthesis showed insufficient mounting.

Anchoring of the partial prosthesis was poor; the patient was able to loosen it with minimal tongue-applied pressure. The pronounced tendency of the prosthesis saddles to cave in also resulted in complications in the form of multiple recurrent pressure sores. The patient was referred to us at this point. The reason for this according to her dentist was that implants, which the patient had inquired about, could be inserted

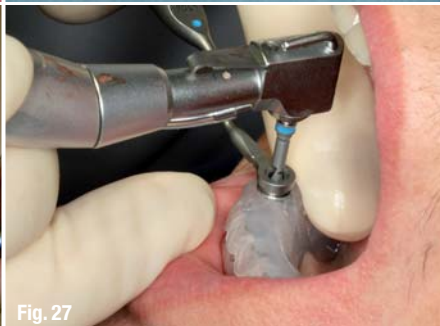
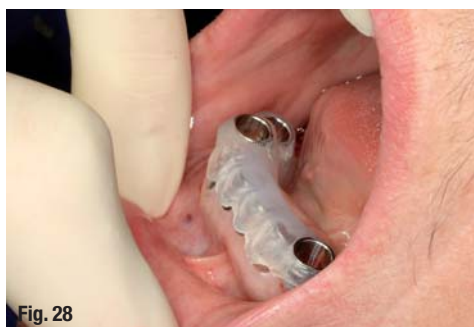
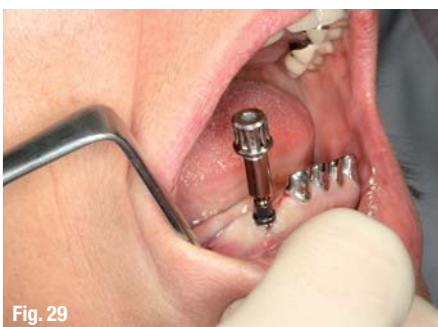
Figs. 27–29 With the aid of 3-D imaging and planning, four implants were inserted in regions #46, 43, 33 and 36—without any augmentative treatment.

The insertion of four implants in the regions of teeth #46, 43, 33 and 36 and their osseointegration were followed by treatment with the supra-structures, which consisted of two bridges in regions #46 to 43 and 33 to 36, entirely supported by implants, and four individual crowns on the

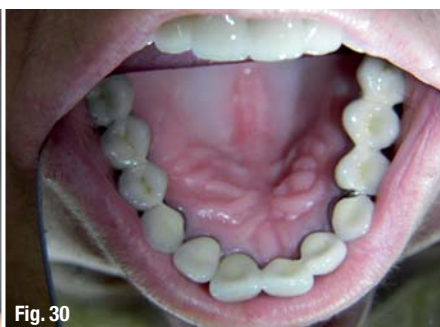
Fig. 30 After osseointegration of the artificial abutment teeth, two side-tooth bridges entirely supported by implants and four individual crowns were integrated with the remaining mandibular teeth.

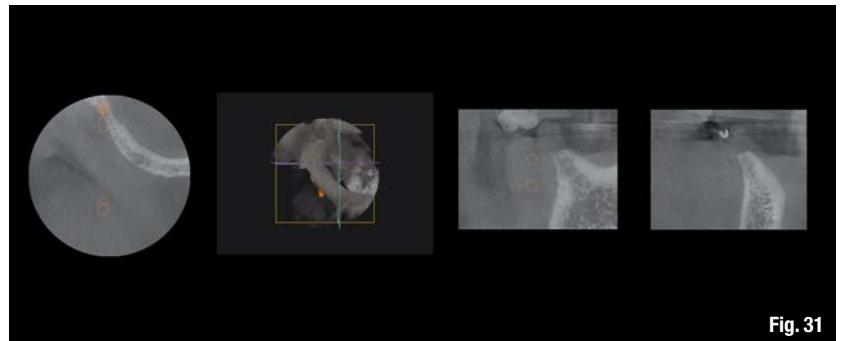
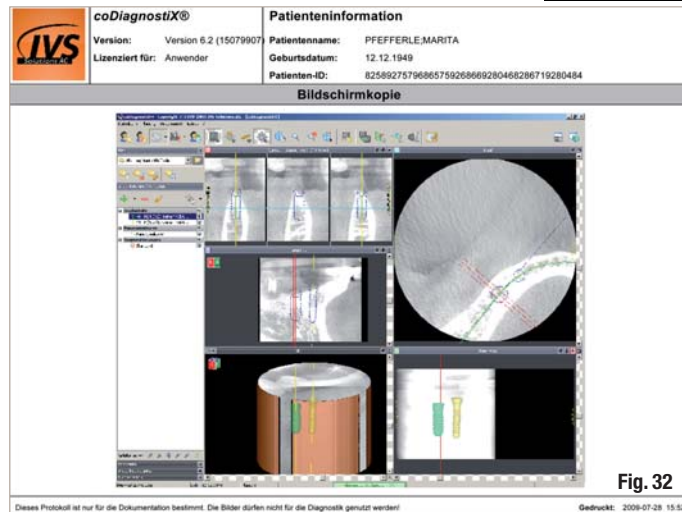
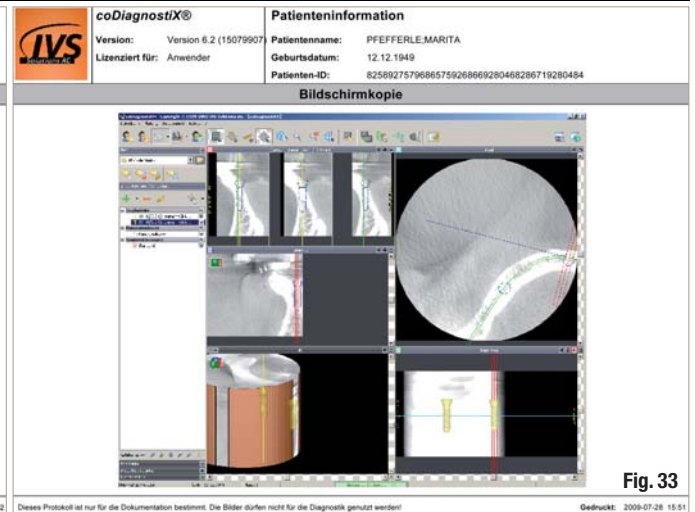
Figs. 31–33 Three-dimensional diagnosis and planning (see dental pins) of the third and fourth quadrant. **Fig. 34** Orthopantomogram after incorporation of four implants, three of which were diameter-reduced Roxolid (Straumann) implants.

The patient thus showed considerable osseous deficits in both the oro-vestibular and horizontal dimension. In order to assess the basic possibilities of oral implants, we decided to perform 3-D imaging, which proved extremely helpful in this complex patient case. After illustration of the osseous situation, there were indications that implantation would be possible without carrying out augmentation procedures. We then prepared a virtual implant plan, the results of which led us to prepare a drilling template.
