Second implantation after **implant fracture**

Authors_Dr Michael Hopp, Andreas Klar, Prof Dr Reiner Biffar, Germany

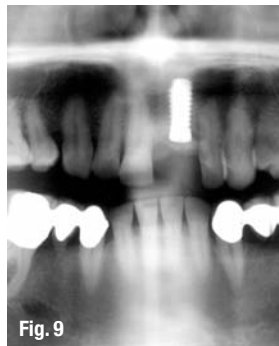
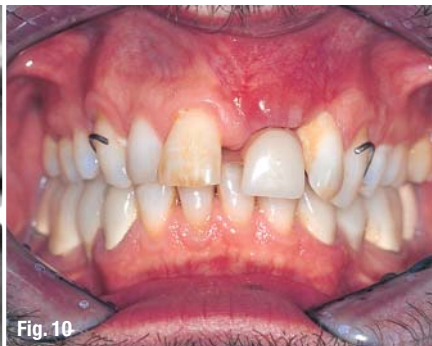
Fig. 9_OPG after implantation.
Fig. 10_Temporary restoration with a removable denture.

the muco-periosteal flap. The site of the operation was closed with 9 simple interrupted sutures (Fig. 8) after mobilization of the muco-periosteal flap through periosteal slitting and a control X-ray was taken (Fig. 9).

During the 6-month healing phase, a denture with a prosthetic tooth anchored with a clamp was worn (Fig. 10), which had been relined underneath with Flexor CC (Schütz Dental, Rosbach) to prevent any pressure on the site.

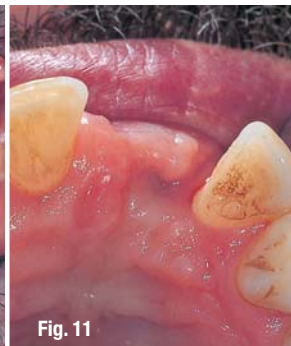
Fig. 11_Situation after healing process, seen from occlusal view.

Following healing (Fig. 11), the covering mucosa was opened with a semi-circular cut with a scalpel under local anaesthetic (Fig. 12) and a cylindrical gingiva former, 2 mm in height, was inserted (Fig. 13). The X-ray shows an implant with good osseointegration (Fig. 14) and, to a large extent, maintenance and restoration of the gingival structures (Fig. 15). Only the papillary region between 21 and 22 is reduced. The prosthetic treatment was conducted after the gingival tissues had healed. The impression was made using Impregum (3M ESPE, Seefeld) and

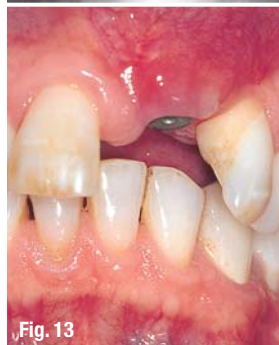
Fig. 13_Situation with the gingiva former.

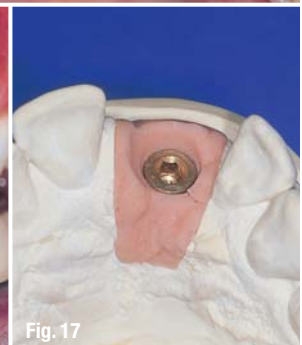
Fig. 16_Inserted impression post.

the open tray technique (Fig. 16). The model made from type-IV gypsum with a gingival mask permits the production of an aesthetically high-quality crown (Fig. 17). An angled abutment was selected to correct the angulation and adapted to follow the line of the gingiva (Fig. 18). The internal hexagon connection prevents rotation (Fig. 19). A cementable metal ceramic crown, based on an alloy with a high gold content that can be fired, completes the restoration (Fig. 20). The diastema at the front was left in accordance with the patient's wishes, as was the slightly rotated and paradontally worn no. 2 (Fig. 21). The otherwise triangular crown of the no. 1 was rounded off distally so that the papillary triangle between 21 and 22 was less prominent. The colour was adjusted to the lively colour of 11 in the laboratory in the presence of the patient (Figs. 22 & 23). The abutment (Fig. 24) was screwed in at a torque of 20 N/cm and the crown was inserted for three weeks on a provisional basis (Fig. 25).

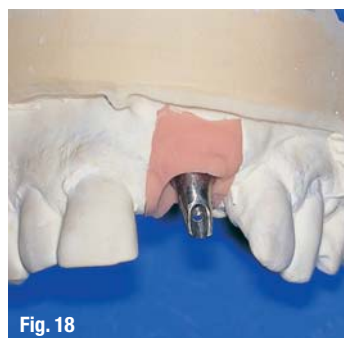
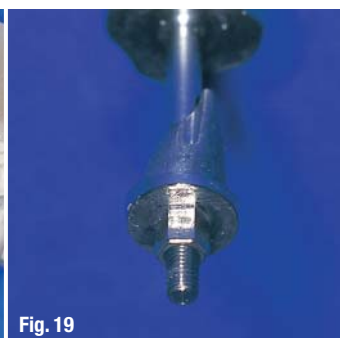
Fig. 17_After taking the impression the model with gingiva mask is produced.

Fig. 18_Adapted abutment.

Fig. 19_Internal hexagon to prevent rotation.

Fig. 20_Model of the crown.

Fig. 21_Processed crown cap prior to application of the ceramic.

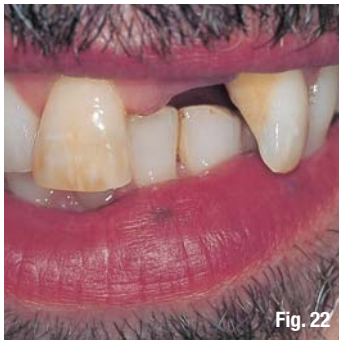
Fig. 22

Fig. 22_ The gap requiring restoration.

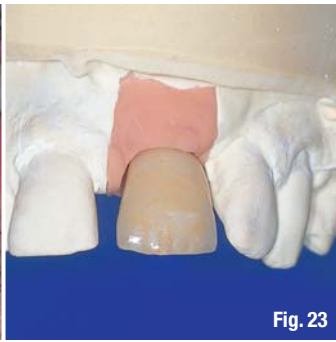
Fig. 23

Fig. 23_ Fired ceramic crown.

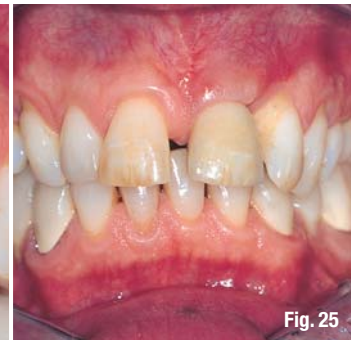
Fig. 25

Fig. 25_ Crown in situ.
