Second implantation after **implant fracture**

Authors_Dr Michael Hopp, Andreas Klar, Prof Dr Reiner Biffar, Germany

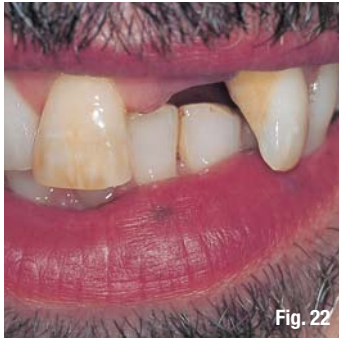
Fig. 22 The gap requiring restoration.

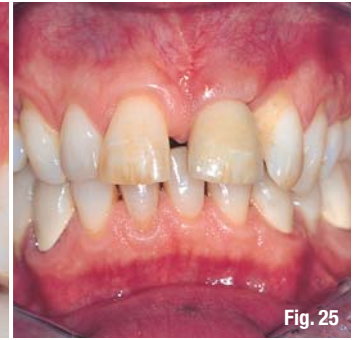
Fig. 25 Crown in situ.

the open tray technique (Fig. 16). The model made from type-IV gypsum with a gingival mask permits the production of an aesthetically high-quality crown (Fig. 17). An angled abutment was selected to correct the angulation and adapted to follow the line of the gingiva (Fig. 18). The internal hexagon connection prevents rotation (Fig. 19). A cementable metal ceramic crown, based on an alloy with a high gold content that can be fired, completes the restoration (Fig. 20). The diastema at the front was left in accordance with the patient's wishes, as was the slightly rotated and paradontally worn no. 2 (Fig. 21). The otherwise triangular crown of the no. 1 was rounded off distally so that the papillary triangle between 21 and 22 was less prominent. The colour was adjusted to the lively colour of 11 in the laboratory in the presence of the patient (Figs. 22 & 23). The abutment (Fig. 24) was screwed in at a torque of 20 N/cm and the crown was inserted for three weeks on a provisional basis (Fig. 25).
