Laser-assisted re-establishment of Canine Guidance:

Esthetic and Functional Reconstruction of Worn Canines

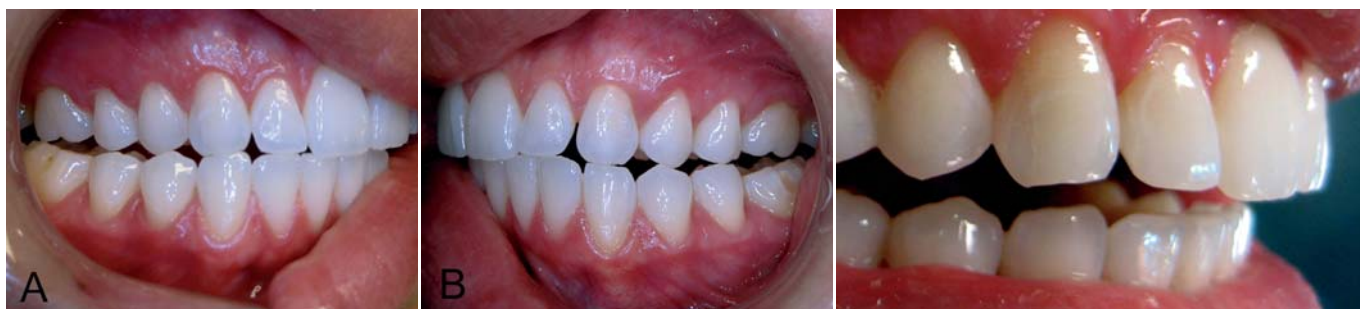
Fig. 1 _Initial clinical status.

A _Right side view: Loss of canine guidance and presence of contacts on lateral incisors, pre-molars and disto-buccal cusp of the first molar.

B _Left side view: Loss of canine guidance and occlusal contacts on lateral incisors and pre-molars.

A diastema between the upper right canine and lateral incisor caused by the occlusal interference can be noticed.

our clinic presenting wear facets on the edges of the upper and lower canines (Fig. 1). The patient reported muscular fatigue in the morning and clenching during the day, and these symptoms were attributed to the patient's parafunctional bruxing habit. The canine guidance was no longer present, and the wear pattern indicated that jaw lateral excursive movements were predominant during bruxism episodes. This fact could also be attested by the presence of a diastema between the upper right canine and lateral incisor (Fig. 1B), as the patient reported that it first appeared after bruxism habit initiated. Since the canine edge was lost due to tooth wear, the canine guidance was substituted by group function guidance, and an intense contact between upper and lower lateral incisors during lateral excursive movements may have caused tooth movement and diastema appearance. The intense strength exerted on the canines during clenching and grinding resulted in the appearance of cracks (Fig. 2), as well as in the loss of tooth anatomy.

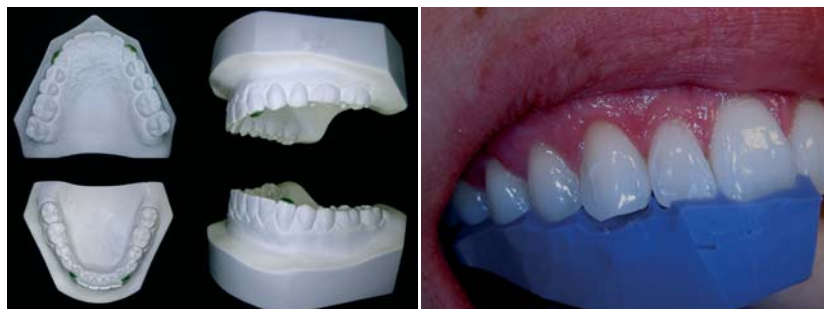
Fig. 3 Diagnostic wax-up and reconstruction of upper and lower canines.

Fig. 4 Stent of polyvinyl siloxane impression material in position.

Before restoration procedures, impressions of both arches were taken. To determine the size and shape of the upper and lower canines and the exact amount of lost structure to be reconstructed, a diagnostic wax-up was fabricated (Fig. 3). After the teeth anatomy was rebuilt, the articulator was used to adjust the canine guidance and the correct lateral excursive jaw movements, and also to establish the ideal occlusal relation between both arches. The diagnostic wax-up enabled an ideal association of both esthetics and function.

Four silicone stents were fabricated (one for each canine) with heavy-bodied addition silicone impression material (Ivoclar Vivadent, Schaan, Liechtenstein). The silicone was positioned in the waxed cast, completely involving the canine without the use of impression trays. After material cure, the silicone was removed from the cast and its buccal portion was cut with a #15 blade in the mesiodistal direction and disposed. The incisal margin was preserved in the silicone matrix in order to guide the canine edge reconstruction.⁸ After this, the silicone stent was tested in the mouth and its adaptation was checked, as well as the amount of resin to be placed (Fig. 4). The tooth color selection was followed, and, as regarding previously bleached teeth, a composite resin for bleached teeth (Venus, Heraeus Kulzer, Armonk, NY, USA) was used.

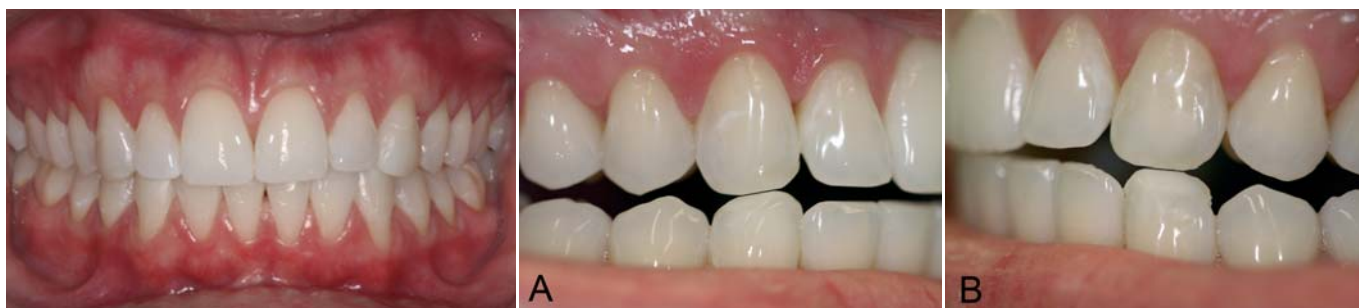
Fig. 10 Final clinical status. The patient was oriented to use an acrylic occlusal guard to preserve the results.

Fig. 11 At 1-year follow-up, wear of the restorations was caused by the misuse of the occlusion guard. Restorations adhesion to teeth was sufficient to tolerate occlusal stress and the canine guidance was still present in both **A**) right and **B**) left sides. The re-establishment of the canine guidance was also responsible for the closure of the diastema.

At 1-year follow-up, the patient reported that the occlusal splint was not used as oriented. This fact could be clinically observed, since worn facets were again present in the restorations of both upper and lower canines (Fig. 11). The resin lost during bruxism episodes resulted in the exposition of the opaque

resin used for the reconstruction of the dentin portion. This follow-up outcome is of extreme importance, since it indicates that adhesive procedures, including enamel etching with Er:YAG laser, were capable of providing the restoration with sufficient adhesion, so that it could tolerate the intensive occlusal charges generated during bruxing without any failure. Since adhesion was successful, the clinical consequence of continuous grinding during one year was the composite restoration wear. In spite of this, the canine guidance was still present, and the patient was oriented to effectively use the occlusal splint to avoid further wear and the need of a new restorative procedure. The presence of guidance was responsible for the closure of the diastema between the upper right canine and lateral incisor, and this could be observed one year after restoration (Fig. 11).
