Immediate functional loading of the edentulous mandible

Tapered implants & overdentures

Author_Dr Suheil M. Boutros, USA

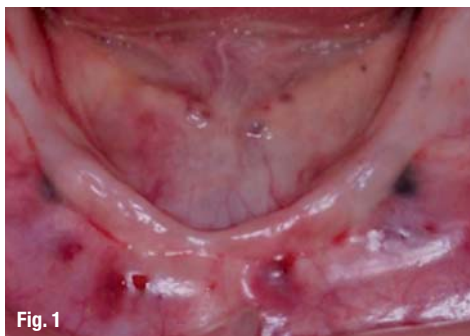
Fig. 1_Mandible at the time of implant placement with moderate bone resorption.

A 55-year-old female patient without any medical contra-indication for implant therapy presented with an ill-fitting, lower complete denture that she had been wearing for four years. The clinical and radiographic findings revealed slight to moderate mandibular ridge resorption with an ill-fitting lower denture (Figs. 1 & 2). The patient was given the option of placing four implants to support her existing lower

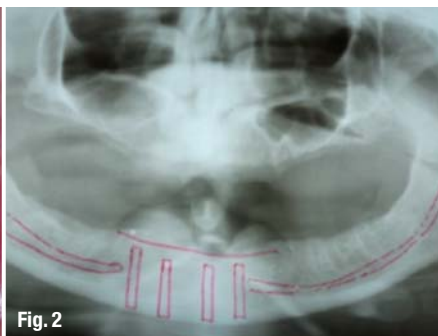
Fig. 2_Pre-op panoramic radiograph.

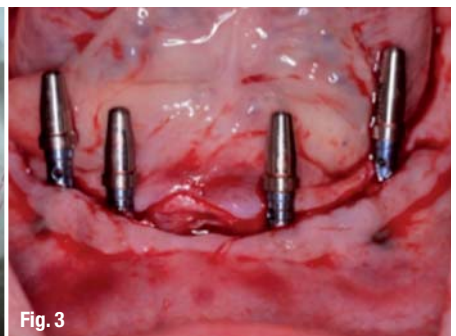
Fig. 3_Guiding pins at the time of implant placement.

At the surgical appointment, following the administration of local anaesthetic, a mid-crestal incision was performed and a full-thickness flap was reflected. In addition, osteotomies were prepared in type II bone. Bone taps were used to countersink the sites, after which four OSSEOTITE Tapered Certain implants (BIOMET 3i; 4 mm in diameter, 13 mm in length) were placed with the handpiece and hand ratchet. The implants were torqued to 35 N (Figs. 3 & 4).

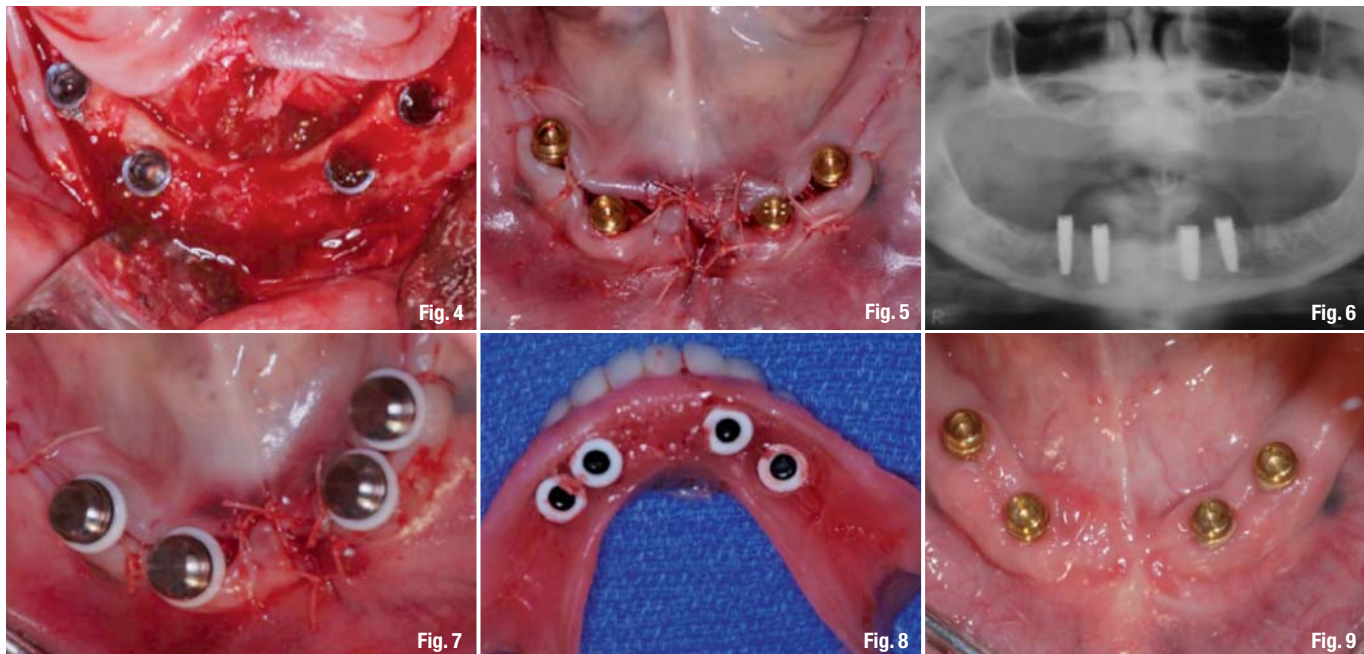
Fig. 4 Four tapered implants at placement.
Fig. 5 Flap was sutured around the locators using 4-0 vicryl suture.
Fig. 6 Panoramic radiograph immediately after implant placement.
Fig. 7 Occlusal view of the processing rings.
Fig. 8 The processing rings were picked up directly in the mouth.
Fig. 9 Occlusal view of the locators two weeks post-implant placement.

Fig. 10 Buccal view of the locators two weeks post-implant placement.
Fig. 11 The processing rings were removed ten weeks post-placement.
Fig. 12 The blue retention rings were placed as the final rings.

Immediately after implant surgery, the mandibular denture was seated in the patient's mouth and adjusted to provide clearance in the area of the locator(s). Four locators (4 mm in length) were torqued to 30 N (Figs. 5 & 6). Following the suture of the flap with

4-0 vicryl, the processing rings were placed over the locators and were picked up directly in the mouth using hard self-curing acrylic (Rebase II, Tokuyama; Figs. 7 & 8). The patient was given post-operative instructions, including the use of 0.12% chlorhexidine gluconate (Peridex, Procter & Gamble) three times a day. She was furthermore prescribed 500 mg of amoxicillin (to be taken every six hours for seven days). The patient was then informed that the implant-supported overdenture was to be left in place for 48 hours. Two days later, she was seen for a follow-up visit and the healing process was uneventful. The black processing rings were switched to blue rings ten weeks after the placement (Figs. 9-14).

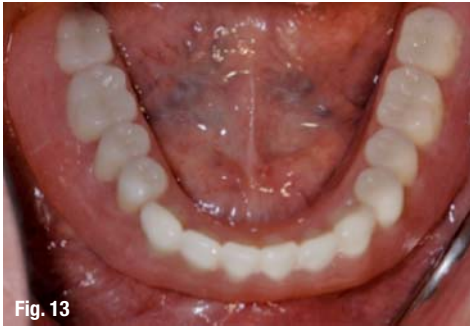
Fig. 13 Occlusal view of the overdenture in place at ten weeks post-placement.

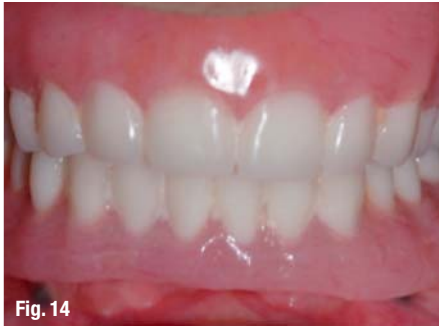
Fig. 14 Buccal view of the overdenture in place.

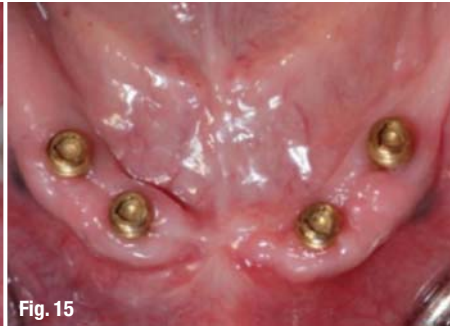
Fig. 15 Occlusal view of the locators six months post-placement.

After six months, the patient returned for another follow-up visit and all four locators were torqued to 30 N (Figs. 15-21). It was determined that all four implants had achieved full integration. Currently, the patient is on a six-month recall to ensure the proper maintenance of the implants and the prosthesis. The last maintenance visit was 24 months post-plac-

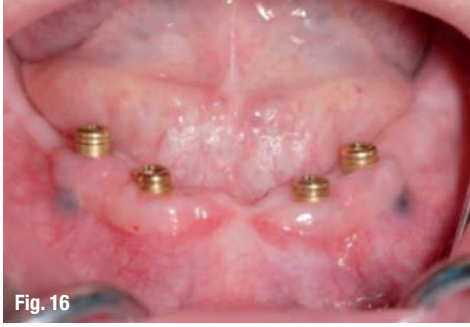
Fig. 16 Buccal view of the locators six months post-placement.

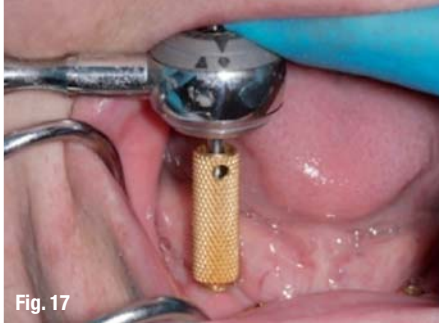
Fig. 17 Retorquing the locators to 30 N six months post-placement.

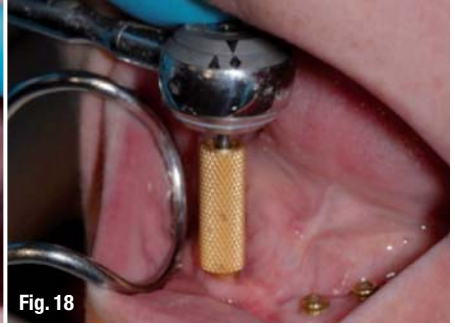
Fig. 18 Retorquing the locators to 30 N six months post-placement.

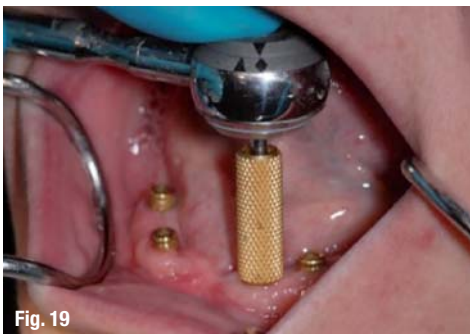
Fig. 19 Retorquing the locators to 30 N six months post-placement.

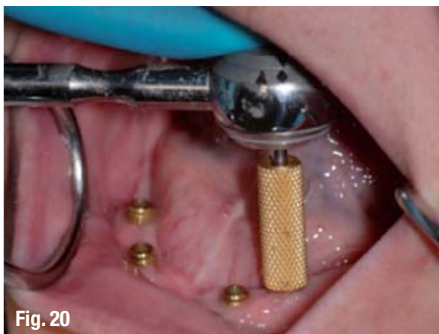
Fig. 20 Retorquing the locators to 30 N six months post-placement.

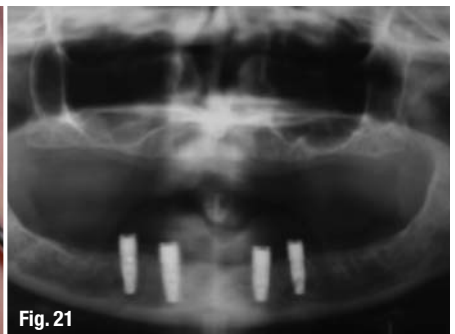
Fig. 21 Final panoramic radiograph six months post-placement.
