# The same-day tooth: From the diagnosis to the final restoration

Author\_Dr Stefanos G. Kourtis, Greece

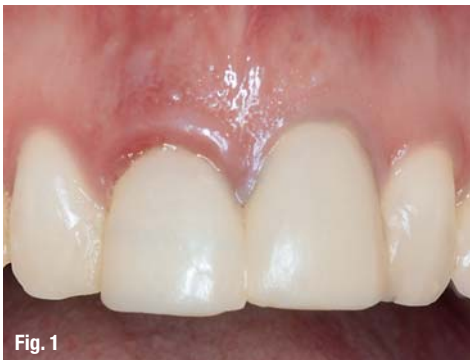
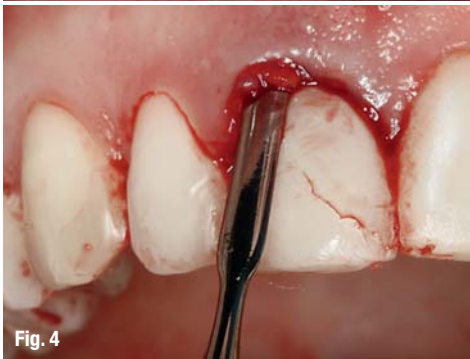
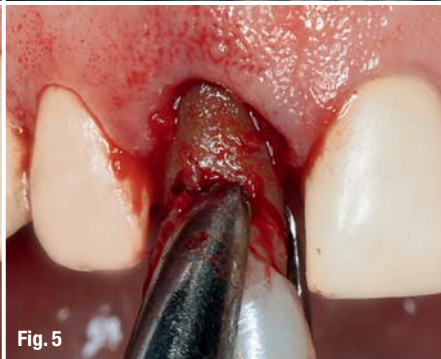
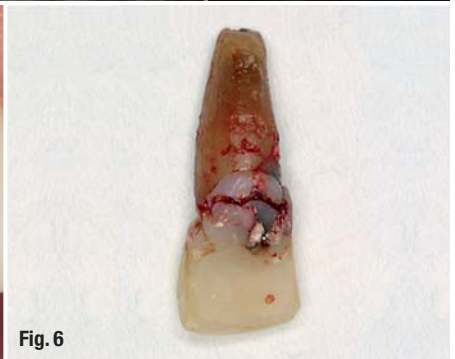
Fig. 6\_The horizontal root fracture was evident on the extracted tooth.

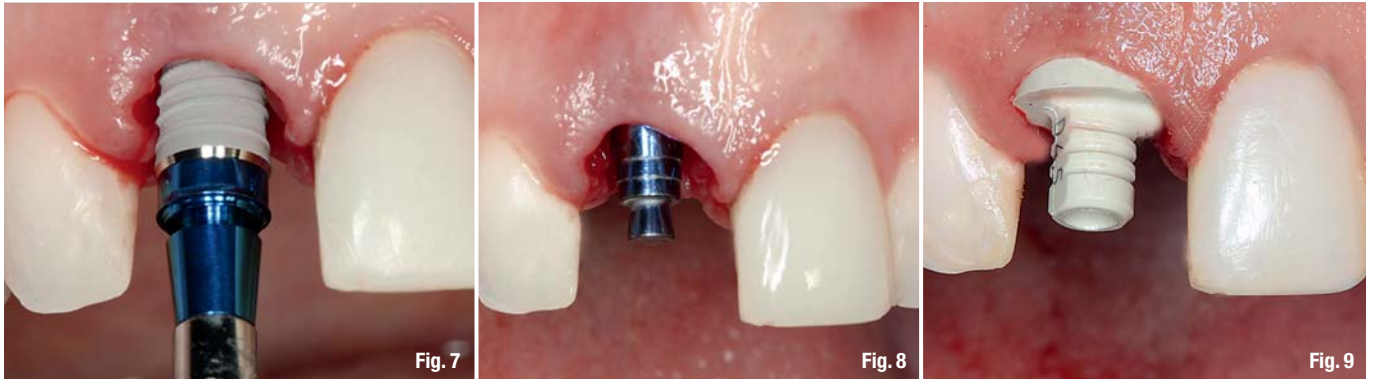
palatally. Hence, its periodontal conditions differed evidently from those of the remaining dentition. The left central incisor was discoloured and had extensive composite resin restorations with inadequate fit at the margins (Fig. 1).
