The same-day tooth: From the diagnosis to the final restoration

Author_Dr Stefanos G. Kourtis, Greece

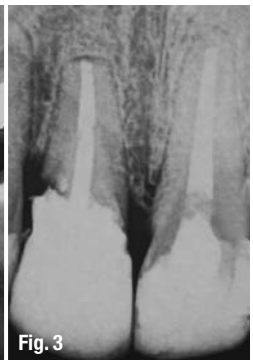
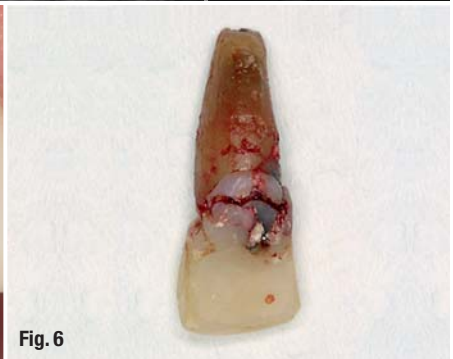
Fig. 6_The horizontal root fracture was evident on the extracted tooth.
