The same-day tooth: From the diagnosis to the final restoration

Author_Dr Stefanos G. Kourtis, Greece

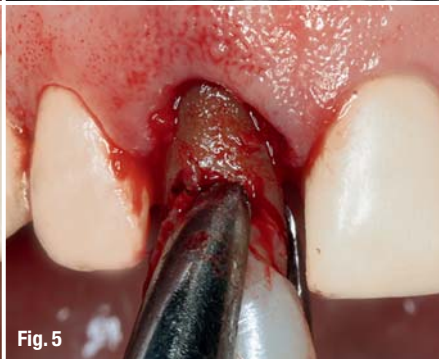
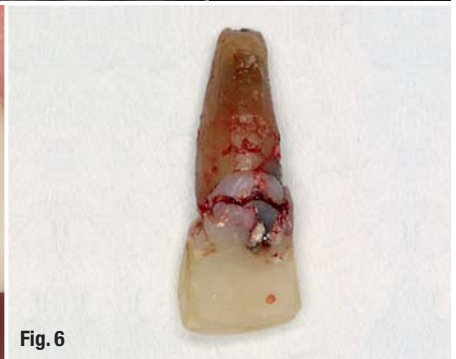
Fig. 6_The horizontal root fracture was evident on the extracted tooth.

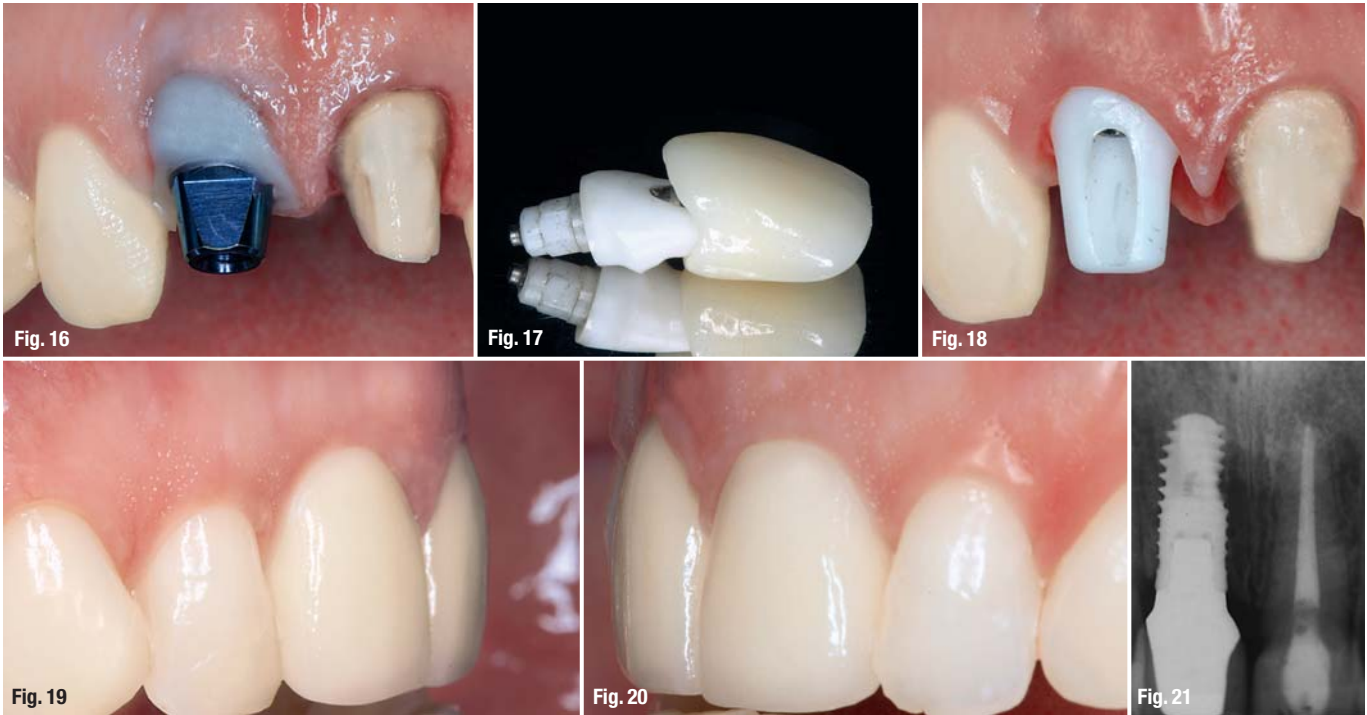
Fig. 16 Impression for the prepared natural tooth and the XiVE S plus implant.
Fig. 17 All-ceramic crown and corresponding implant abutment (CERCON).
Fig. 18 Try-in of the modified ceramic CERCON abutment.
Fig. 19 Final clinical result: buccal view of the implant restoration.
Fig. 20 Buccal view of the restored natural tooth.
Fig. 21 Radiographic control at one year post-implant placement.
