The same-day tooth: From the diagnosis to the final restoration

Author_Dr Stefanos G. Kourtis, Greece

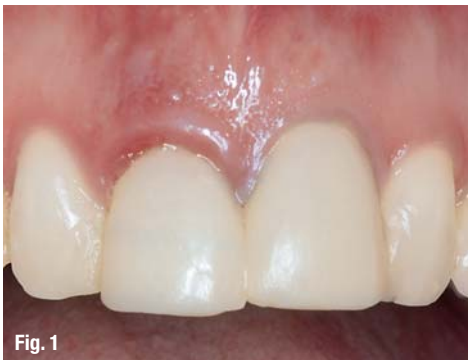
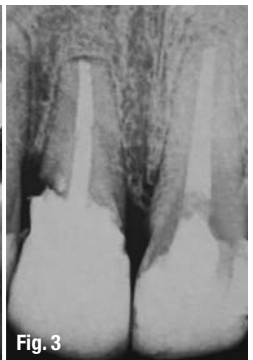
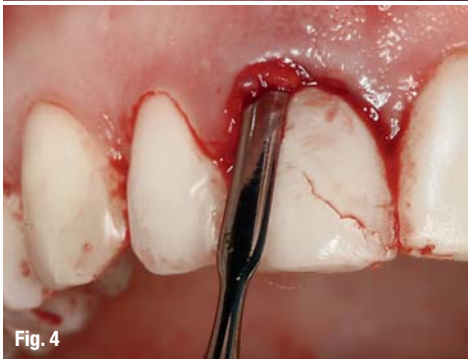
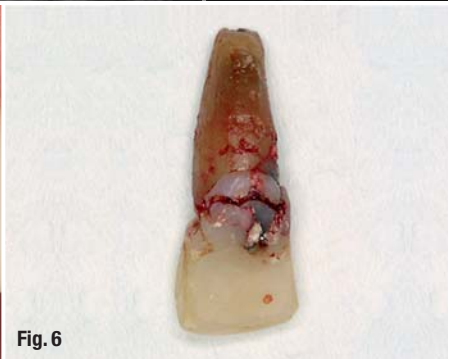
Fig. 6_The horizontal root fracture was evident on the extracted tooth.
